A Forensic Investigation on Sinkhole Formation in Urban Area

Albert T. Yeung, PhD, FASCE, FICE, FHKIE, RPE (CIV, ENV, GEL), CEng, PE¹

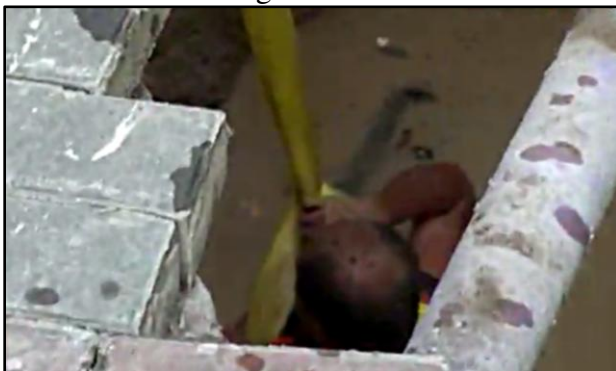
Figure 1. Falling of people into a sinkhole.

The sudden occurrences of sinkholes or ground collapse in urban areas, such as Hong Kong, can be disastrous (Friend 2002). The sinkhole can be dry or submerged in water. People, properties, and/or moving vehicles can fall into sinkholes suddenly without any warning as shown in Figures 1 & 2, resulting in personal injuries and/or property damage.

Sinkhole or Sudden Ground Collapse. A sinkhole or ground collapse occurs suddenly without any warning. The ground surface suddenly cracks and the surface materials collapse into an underground cavity, resulting in the formation of an opening on the ground surface. The sinkhole may be dry or submerged in water. In most cases, the sudden ground collapse is triggered by the application of additional load on the ground surface, such as the weight of a pedestrian walking by or that of a vehicle driving by, resulting in the falling of the pedestrian or vehicle into the sinkhole as shown in Figures 1 & 2.

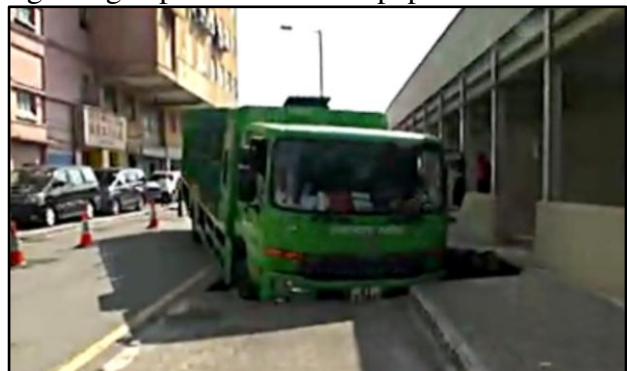
Figure 2. Falling of a drinking water delivery truck into a sinkhole.

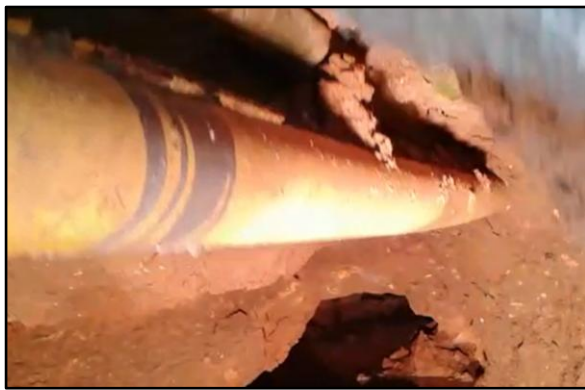
Another underground cavity was discovered farther away from the site during the field investigation. If the underground cavity is allowed to grow unnoticed by erosion, it may eventually develop into a sinkhole similar to the sinkhole of the Incident, indicating the possibility of underground cavity formation without any involvement of construction activities at the site. It can be observed in Figure 5 that there are utilities and water in the underground cavity.

Figure 5. Utilities and water in the other underground cavity.

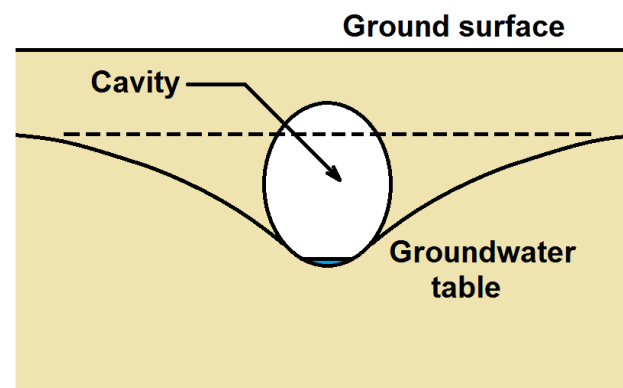
There was no observation in the site monitoring data on groundwater levels to justify any drawdown of groundwater table caused by the excavation and lateral support works at the site. However, the groundwater table may be drawn down locally in the underground cavity prior to the formation of the sinkhole as shown schematically in Figure 6 if the underground cavity was connected to somewhere thus providing a conduit for drainage of groundwater. The phenomenon explains why the victim did not feel any water in the sinkhole in addition to the fact that he was standing atop the paving blocks that fell with him into the sinkhole.

Figure 6. Local drawdown of groundwater in the underground cavity.
