Failure of Coal Ash Containment Facilities: Causes, Impacts, Remediation, and Lessons Learned

Girish Kumar¹, Iziqiel Cecchin², Antonio Thomé² and Krishna R. Reddy¹

¹University of Illinois at Chicago, USA and ²University of Passo Fundo, Brazil

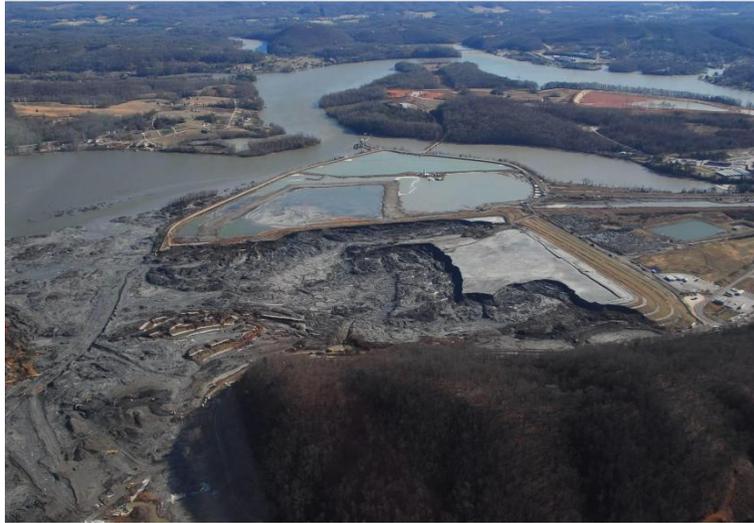
The incident at the TVA Kingston Fossil Plant occurred on December 22, 2008. The dike that held the disposed ash collapsed, causing the release of coal ash material to an area of about 300 acres in the Roane County, Tennessee, USA. An aerial survey of the affected area presented an estimate that more than tripled the first estimate of spill provided by TVA and EPA (1.3 million cubic meters), reaching over 4 million cubic meters (TVA, 2012). After the failure, the stored coal ash slurry crossed the Emory River, reaching the opposite shore of it covering about 1.2 square kilometers of the surrounding area, damaging the residences and the flowing watercourses nearby.

The mudflow caused by containment dike breakdown covered 12 homes stripping them completely of their foundation and causing damage to at least 42 other residential properties. The accident resulted in breaking a natural gas line that crossed the area, blocked a railway line, and destroyed one of the water supply systems and electricity supply lines. This incident was the largest coal ash spill in the history of US, exceeding by more than 3 times the sludge spill in Martin County in 2000, which shed 1.16 million cubic meters of coal ash slurry (TVA, 2012). A picture of the TVA incident is shown below.

Figure 1: Failure of the dike causing coal ash spill at Kingston fossil plant (Source: TVA, 2011)

The failure involved a number of contributing factors. In the EPA final report, the factors that promoted the failure of the dike that collapsed are listed. The dikes were built under the wet ash with a high void ratio and on a sensitive silt layer (slime) causing instability in the new dikes built over the existing dikes (TVA, 2012). The dredge cell area for the additional coal ash produced became smaller by introducing dikes one over the other. In order to fit the same volume of coal ash produced the height of the dike had to be increased. This increased the load on wet ash at the lower layers that rested on weak slime layer contributing to the failure of the dike. Several creep failures were also observed due to reduction in available strength in slimes.

The old ash disposed in the cell had high water content in the system, an unusually high liquid limit and relatively low undrained shear strength (TVA, 2012). In addition, the ash sent to the dredge cell had a high void ratio and low consolidation or densification by the weight of the ash from the upper layers (Walton and Buttler, 2009). Thus, the ash became highly compressible, leading to low resistance. The same report noted that TVA could have prevented the spill at Kingston Fossil Plant if it had made the recommended corrective actions as observed during the regular inspections.

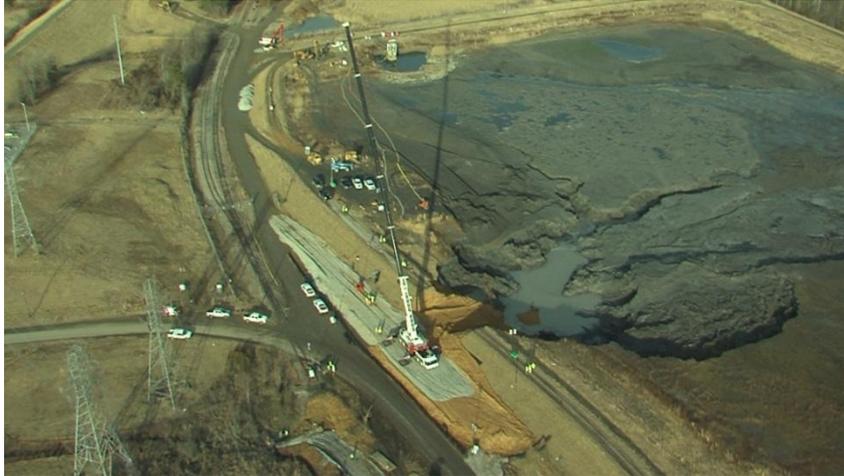
On February 2, 2014, a section of the 48 inch diameter stormwater pipe partly made of corrugated metal that ran beneath the primary ash basin collapsed releasing around 39,000 tons of coal ash and 27 million gallons of contaminated water into the Dan River (Duke Energy, 2014a). This coal ash spill was reported to be the third largest coal ash spill in the history of U.S. In a report, the United States Fish and Wildlife Service (USFWS) reported that the coal ash and ash like material were mixed with the sediments as much as 5 feet deep in places and as far as 70 river miles downstream within days following the spill. An immediate action was taken to stop the release and begin assessment of the environmental impact. A concrete plug was placed permanently at the outlet of both the stormwater pipes where the stormwater discharged into the Dan River. The ash deposits were removed from the immediate vicinity of the pipe failure and other downstream locations. Once the ash settled, few locations wherever identified, the ash was successfully removed.

**Figure 2: Coal ash spill at Dan River due to stormwater pipe collapse
(Source: Duke Energy)**

- Poorly maintained infrastructure was one of the main reasons for the failure of both the coal ash spills. In Dan River coal ash spill, there is an evidence of the failure of the stormwater pipe in the portion built of corrugated metal. Similarly, in the case of TVA facility the physical instability of the slope and the dikes were overlooked. Hence, it is imperative to check and assess for physical safety in terms of the integrity and stability of the containment system by performing static and seismic analyses to avoid such failures. Structural stability of the impoundments could be maintained by strengthening the containment features (e.g. dikes, MSE berms), and solidifying the load bearing ash to support the overlying load. Although the system is designed for a design life, there could be several factors during the course of its operation which can cause failures and hence timely inspection is indispensable.
