Vulnerability of Buildings to Landslides: Impact Loads and Failure Mechanisms

Limin Zhang¹, Liang Gao², and Hongxin Chen³

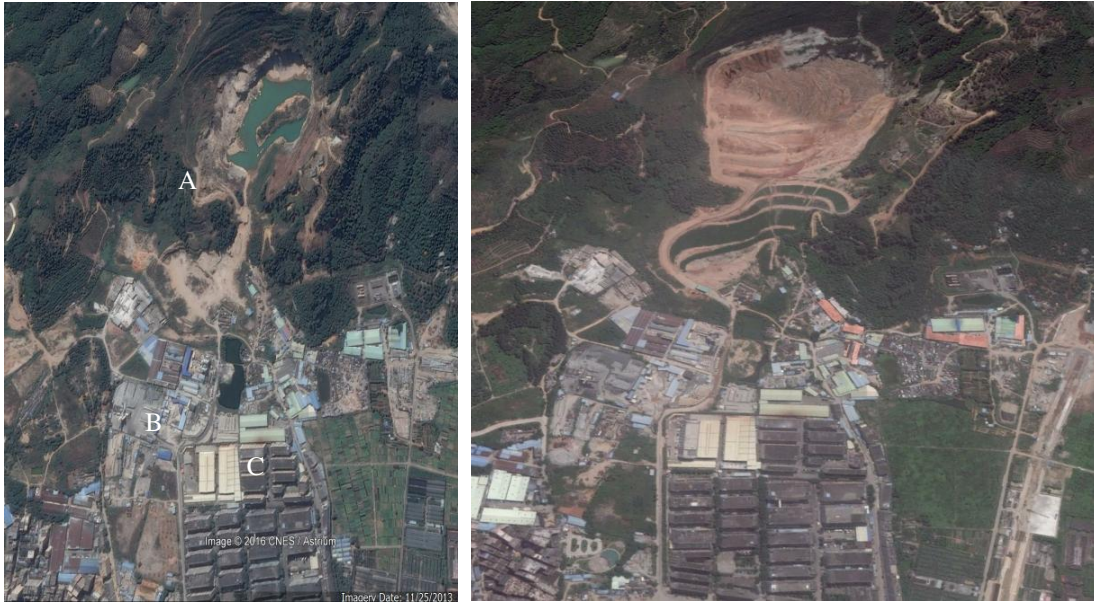
The Hongao Spoil Soil Reception site is located at northwestern Shenzhen in Guangdong Province. The site was a quarry in late 1990's and was abandoned for some time. Figure 1(a) shows the quarry by the end of 2013, which was ponded with a reservoir volume of about 90,000 m³. The quarry was later utilized as a spoil soil reception site, and was filled up rapidly in 2014 and 2015. Figure 1(b) shows the fill slope site in Sept. 2015, less than three months before the failure of the slope.

Figure 1. The spoil slope site as of (a) 25 Nov. 2013 and (b) 29 Sept. 2015.

As shown in Figure 1(b), the proximity of the spoil soil slope endangers a large number of buildings downstream. In fact, the failure of the slope on 20 Dec. 2015 buried or destroyed 33 buildings as shown in Figure 3, including 24 industrial buildings, 3 residential buildings and 6 houses. To investigate the failure mechanisms of these buildings, it is essential to rebuild the landslide debris flow and building impact process. This paper reconstructs the process using numerical modelling.

The flow velocity in the frontal area is 5-7 m/s and the flow depth was about 6 m. The flow velocities are larger than those required to push over a 5 story building (e.g. 4.29 m/s). The flow velocities when the debris flow just arrived at the buildings in Area B in Figure 1(a) are estimated

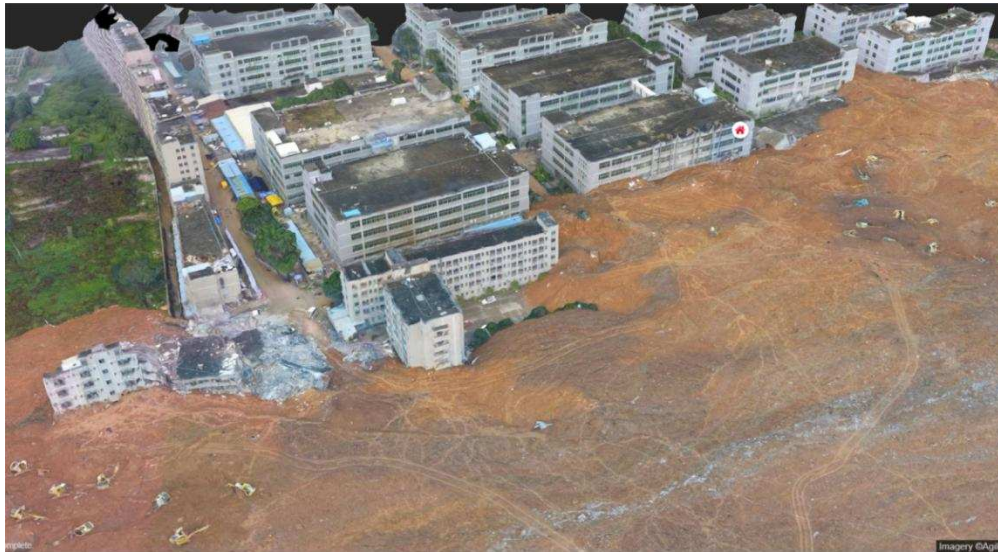
Figure. 3. Buildings that faced the landslide.

Figures 3 and 10 show the failure of several buildings at the front of the debris flow in the Shenzhen slope failure case. Two buildings (Buildings I and II in Figure 10(a)) exhibited a typical shear failure mechanism. Building I was sheared into two parts; the first part collapsed at place while the second part was sheared off its original location by about 50 m. The second building was sheared off site completely, and moved by more than 140 m.

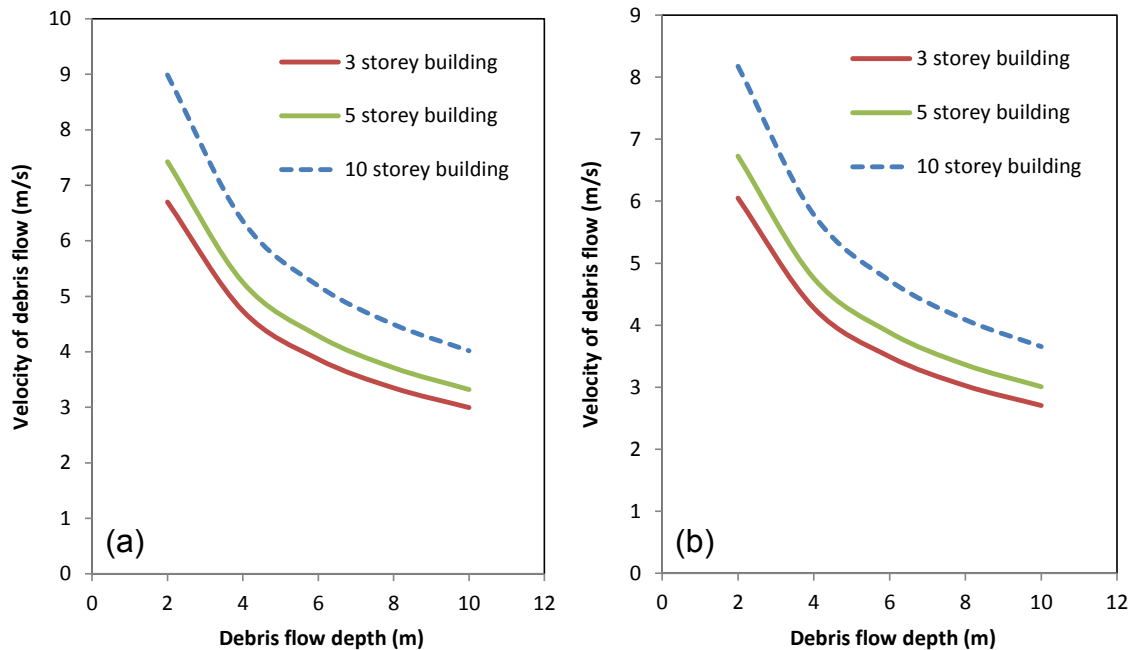
The vertical load on the foundation is the sum of the self-weight of the foundation and the superstructure load. The superstructure loading may be assumed to be 15 kPa per floor. The vertical pressures on the foundations of 3-, 5- and 10-storey buildings are shown in Table 2. Given the pressures and according to Equations (5) and (8), critical debris flow depth and velocity values are generated as shown in Figure 9.

Figure. 9. Critical flow depth and flow velocity when no boulders are involved: (a) $\phi' = 35^\circ$ and $\mu = 0.455$; (b) $\phi' = 30^\circ$ and $\mu = 0.384$.

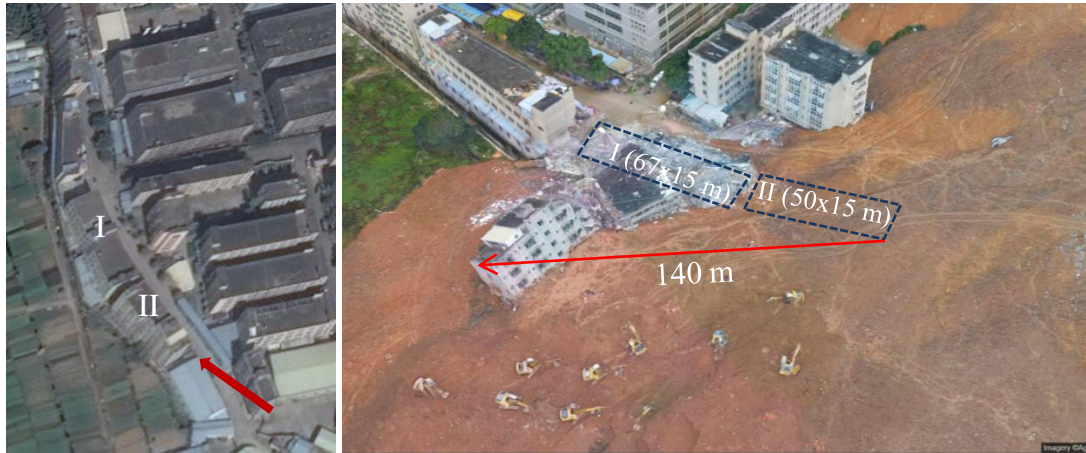
FIG. 10. Front view of the building that was subject to sliding and overturning failure. (3D images with permission from Prof. Quan Long, <https://www.altizure.com/project/567791fe9e0bd5b06ced19ba/model>).
