Rehabilitation of Southern Cross-Island Highway in a complex disaster environment

Hsin-Kai Chuang

CECI Engineering Consultants, Inc, Taiwan, kennyck@ceci.com.tw

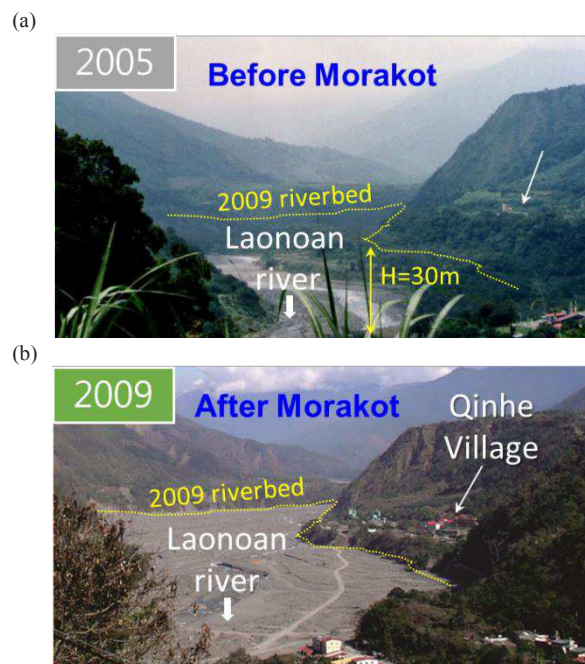
Figure 1. Figure 1-(a) shows a photo of Qinhe village by the river in 2005. Compared with Figure 1-(b), Typhoon Morakot caused river deposition of more than 30m in a short time.

In 2009, Typhoon Morakot destroyed Southern Cross-Island Highway in Taiwan. The section between Qinhe and Fuxing village was damaged severely. The storm produced 2,578mm of rainfall and caused river deposition of more than 30m in a short period of time (see Figure 1).

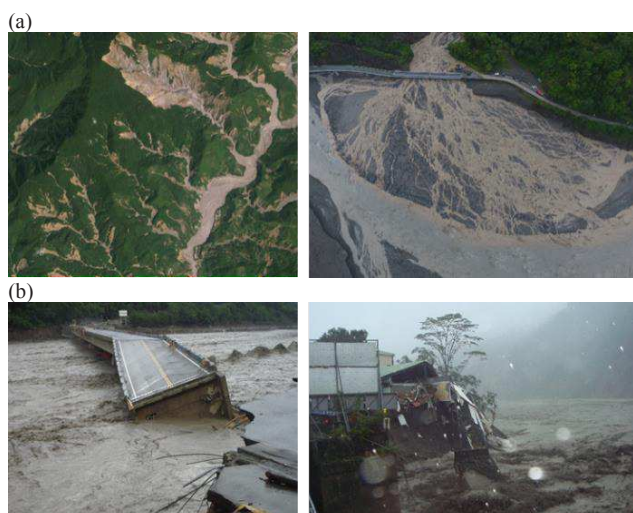
Figure 2. Figure 2-(a) shows the massive landslides and debris flow alluvial fans directly impacted the road built along the river, Figure 2-(b) shows in facing compound disasters, rehabilitation construction became quite difficult and hard to maintain.

After Typhoon Morakot, the slope stability around this site was undermined and the overall environment turned unsteady. The drastic river deposition and the frequent debris flow made temporary road repairs unsustainable, leading to multiple repair failures (see Figure 2).

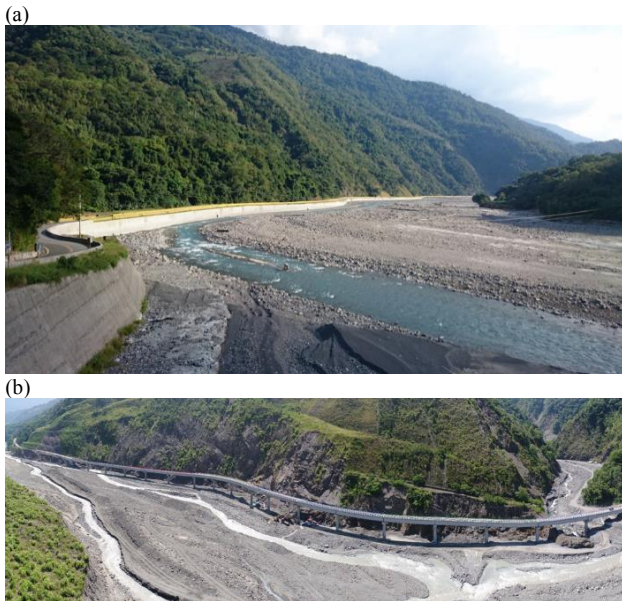
Figure 6. Figure 6-(a). The road alignment was adjusted at the northern end of this section, and several unstable slope units were avoided by lifting the road embankment closer to the river. Figure 6-(b). The viaduct form was selected at the confluence of tributaries to avoid the attack of debris flow. The mid-term road was completed in 2017. After several typhoons and heavy rainfall events in recent years, the road has survived safely.
