The paper was published in the proceedings of the 7th International Young Geotechnical Engineers Conference and was edited by Brendan Scott. The conference was held from April 29th to May 1st 2022 in Sydney, Australia.

The engineering mitigation of a water bearing fissure in the Chalk at the Tideway Deptford Church Street Shaft

Emily Riley

Card Geotechnics Limited (formerly Costain Group Plc), United Kingdom

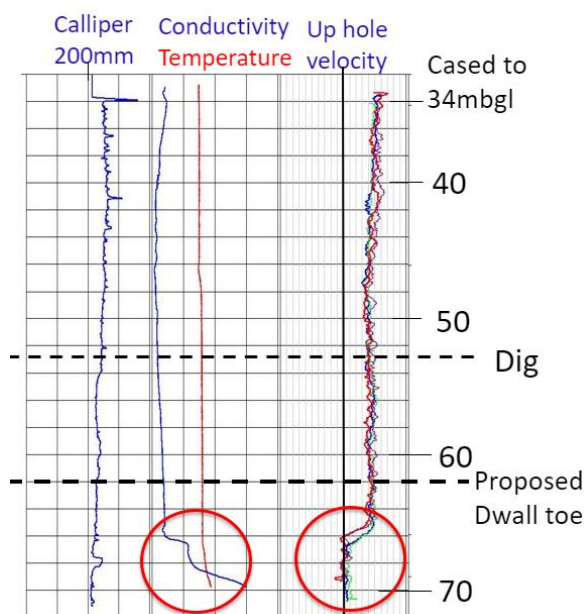
Figure 3. Geophysical logging of BH7401, identifying a feature at 66 mbgl. (original image courtesy of WJ Groundwater and European Geophysical Services)

Borehole wireline geophysics was also carried out in the pumping test well. This involves using probes lowered inside the test well to record a suite of parameters including Caliper for assessment of the borehole wall integrity, Conductivity & Temperature, Acoustic Images and Up-hole velocity. The use of borehole geophysics is described by Parker et al (2019) and when implemented to a high standard, produces good quality data. This was fundamental to understanding the large flows encountered within the pumping well. Reductions in up-hole velocity indicate where groundwater is entering a well. Where permeability is fairly uniform, case studies typically indicate a gradual stepped reduction to zero as inflows are provided by the fracture network.

However, during the geophysical testing of the initial pump well at Deptford Church Street indicated that almost all the groundwater inflow entered the well at 66 metres below ground level (Figure 3), approximately 4 metres below the proposed toe of the diaphragm wall, evidenced by a large step to near zero up-hole velocity. The optical borehole log identified a steeply inclined north dipping fissure at the same depth in the chalk. The apparent dip of the fissure was 67 degrees to the horizontal towards the north (000) suggesting that it would be cut-off by the diaphragm wall on the south side of the shaft but potentially pass up to 40 metres below the design toe depth of the diaphragm wall to the north.

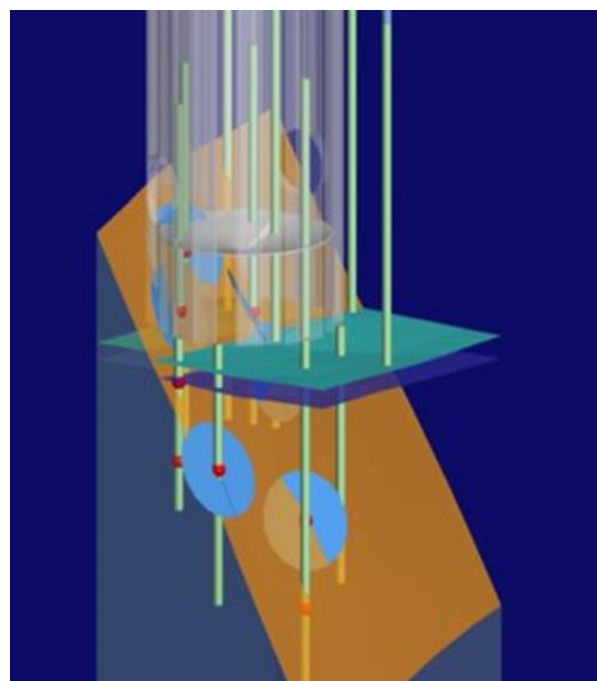
Figure 4. 4D model extract of the fissure (postulated in orange) with known strikes in each borehole indicated as red dots and disks indicating orientation where measured in downhole geophysics. Produced by Mott MacDonald.

BH7403 was drilled deeper than BH7404 to the South, with calculated drill depths a response to the large angle of dip. Pump testing of both wells confirmed that almost all inflow was associated with single fissures intercepted at 54 metres below ground level (up dip) and 80 metres below ground level (down dip) of the original feature. The downhole image logs showed an almost identical feature, very close to the predicted horizon and dip angle, confirming that all three wells showed hydraulic connection with the fissure. An extract from a 4D model of the boreholes drilled, depth of fracture encountered in relation to the design depth of the diaphragm wall is shown in Figure 4.

The projection of the fissure plane between all three boreholes suggested that it would intercept the base of the drop shaft, which

was still to be constructed. As such the fissure presented a risk of large inflows and inundation of the drop shaft during excavation. As hydraulic connection with the fissure was present in all three wells as confirmed by pump test, the opportunity was taken to implement a targeted pressure grouting campaign. The boreholes provided a direct pathway into the feature and an opportunity for eliminating the requirement of any additional groundwater control works, such as the completion of a stepped grout curtain or base grouting exercise.

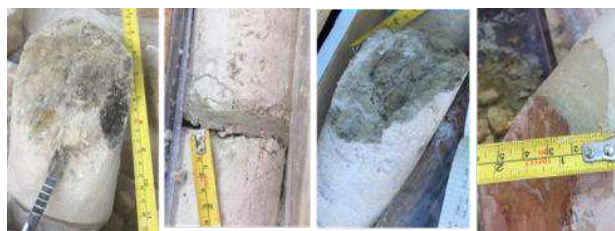
Figure 5. Areas of grout identified within boreholes drilled below the toe of the diaphragm wall

To further confirm the success of the grouting campaign, additional verification investigations were made before the commencement of shaft excavation. Reservation tubes are often included within diaphragm wall panels to allow verticality checks and for any Instrumentation and Monitoring installations that may be required for long term assessments of the structure (Schwamb et al., 2016). The reservation tubes provided an opportunity to drill below the toe of the diaphragm wall to provide confirmation of grout infill within the fissure. High quality Geobore S methods enabled high quality recovery of chalk from a range of depths below the toe of the diaphragm wall. Four boreholes positioned around the circumference of the shaft were geologically logged to identify fissures and key marker bands. All of these boreholes encountered a fissure around the projected depth, two containing grout fill and the other two locations showing the fissure to be closed with undulating, striated, grey and black stained surfaces (Figure 5). These observations confirmed that grout had travelled to the shaft perimeter in the open parts of the fissure, but also indicated that

the fissure was closed in some places due to small scale undulation on the fissure surface.

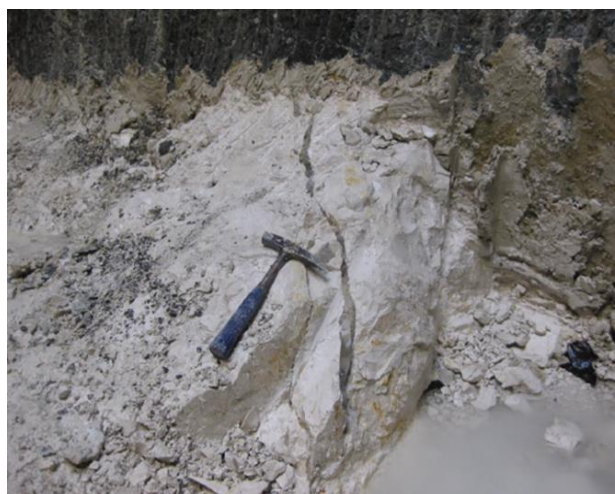
Figure 6. Grouted fissure exposed during the shaft excavation (photo by Tim Newman).

During the shaft excavation, regular visits by the Project Geologist, Designer and Imperial College PhD Students were completed. These provided an opportunity to visually inspect the treated chalk to further assess the effectiveness of the grouting campaign; verification rarely possible following an in-situ grouting campaign. The grouted fissure was encountered towards the base of the chalk excavation (Figure 6), with travel of grout observed at the very edge of the shaft corroborating with the observations of grout inside the reservation tube boreholes. This confirmed that the potential risk of shaft inundation would likely have been realised without the mitigation measures. The absence of significant water flow along the grouted fissure provided the further confirmation that the risk of a significant water pathway had been suitably mitigated at the time.

Fracture logging and review of marker horizon depths (Shoreham Marls) estimated that north-south across the fissure, a maximum of one-metre offset was apparent. This in combination with the striation observations confirmed that the fissure was a small offset, normal fault.
