# Monitoring the Construction of a Large Diameter Caisson in Clay

**R. Royston**<sup>1,2)</sup>

Large diameter caissons are a common solution for creating attenuation and storage for foul and storm water. This paper describes the monitoring undertaken on a 13 m external diameter caisson at Sloway Lane (Bridgewater, UK). The caisson was formed using a 1 m thick in-situ reinforced concrete section, and sunk through soft clay (Blue Lias) to a mudstone formation 20 m below ground level. This paper considers the construction process, describing an instrumentation system on the caisson shaft, used to enhance understanding of caisson sinking in clay. An innovative levelling system was developed and deployed, measuring caisson movements to within 1 mm. Load cells were placed on the outside of the wall, measuring the soil-structure interaction during sinking. All measurements were processed in real-time and used to guide the construction process on site, via a tablet, in conjunction with wireless connectivity.

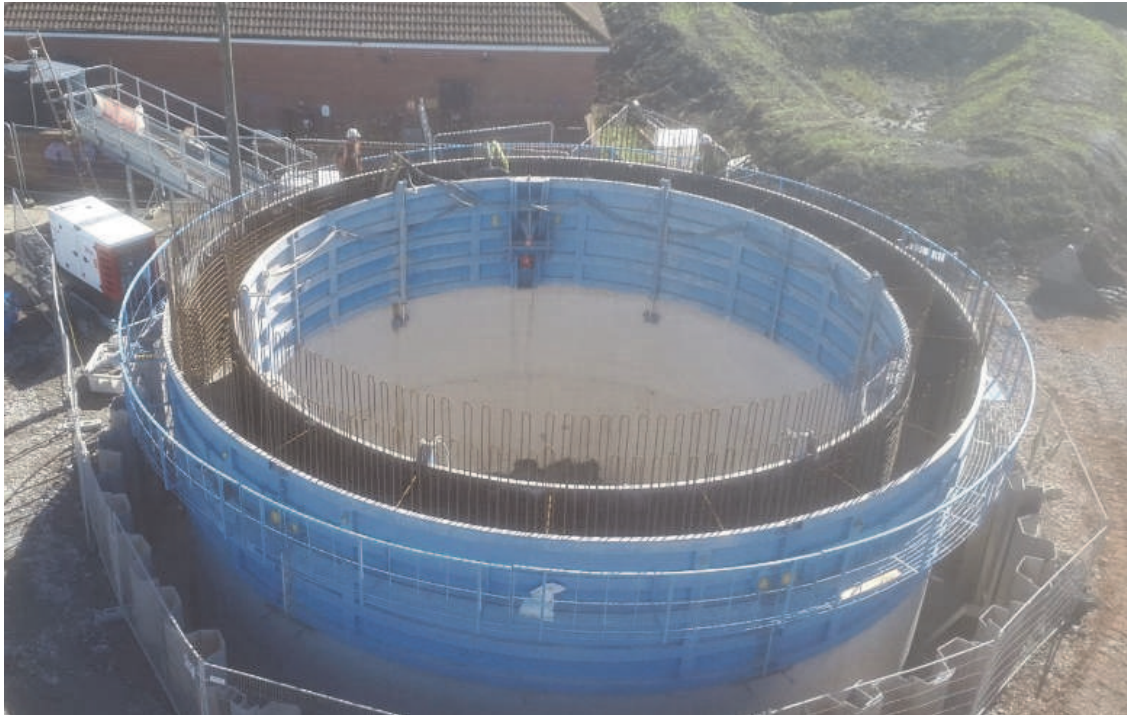
**Fig. 1:** Sloway Lane caisson under construction

This paper describes the construction and monitoring of a 13 m external diameter, 20 m deep caisson installed at Sloway Lane, West Huntspill, UK (see Fig. 1). The caisson was constructed using a complex system of concurrent casting of 1 m thick concrete walls and excavation of the soil, both inside and beneath the caisson wall (Royston et al., 2016). A tapered edge ( $60^\circ$ ) is adopted at the base of the wall to provide control during caisson sinking, see Fig. 2. The self-weight of the concrete wall provides the kentledge for sinking the caisson. A 1 m thick wall was used to reduce the risk of reverse bearing during the internal excavation of the soft clay. The heavy wall allowed the caisson to sink into the ground, with the internal soil plug countering the external soil load. The caisson was founded 20 m below ground on firm mudstone strata.

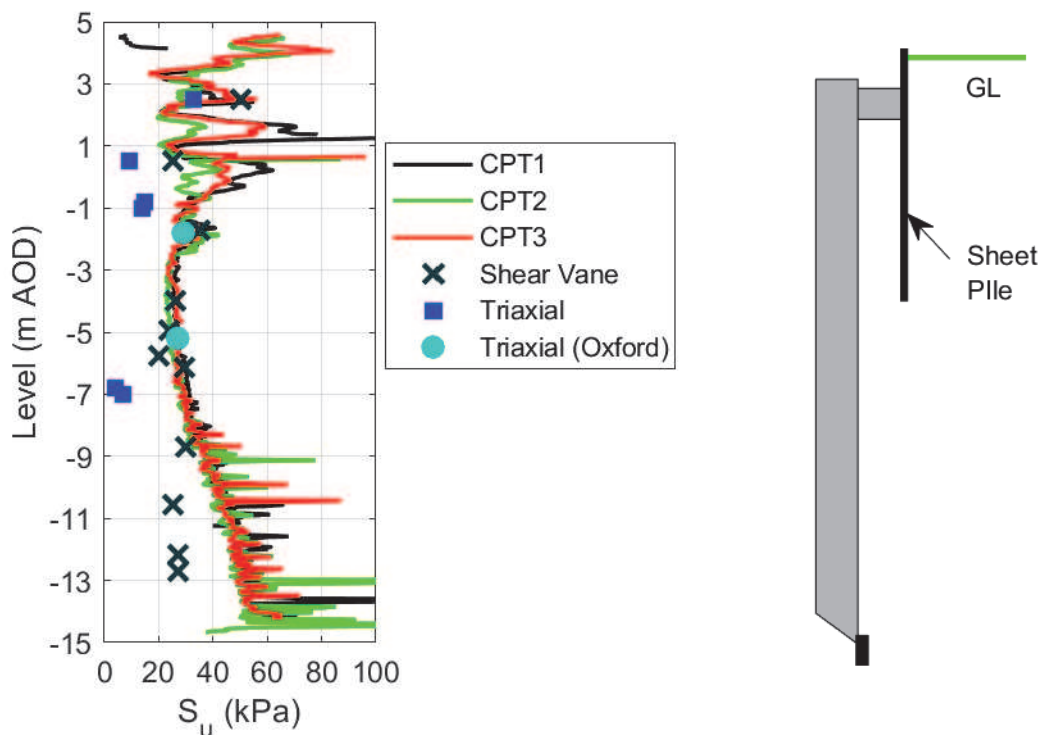
**Fig. 3:** Site investigation

Local geology comprises 20 m of soft normally-consolidated ‘Blue Lias’ clay, underlain by mudstone. Undrained shear strength,  $S_u$ , measurements determined from cone penetration tests (CPT,  $N_{kt} = 19$ ), hand shear vanes and triaxial tests are shown in Fig. 3. The newly constructed 13 m diameter caisson was located 8 m from the control building which houses a sewage treatment works and pumping systems (see Fig. 2).

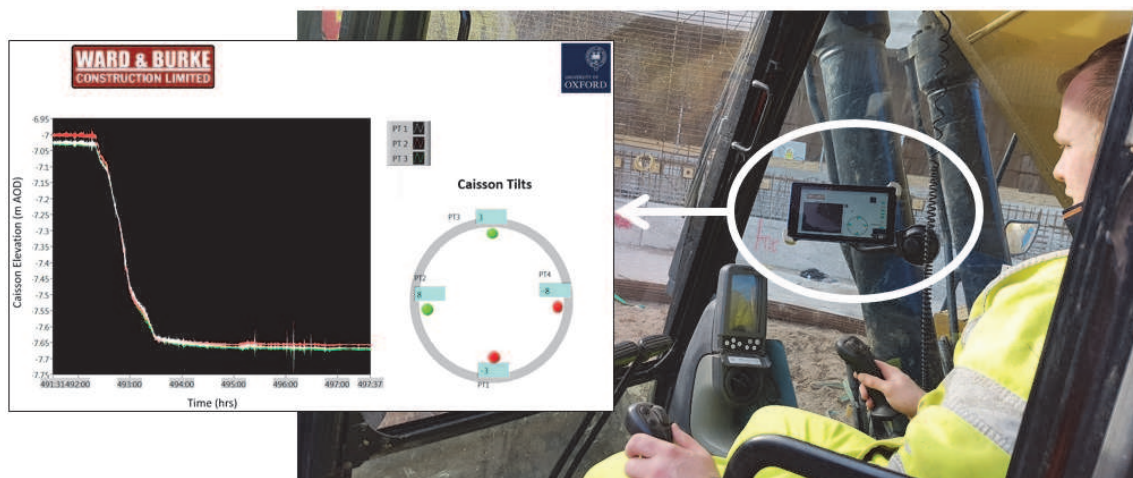
**Fig. 4:** Monitoring dashboard located in excavator during caisson sinking

The instrumentation installed on the caisson comprised a level detection system along with sophisticated load cells for measuring SSI during the caisson sinking process; see Fig. 2 for instrumentation layout. The load cells were designed for quick field deployment, to comply with the strict project timetable. Consequently, preparation time at site was minimised, with the installation of the instrumentation resulting in no time delays, or interference to the construction process. All cells and equipment were waterproofed to withstand severe environmental conditions. Cables were cast through the centre of the 1 m thick caisson wall to ground level, and brought to the control building through underground ducting. All sensors were continuously logged at a rate of 1 Hz and displayed wirelessly to the site team via a tablet (see Fig. 4).

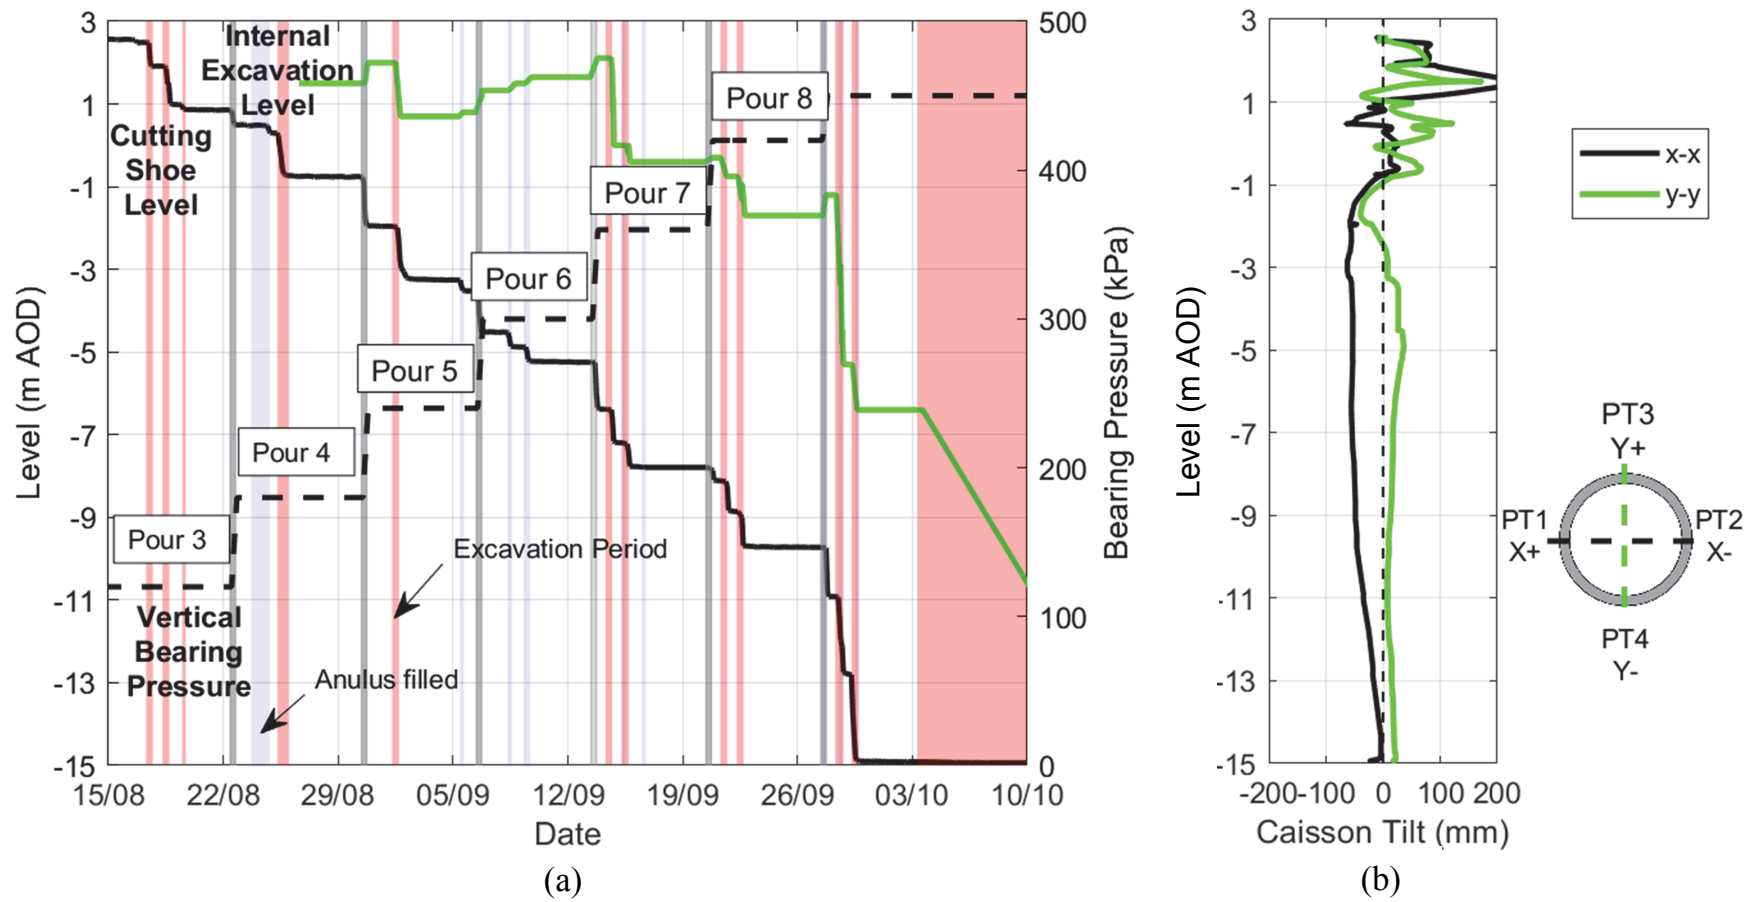
**Fig. 7:** (a) Caisson and internal ground level movements, (b) Caisson tilting during sinking

The movement of the caisson, and the actions that cause movement, is of interest during sinking. Fig. 7(a) displays the time history of caisson motion, showing vertical displacement, excavation level and downward vertical pressure applied from concrete pours. Caisson movement occurs as a result of three actions: (i) increasing caisson weight, (ii) internal excavation (pink), and (iii) pumping TK60 into the annulus (blue).

From Fig. 7(a), a clear trend is noted; as additional pours are added the caisson penetrates further into the ground. The forces which resist the vertical load are: (i) bearing beneath the wall, (ii) internal overburden and, (iii) the internal and external friction between the wall and the soil. These forces move out of equilibrium when movement takes place.

Fig. 7(b) shows the difference in level across the caisson (i.e. “tilt”). This is vital information used by the site team for controlling the caisson sinking. A positive relative tilt value means the caisson is higher at that location. As the downward force increases and embedment becomes larger, tilting begins to reduce and fewer changes in direction are observed. The importance of vertical alignment at the beginning is highlighted by the larger tilting between 3 m AOD and -1 m AOD. As embedment increases the tilt becomes more difficult to correct, due to the soil inside the caisson. Each change in tilt corresponds to an action on the caisson. The caisson guide collar acts to maintain verticality of the caisson as sinking progresses.

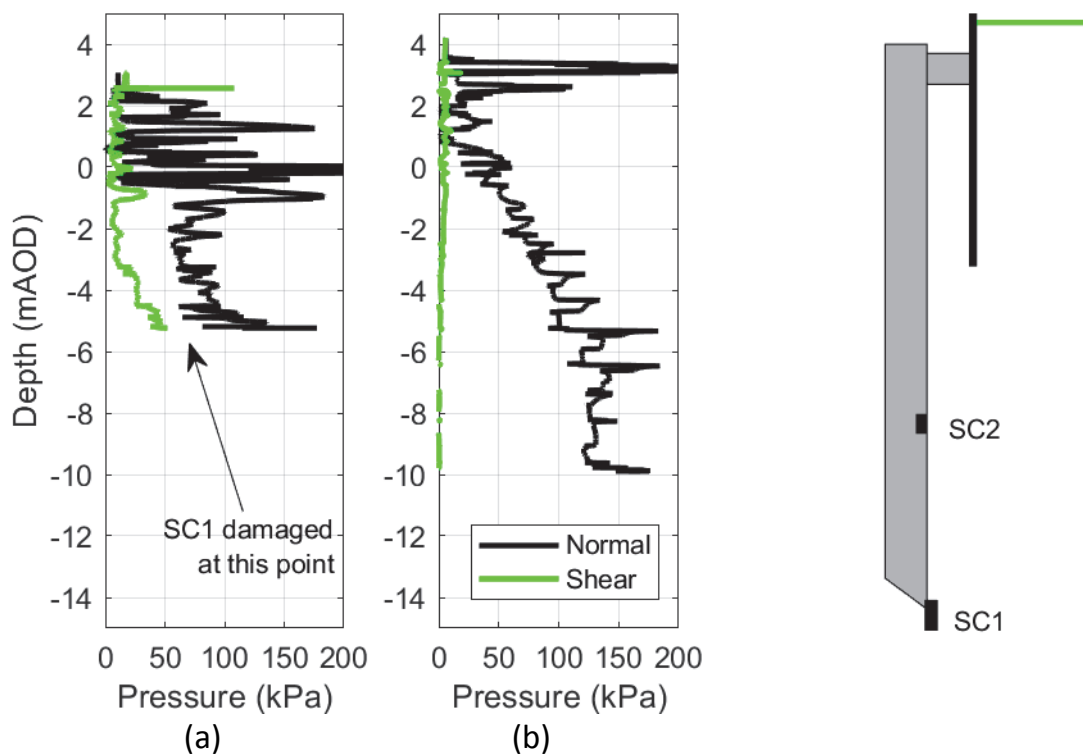
**Fig. 8:** Normal and shear force at wall soil interface (a) SC1, (b) SC2

The friction and normal stresses that develop on the caisson wall are shown in Fig. 8. The lower cell (SC1; Fig. 8), placed in the cutting edge and in contact with the clay, indicates the friction and normal pressure increase with depth. Unfortunately, this cell was damaged at -5.2 m AOD. The variations shown on SC1 are due to actions, such as pours and excavations, and the large tilts experienced at the beginning of sinking. The upper cell (SC2; Fig. 8) records minimal shear stress indicating no contact with the ground. The normal pressure on the cell corresponds to the pressure head from TK60 filling the annulus. These measurements confirm that the annulus remained open.
