## Geotechnical investigation for determination of causes for occurred deformations of the Skopje Aqueduct

*This paper deals with geotechnical investigation works for assessment of factors which led to occurrence of deformations of Skopje Aqueduct – significant monument for Macedonian cultural heritage.*

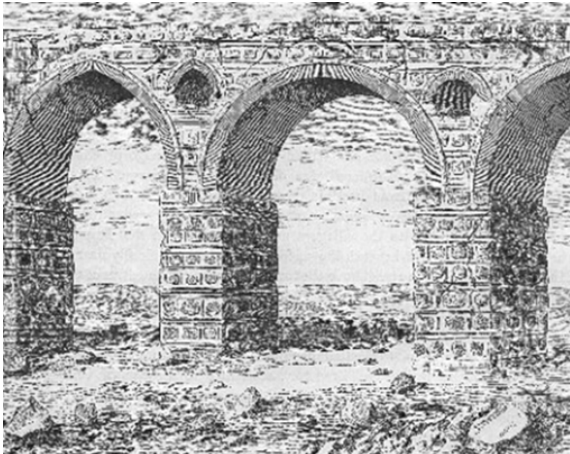
Figure 1. The oldest overview of the Aqueduct in Skopje, drawing from year 1883-1884 (published by the English archaeologist Arthur John Evans, 1885)

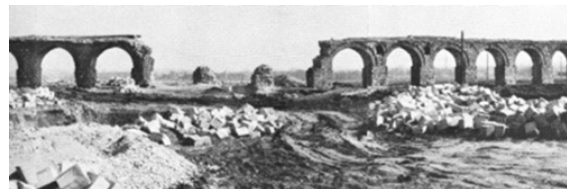
Figure 2. Aqueduct after the dynamites' exercise

Few construction phases and repairs can be noticed on the building. Most of those originate from the end of 19<sup>th</sup> century and the beginning of 20<sup>th</sup> century. After the Second World War, three vaults were destroyed by mines in a military exercise to demonstrate the destruction of bridge vaults. It is presumed that these vaults were reconstructed in 1968 yr.

The last restoration of the Aqueduct was carried out after the earthquake in Skopje in 1963, repairing three arcs and two pillars destroyed due to the earthquake activity.

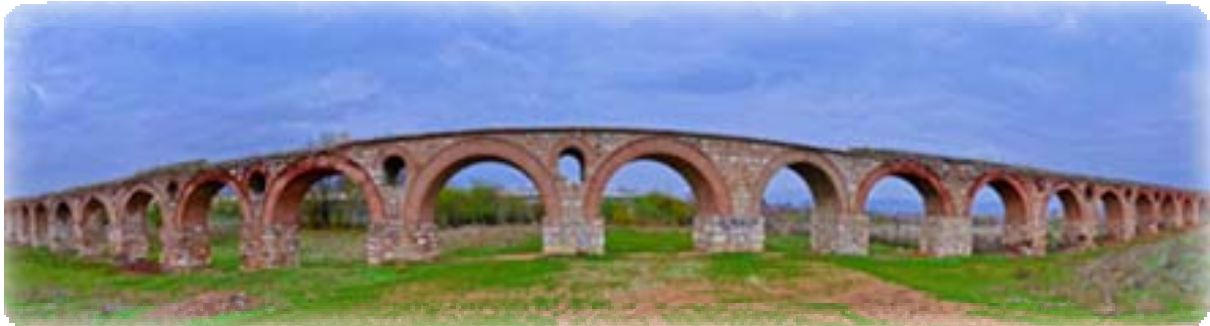
Figure 3. Panoramic view of the Aqueduct in Skopje

In the central part of the Aqueduct the construction is not vertical, it is with an inclination to the west which is up to 53 cm, and there is a very serious problem of disturbance the stability and demolition the section between pillars no. 9 and pillars no. 15.

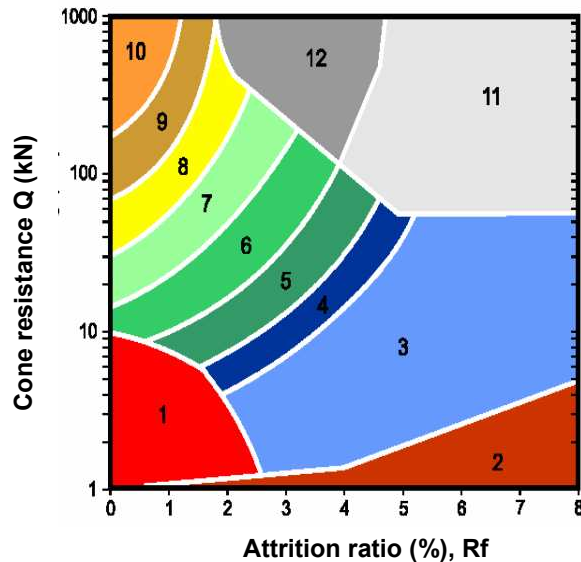
The classification of soil materials is performed according the recommendations of Robertson et al, 1990 which is showed in following pictures and tables.

Table 7. Classification of soil materials
