The paper was published in the proceedings of the 25th European Young Geotechnical Engineers Conference and was edited by Ernest Olinic and Sanda Manea. The conference was held in Sibiu, Romania 21-24 June 2016.

Eurasia Tunnel Project: The Geotechnical Challenges of the Asian Transition Box

Alexis ROSE*

WSP | Parsons Brinckerhoff, Cardiff, UK

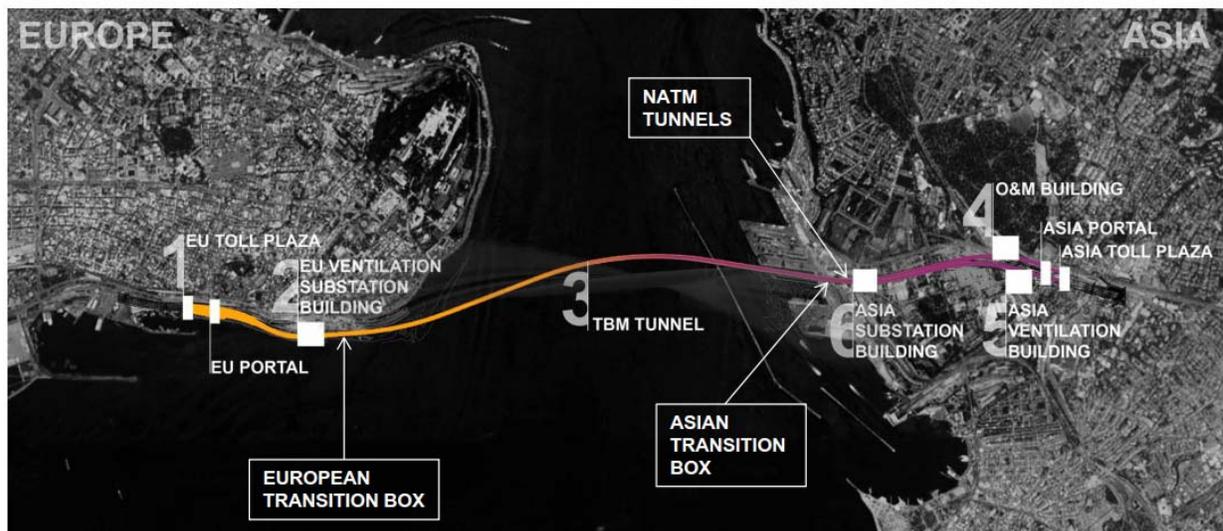
Figure 2. Eurasia Tunnel design elements

The main elements for the 14.6km route are shown in Figure 2. The approximate lengths of the alignment components are as follows:

- 5.4km European approach roads
- 3.8km Asian approach roads
- 3.4km TBM tunnel
- 1.0km NATM tunnel
- 1.0km cut and cover tunnel

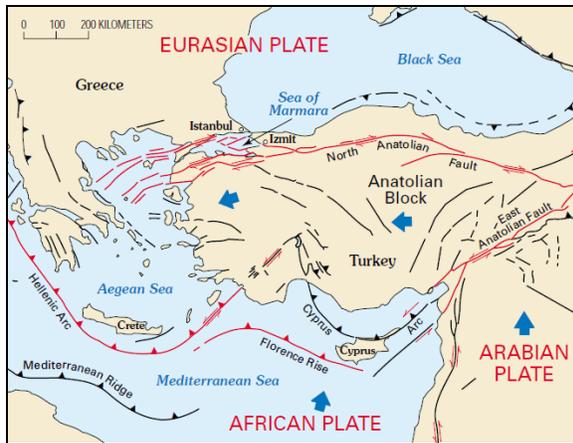
Figure 3. Fault map

The geological setting is within a large scale fault system called the North Anatolian Fault Zone. The Marmara Fault System is the part of this fault zone that runs beneath Istanbul and many strong earthquakes occur along these fault lines. The fault map is shown in Figure 3.

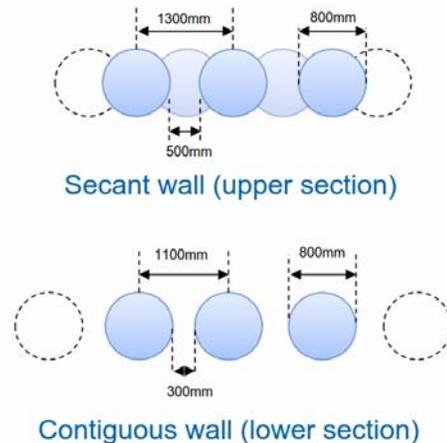
Figure 4. Pile dimensions

The option taken forward to final design involved an upper secant piled wall and a lower contiguous piled wall, as shown in Figures 4 and 5. The secant piles were up to 21m in length and the contiguous piles were up to 25m in length, all reinforced to full depth.

The ground anchors were up to 38m in length. They were double corrosion protection (DCP) anchors and were prestressed to 60 tonnes.

It was preferred to construct the wall in a two-phase approach because there were concerns over buildability and the installation of ~50m long piles into rock. This solution would provide a stiff ground control system and allow for flexibility in adapting the design if necessary, via the observational approach.

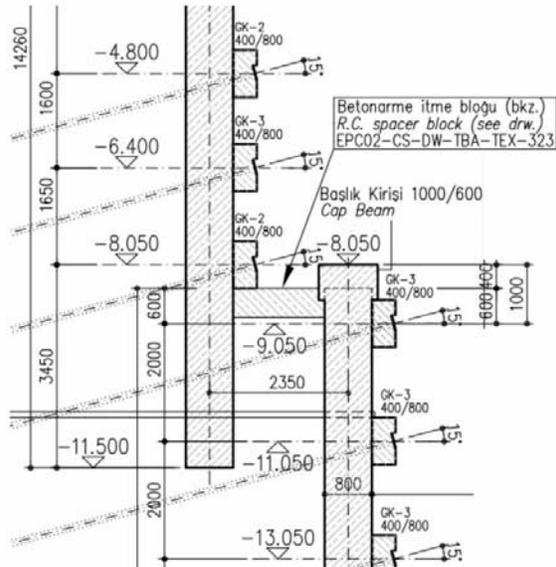
Figure 5. Interface between piled walls

The secant piled wall was required for the top half of the excavation, where ground conditions and water seepage was considered more likely to be a problem. Accordingly, the design included inclined drain holes within the lower part of the secant piled wall to prevent build-up of water pressures. A contiguous piled wall was considered appropriate for the lower level, where the ground conditions were believed to be more favourable.

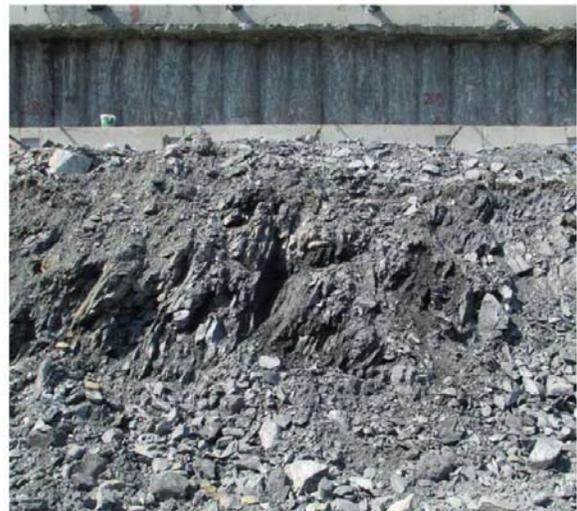
Figure 6. Fault breccia

Excavation began in April 2013. Examples of the ground conditions revealed during excavation are shown Figures 6 and 7. As indicated in Figure 7, the material at some locations was extremely weak and clayey and could be excavated by hand. It was clear that in these instances, the material did not accord with the geotechnical design parameters. Also, groundwater was a problem and was observed flowing from the excavation walls and collecting in the base of the excavation.

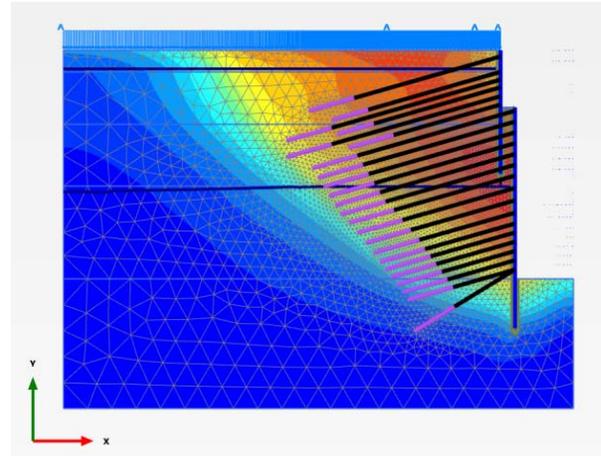
Figure 8. Plaxis model example

The back analysis was undertaken using Plaxis 2D software (Figure 8) and aimed to replicate the observed deflections. The Mohr-Coulomb soil model was unable to reproduce the observed deflections and it was proposed to use the Hardening Soil model.

The Hardening Soil model allows stress dependency of soil stiffness, where different stiffnesses can be applied to primary and unloading moduli. It was not originally considered appropriate to use this soil model for the initial design because the added degree of complexity

could not be supported by the available data. However, with the addition of the monitoring data to allow model calibration, this approach was now regarded as the preferred solution. The analysis revealed a failure surface behind the wall within the free anchor length zone.

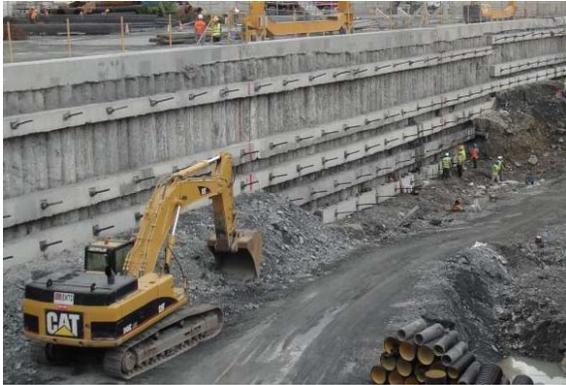
Figure 9. Progress 1st July 2013

Following the successful reanalysis and revised design of the ATB, the excavation recommenced. Work was only halted for two weeks before the new design started to be implemented on site. The stages of progress are shown in Figures 9 to 11. Final excavation depth was reached in January 2014.
