Stabilization of railway landslide with bored pile retaining wall

Marko BISCAN^{1*}, Goran DIZDAR^{1*}

¹Institut IGH d.d., Zagreb, CROATIA

On the RAILWAY ZAGREB-RIJEKA, instability (landslide) has been noticed from km 571+270 to 571+700 (line is in the cut), but since 1958 mentioned part of railway was never fully repaired. For improvement was chosen 140 m long bored pile retaining wall, 10 m deep, with horizontally dug drains. Plaxis 2D and GeoStudio-Slope/W software were used for simulation of the current situation and for designing stabilization elements. The solution is implemented and there are several measurements of pile retaining wall displacements that will be presented.

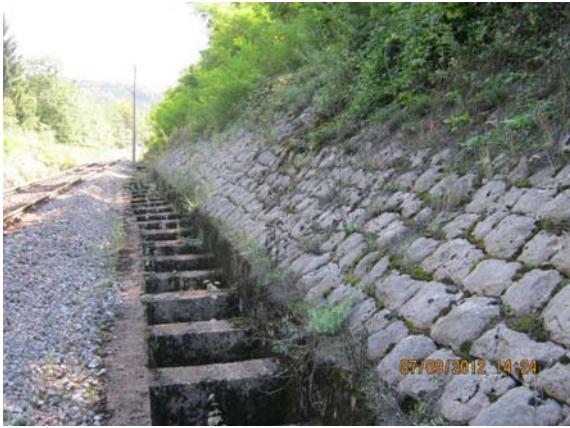
Figure 1. Previous solution – drainage channel and stone facing

railway track, damaging drainage channel along the track and stone facing in the cut.

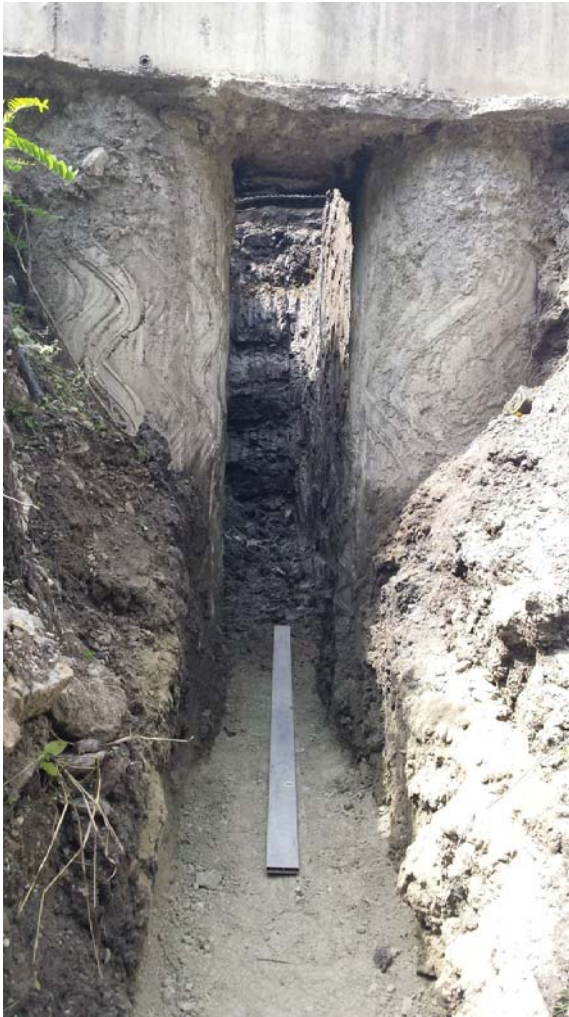
Figure 10. Photo of performed piles during drainage installation

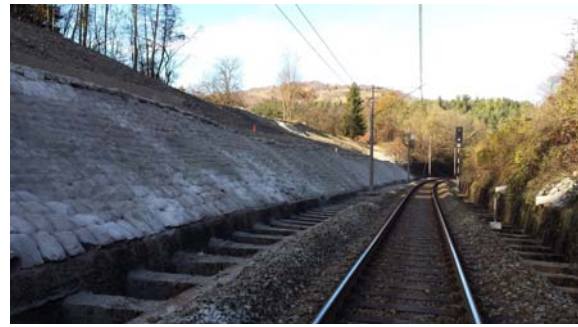
Figure 10. Photo of renewed stone facing with pile retaining wall

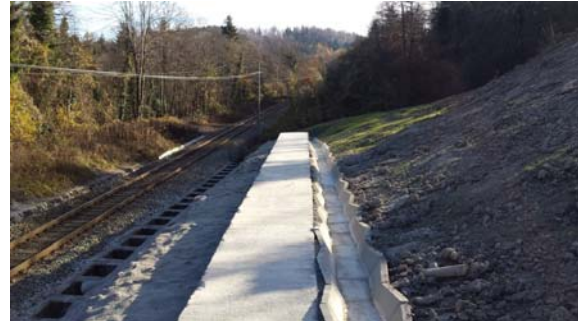
Figure 11. Photo of performed pile retaining wall

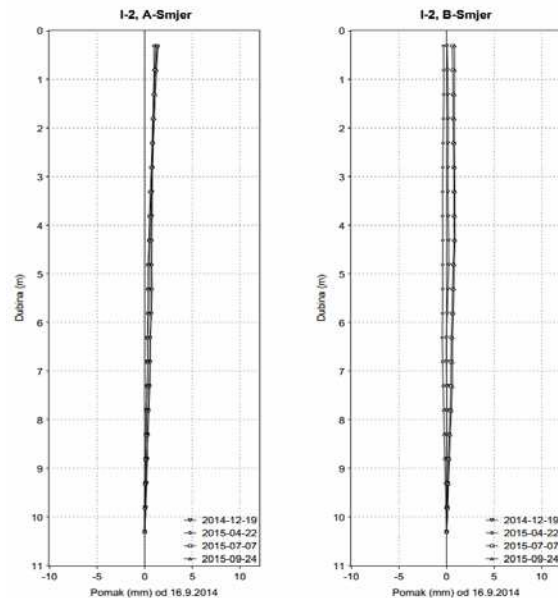
Figure 12. Display of inclinometer measurements

Observation included horizontal displacement monitoring of pile retaining wall, using the built-in inclinometer tube. Inclinometer tube is built into the pile. The measurement shows a peak horizontal displacement of pile for about 2 mm in the period since the end of reconstruction to today.
