# Raising the standard of flood protection in Hull: the Humber Hull Frontages flood defence scheme

L. Allievi\*, A. Willoner  
Mott MacDonald, Sheffield, UK

**ABSTRACT:** The Humber Hull Frontages flood defence scheme reduced the risk of flooding from the Humber estuary for 113,000 properties and it consists of more than seven kilometres of tidal flood defences along the estuary frontage. This paper describes the design of a variety of flood defences in challenging ground conditions, typically comprising deep fill deposits associated with the pre-existing flood defences and with large areas of reclaimed land overlying normally consolidated soft tidal flat deposits. The solutions provided to overcome multiple design and construction constraints due to the current and historical use of the project setting are presented in this paper.

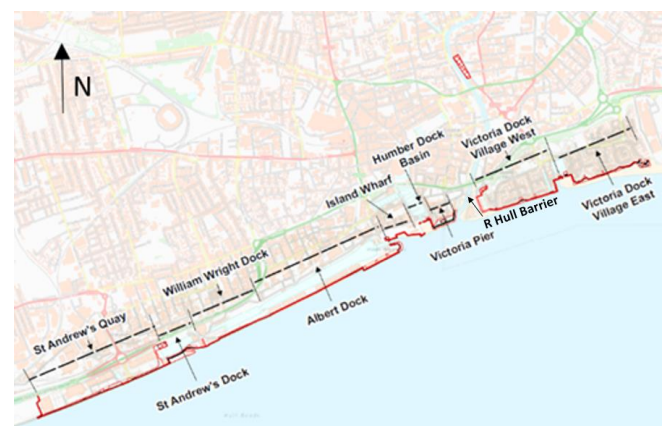
Figure 1. Plan overview of the Humber Hull Frontages scheme.

The £42 million scheme reduced the risk of flooding for 113,000 properties upgrading more than seven kilometres of tidal flood defences, from St Andrew's Quay Retail Park in the west to Victoria Dock Village in the east, as shown in Figure 1.

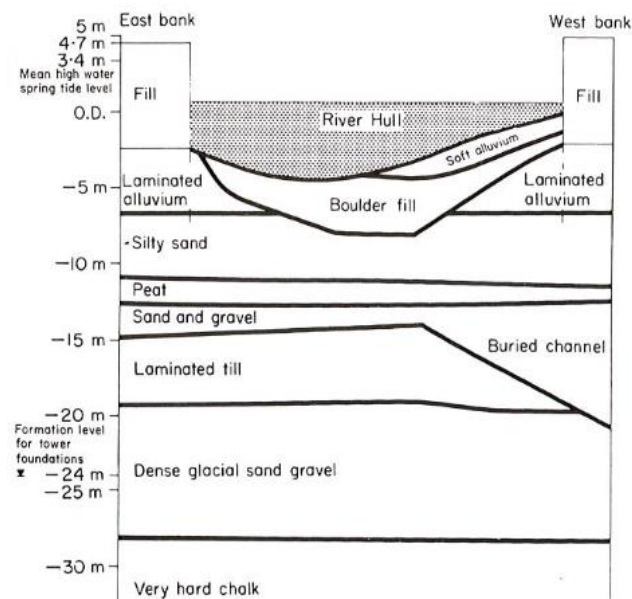
Figure 2. Conceptual ground model of the River Hull Barrier (Fleming et al., 1980).

A conceptual ground model of the River Hull Barrier, which is also applicable to the HHF project, is depicted in Figure 2.

In general, the ground conditions at the scheme comprise a variable thickness of made ground overlying TFD. Notably, along the Humber frontage vast areas have been reclaimed from the estuary through time and flood defences were built on top of the reclaimed land, resulting in the presence of sections of deep fill, mostly consisting of reworked TFD, overlying a starter layer of gravel to cobble sized chalk. Typically, a 1.0 to 1.5m thick firm to stiff desiccated crust is found at the top of the TFD, where this has not been removed by historical anthropogenic activities. The underlying TFD generally consists of normally consolidated low-strength and low-stiffness silty clay and clayey silt with organic content and peat layers.

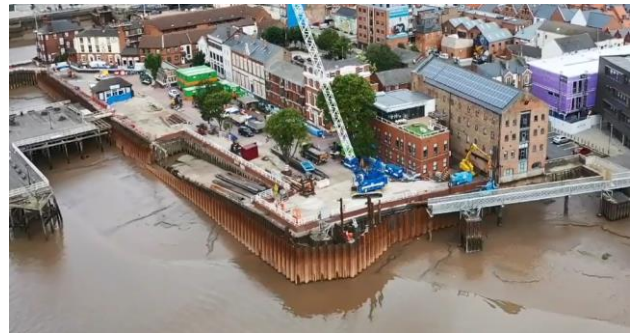
Figure 3. Construction works at Victoria Pier.

The new flood defences required complex piling works as the poor condition of the existing tied sheet pile wall indicated minimal residual life to support a new gravity flood wall constructed on the land.

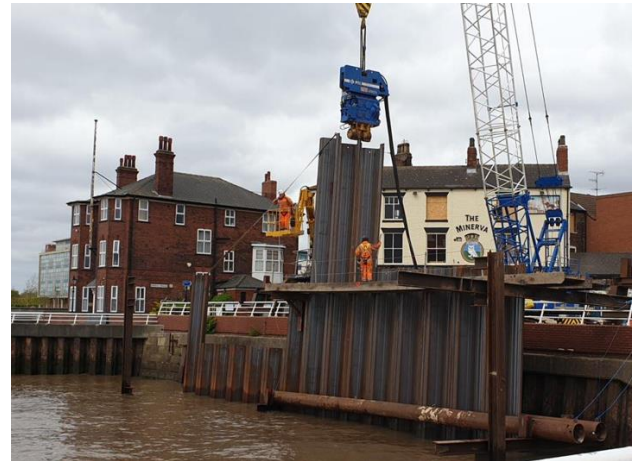
Figure 5. Installation of raked piles along the Humber.

Works commenced with the upstream piles, installed at a 3-degree rake 2m in front of the existing wall and 15m in length to avoid conflict with the exiting piles at depth. Although small, the rake on the sheet piles made the design of the wailing beam complex and a double UKB was needed to resist eccentric loading.

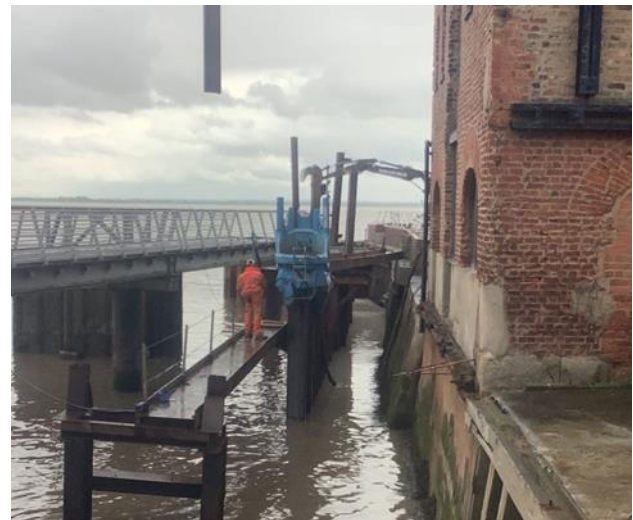
Figure 6. Installation of pressed piles along the River Hull.

As the wall turned the corner from the River Humber to the River Hull, a bespoke triangular pile was installed to transition to vertical piles along the River Hull face. This was vital to enable piles to be pressed rather than driven near existing buildings.

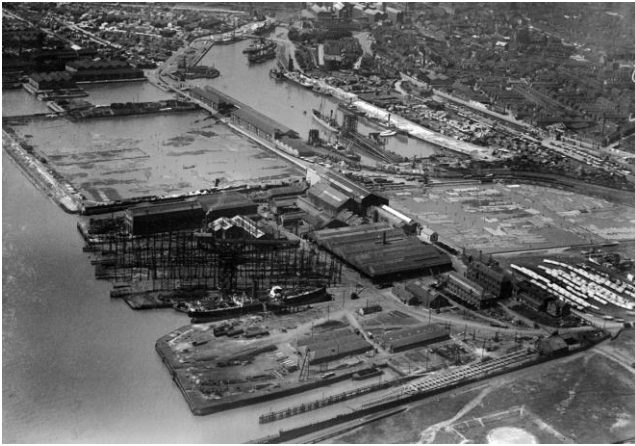
Figure 7. Aerial photograph showing historical timber pond, slipways and shipbuilding yard.

- a timber pond located to the east of the half tide and outer basins; this basin was then infilled and residential buildings were constructed over it.
- two slipways and a historical tidal dock were located within the area of the proposed works. This was confirmed by an obstruction and locally different ground conditions encountered during the investigation at the location of one of these slipways.
- the area east of Harbour Way used to be a shipbuilding yard, where ships were built on the groynes onto a basic slipway.

The main issue presented by these historical features was related to the potential for seepage paths existing underneath the new flood defences. While the typical infill used for reclaimed land in the area consisted of reworked TFD silty clay or clayey silt, hence with low permeability and low risk of seepage during flood events, the ground investigation confirmed that coarser soil was used to infill these features at a later date than the surrounding area.
