# The geotechnical works for the construction of the Travis Brow link road, Stockport, UK

A. Willoner\*, L. Allievi  
Mott MacDonald, Sheffield, UK

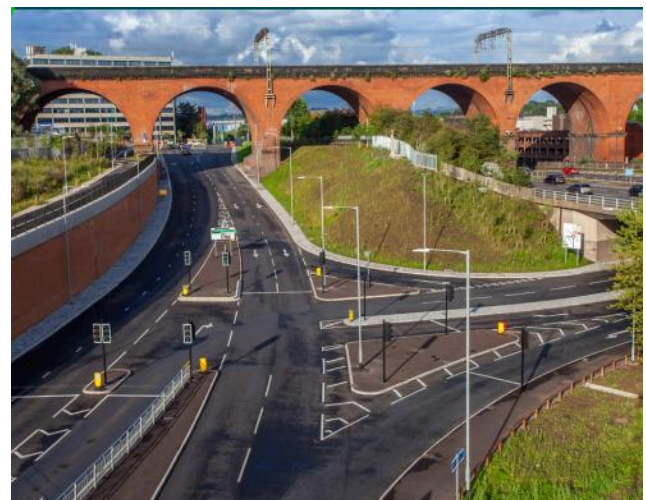
Figure 1. Image of the New Link Road looking towards the Stockport Viaduct, with the M60 to the south.

The new Travis Brow highway provides a link from the M60 Junction 1 to the A6 in Stockport. The project has several challenges associated with urban developments and steep topography as illustrated in Figure 1, as well as presence of contaminated soil and fitting works around an old buried cut and cover tunnel and buried masonry wall.

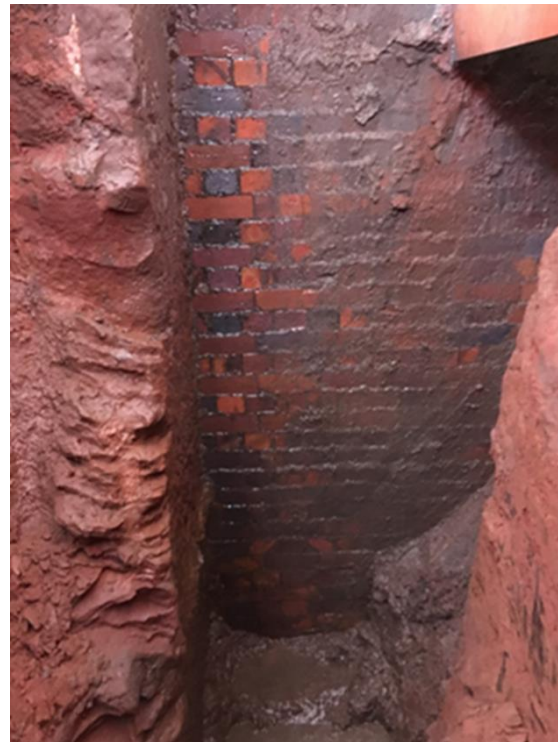
Figure 3. Trial trench perpendicular to pier at Arch 23 illustrating the quality of the rock and bedding.

The formation to the viaduct pad footings comprises the Chester Pebble bed formation of the Triassic Sherwood Sandstone unit. This rock is typically very weak medium to closely bedded red SANDSTONE, with bedding dipping typically 20-degrees to the west. A less persistent steeply inclined joint set is also encountered in this formation. Project specific investigation revealed extrapolated Standard Penetration Test (SPT) N values in the range of 231 to 945. Point Load and Unconfined Compressive Strength laboratory testing verified the SPT results and gave an average UCS of 3.5MPa to be used for ‘best estimate’ SLS prediction of ground movement. Some judgement was applied to establish a worst credible

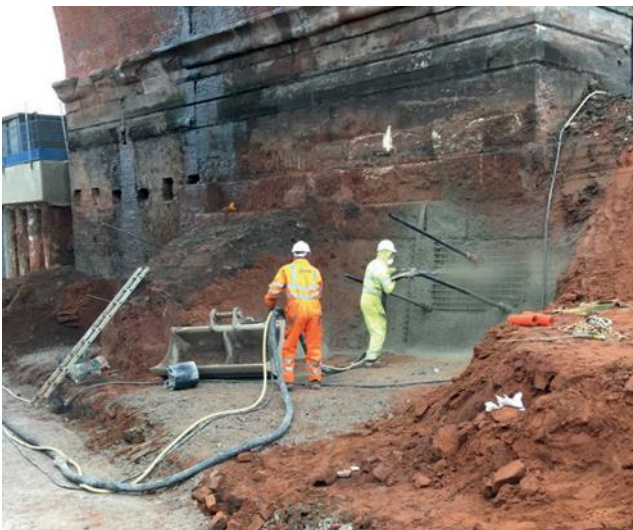
Figure 5. Placing hard facing to the initial working bay below the north footing of arch 23.

However, in order to keep the sub-contractor working continuously, two vertical levels of anchors were installed at the same time with adjacent support being provided from a rock buttress (as illustrated in Figure 5) or by recently installed and stressed anchors, with the gang working on a horizontal ‘hit-and-miss’ basis across 5 bays on each side of the arch and then working down and along the bottom line of anchors.
