Evaluating the effects of a deep excavation on monumental buildings: MarmorKirken station in Copenhagen

F.M. Soccodato*, G. Tropeano
University of Cagliari, Italy

ABSTRACT: This paper describes the Building Risk Assessment (BRA) process implemented during the design and construction of MarmorKirken metro station in Copenhagen. Being the box station very near the monumental church, the evaluation of the effects induced by the excavation on the church was a key issue of the design. Surveys, structural and geotechnical investigations were carried out to setup reliable structural and geotechnical numerical models on which BRA, at the design stage, was based. During construction works, design predictions were systematically compared with monitoring measures, allowing to update the BRA. According to BRA results, no significant effects of construction works on the church was observed.

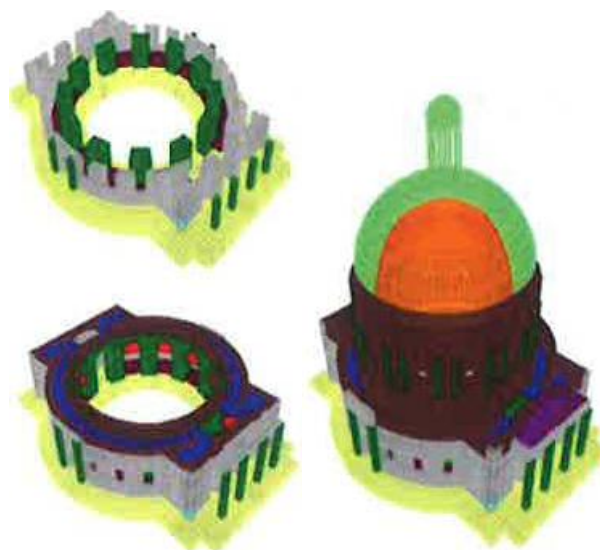
Figure 2. Structural model of the church (SAP2000 code).

About 50000 finite elements were used to define the structural model of church (Figure 2). Both masonry and marble were modelled using a linear, isotropic elastic model due to the expected small strain levels. The estimated total load acting at foundation level was about 300 MN.
