Critical state behaviour of anthropogenic clay in a direct simple shear test

N.S. Walrave*

The paper was published in the proceedings of the 18th European Conference on Soil Mechanics and Geotechnical Engineering and was edited by Nuno Guerra. The conference was held from August 26th to August 30th 2024 in Lisbon, Portugal.

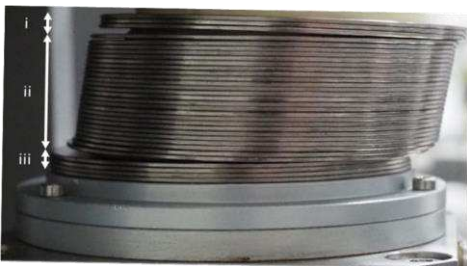
Figure 1. A result at the end of an OC DSS test with slippage.

In a typical DSS test the stack of rings is sheared uniformly. Figure 1 shows an example where slip between the sample and bottom plate has occurred. Three separate zones can be distinguished: i) at the top platen, ii) in the middle, and iii) at the bottom platen. The negative influence of the boundaries on the sample in DSS testing is well acknowledged. However, it is assumed that the centre of the sample is sheared in simple shear and governs the overall behaviour (i.e. DeGroot et al., 1992, Den Haan and Grognet, 2014). The deformation pattern depicted in Figure 1 indicates that, at least at the end of the test, the mobilized resistance is influenced by friction between the sample and the bottom plate, which raises questions regarding the validity and application of the test results.
