# Back analysis of flexible barrier response following an open hillslope landslide impact at Pa Mei, Hong Kong

E.K.L. Wong\*, J.W.C. Lau

*Geotechnical Engineering Office, Civil Engineering and Development Department, Hong Kong, China*

**Keywords:** Flexible barrier; landslide; debris impact; back analysis; LS-DYNA.

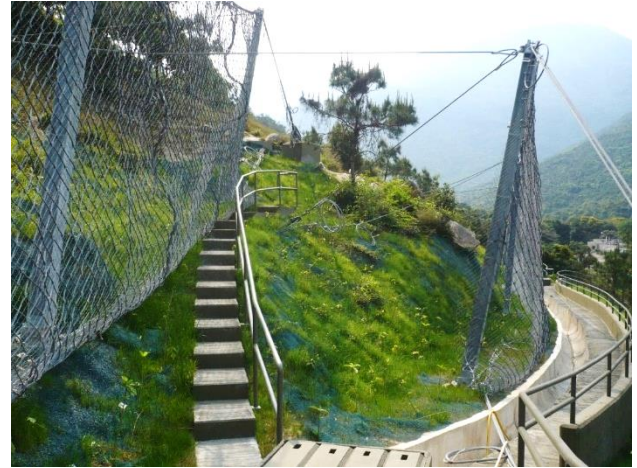
A general view of the flexible barriers is shown in Figure 1. The barriers hit by landslide debris, FW-1A and FW-1B, were located in a largely planar natural hillside sloping at about 30°. FW-1A comprised five net panels while FW-1B comprised four net panels. All panels were approximately 12 m wide. The steel posts in the barriers consisted of 5.5 m high HEB 200 beams. Two top longitudinal “suspension cables” suspended the principal nets in alternate spans (Figure 2). Brake elements were provided to each suspension cable in alternate spans. A third longitudinal cable, the “brake cable”, ran parallel to the two suspension cables. The brake cable was provided with brake elements at the centre of each span. The arrangement of the bottom longitudinal “ground cables” followed a similar arrangement, i.e. two ground cables and one brake cable. The principal net consisted of a diagonal net made up of 10 mm diameter wire ropes arranged in a 140 mm × 140 mm square pattern. The wire ropes were 6×7 IWRC stranded ropes with breaking force of 72 kN. The energy-dissipating devices (brake elements) are mobilised through friction developed as cable loads cause the wire ropes to slip through the openings in

Figure 1. General view of barriers FW-1A (left) and FW-1B (right) after installation in 2012.

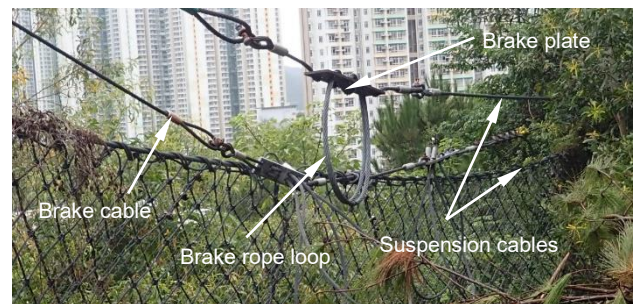
each brake plate, tightening and taking up the available length in the wire rope loop (Figure 2). After mobilisation, the force in each brake element stays relatively constant before the maximum elongation is reached. No major signs of movement were noted in the brake elements after the incident, although signs of abrasion in the stranded ropes to the extent of 1-2 cm were observed. A more detailed description of the components and the working mechanism of the barrier system is given in Wong and Lau (2022).

Figure 2. Longitudinal cables and brake elements.
