Consolidating existing road structures using self-drilling bars

I.A. Ciocaniu*, A.C. Onescu, S. Manea

Technical University of Civil Engineering of Bucharest, Bucharest, Romania

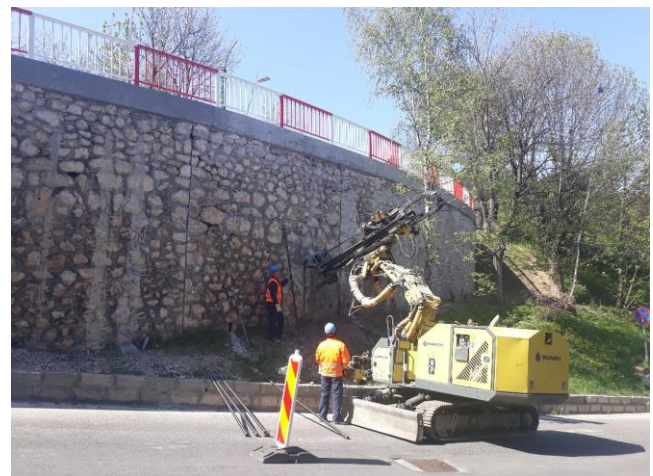
Figure 2. Picture from the site during execution.

The works were executed in well-defined steps as the consolidation of the retaining walls had to be done under traffic, on narrow streets and without changing the specific architectural aspect of the area (Figure 2). The geotechnical design of the structures rehabilitation was carried out in accordance with the requirements of European and Romanian standards.

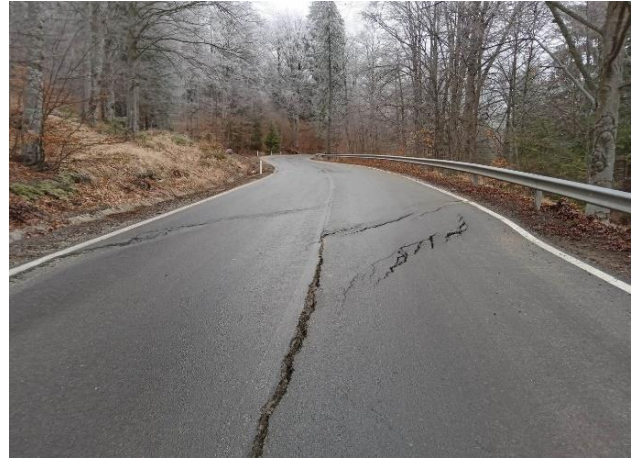
Figure 3. Photo of the affected road area

On a national road in Romania, in the mountain area, with high traffic accentuated degradation and instabilities were discovered with fast evolution accentuated by the rainy condition. Thus, from day to day, the degree of damage was greater, which endangers road traffic without taking urgent rehabilitation measures (Figure 3).

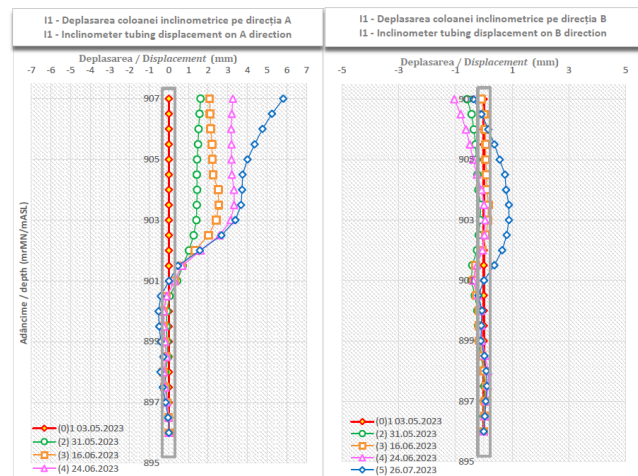
Figure 4. Inclinometer measurement that show the evolution of displacement at different time intervals

The geotechnical investigation, including inclinometer measurements (Figure 4), showed a first layer of soft sandy clay and loose sand to a depth of approx. 6.00 m over a layer of consolidated marl clay. Groundwater was intercepted at depths between 0.40-4.10 m, sometimes having a under pressure character, due to clay intercalations in the first layer that locally block groundwater flow and generate springs locally.
