Ground investigation methods used in high-speed railway for mitigation of dissolution features risk in chalk

S. Pryce, M. Black
COWI UK

H. Saroglou*
Eiffage Keir Ferroviaire BAM (EKFB) JV

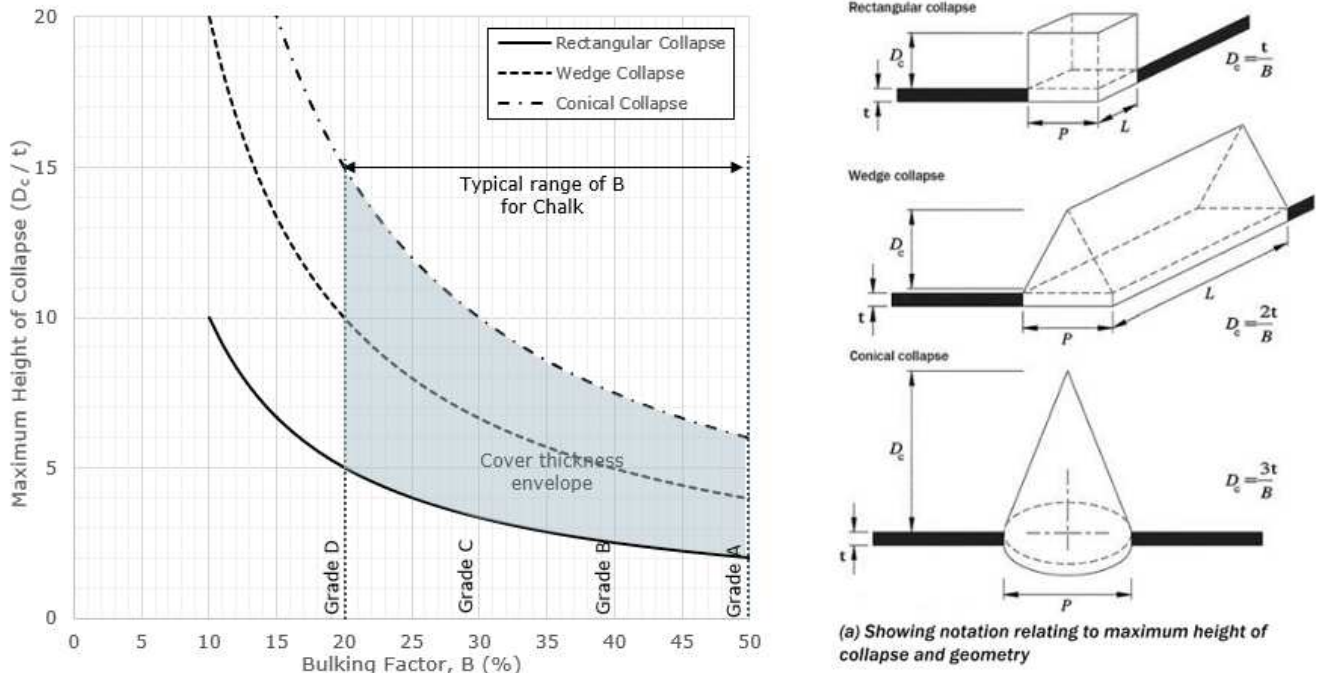
Figure 7. Modified cover assessment method for chalk grades A-D (after Piggot and Eynon, 1978).

The rock cover assessment method shown in Figure 7 utilised existing studies regarding collapse mechanisms in chalk (Z.E. Jeffrey et al, 2020, C.N. Edmonds, 2008, T. Waltham, 2008). The relationship was developed considering a conical failure mechanism for chalk grades A-D.

This assessment model gives relationships for the cover thickness for each chalk grade, as summarised below:

Where t is the ratio of feature size versus the thickness (m) of competent cover materials above.

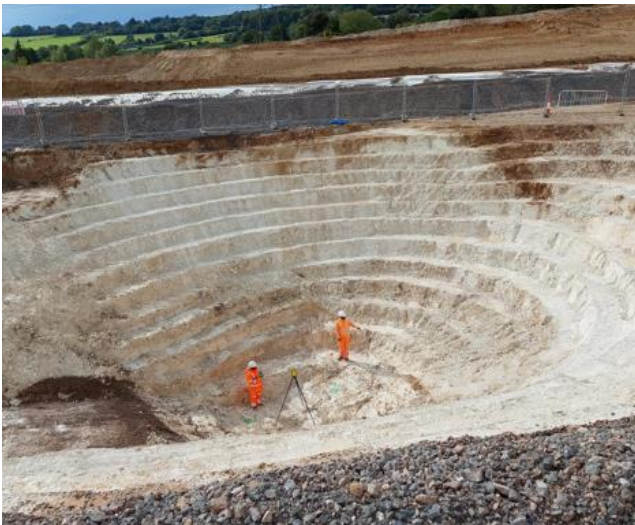
Figure 8. Excavation to base of feature at 'EM-S'.

Figure 8 below shows the excavation to the base of the feature at 'EM-S'. The depth and extent of the feature extended far beyond what was anticipated. It was therefore concluded that the intrusive investigation works at 'EM-S' identified only the outer edge of the feature. This further reinforced the benefit of implementing the excavate and replace under a semi-observational approach. For 'MG-B / EM-Q', the extent of the feature correlated well to the interpretation of the dynamic probing results.

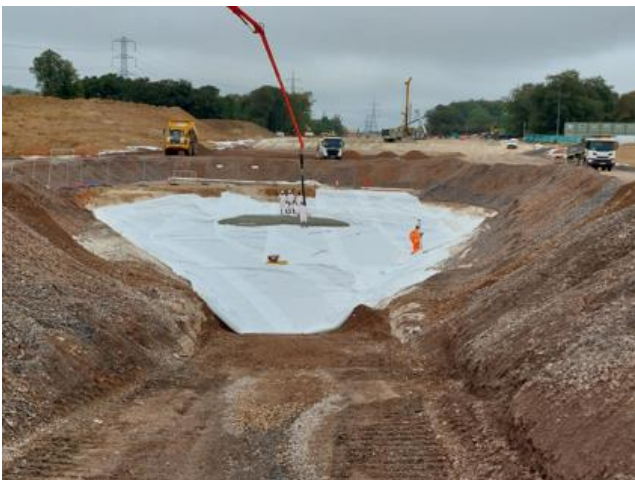
Figure 9. Installation of concrete plug at 'EM-S'.

As part of the backfilling of the feature, a concrete plug was installed at the approximate interface of the natural chalk level. This was to provide an impermeable interface to prevent further long-term deterioration of the chalk, bearing in mind that the mechanism for the initial creation of these features is through infiltration of slightly acidic rainwater. The installation of this concrete plug is shown in Figure 9.
