Landslide monitoring: comparative analysis of long-term automated systems in Brazil and the UK

2 UK CASE STUDY – SOUTHBOUND HIGHWAY

3 BRAZIL CASE STUDY – CAMPOS DO JORDÃO PILOT PROJECT

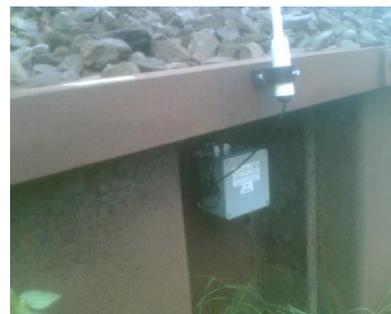
Figure 2. Wireless tiltmeter in a sheet pile wall.

In April 2012, given the rate of displacement and the fact it wasn't possible to traverse the inclinometer casings with an inclinometer probe due to excessive bending, the slope monitoring was automated with ShapeArrays (Figure 3) and water level recorders. To complement this, a rain gauge was also installed on site in June 2012 and wireless tiltmeters were installed on the sheet pile wall in August 2012 (Figure 2).

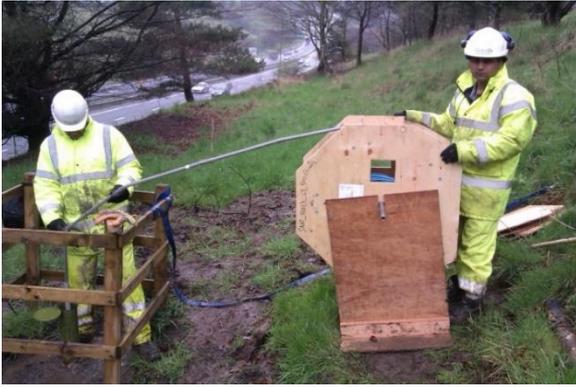
Figure 3. Automatic inclinometers (ShapeArray) installation.
