Endangered historic sites: The case study of Santa Croce in Ravenna (Italy)

M. Marchi*, I. Bertolini, G. Gottardi
DICAM Department, University of Bologna, Italy

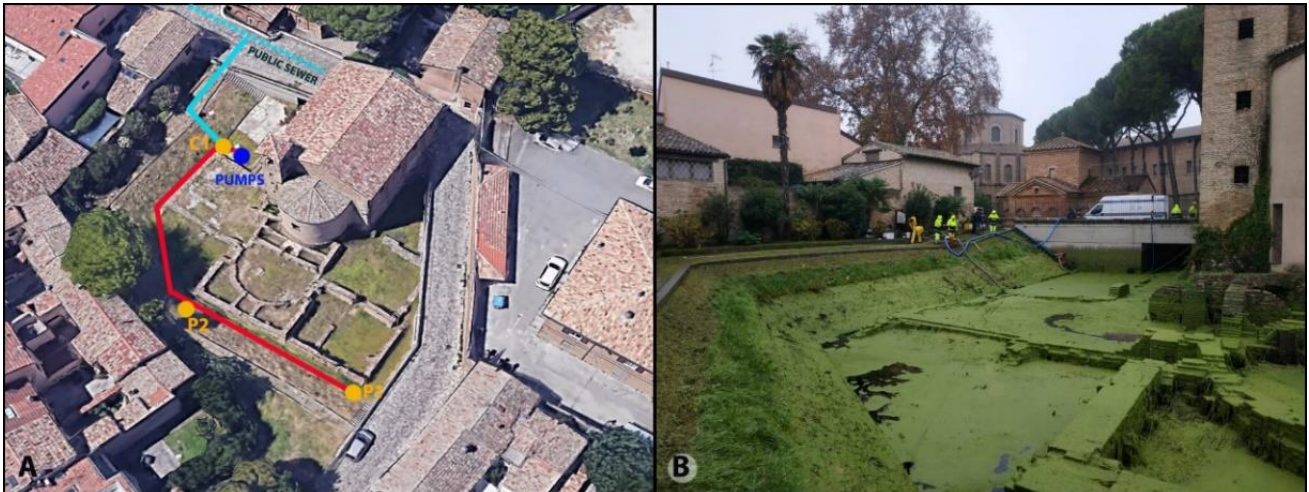
Figure 2. On the left, scheme of the drainage system operating in the area. On the right, a picture taken during the drying procedures required following the basin's flooding caused by the malfunction of the two submersible pumps in 2021.

the church up to a depth of $\sim 3.7\text{m}$ from the current street level (at $\sim 1.5\text{ m a.m.s.l}$) (Figure 1, left). The phreatic water level in the area is consistently located at $\sim 1.5\text{ m}$ below the actual ground level; thus, to perform the excavation and maintain the archaeological remains in dry conditions a drainage system had to be set in place. A scheme of the drainage system, still in operation, is shown in Figure 2 (left). A perforated horizontal PVC tube (red line in Figure) bordering two sides of the excavated basin channels the water from well P1 through P2 and C1 to a buried concrete tank (indicated with a blue dot in Figure 2, left) containing two submersible pumps. The pumps lift the drained water to the street level and release them in the public sewer (light blue line in Figure 2). The subsequent piezometric lowering in the shallow aquifer initially produced new settlements in the

the south side of the church and in the deformation of the slope (Figure 3, right and left, respectively). Furthermore, occasional malfunctioning of the pumps in the past caused multiple flooding of the area with subsequent damages to the archaeological remains and to the roman mosaics (Figure 2, right).

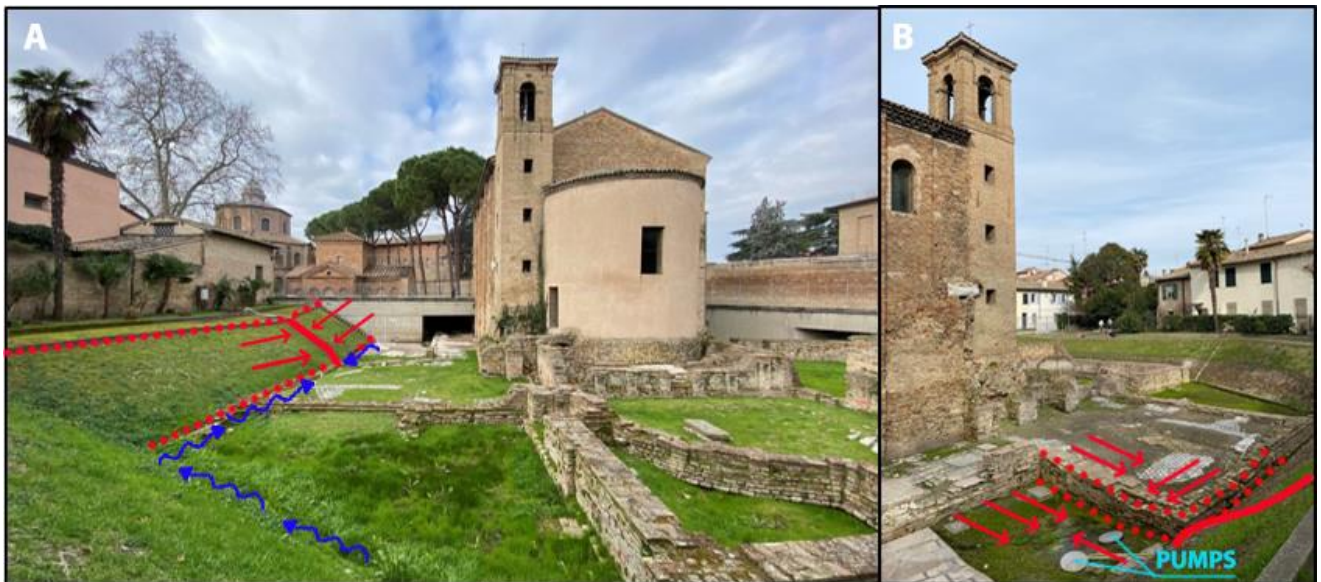
Figure 3. Pictures highlighting the different types of deterioration to the masonry structures and to the earthen slope of the basin, caused in time by the operating drainage system.

overall site containing the church structure, the archaeological remains in the excavated basin and the private buildings standing at the site borders. Moreover, the lack of maintenance to the drainage system caused over the past years the progressive obstruction of the drainage pipes by soil particles. From a recent site inspection, the water still drained by the pumps flows along the soil surface, on a shallow trench self-created above the pipes (blue arrows in Figure 3, left), producing continuous shallow erosion and local instabilities. Despite the underpinning works operated in 1985 to the masonry remains in proximity of the tank, the negative effects of the continuous water withdrawal appears to have never stopped. In fact, the area in proximity of the concrete tank is clearly the most affected by settlements, as visible in all the close by masonry archaeological structures in

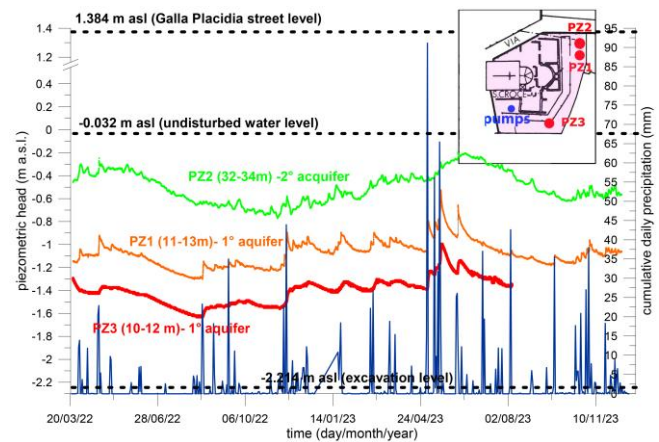
Figure 5. Piezometric head trends with time measured in PZ1 (1st aquifer), PZ2 (2nd aquifer) and PZ3 (1st aquifer).

A piezometric monitoring system was thus installed in the site with the aim of recording in situ pore water pressure (pwp) data in the shallowest aquifers at different distances from the buried tank. As expected, the greatest dropdown in piezometric head is registered in PZ3, installed in the first aquifer and located in proximity of the pumps (Figure 5). The effects of the drainage system seem to reduce with distance in fact, PZ1, 50 m far from PZ3, has a higher piezometric head (with a difference of ~ 0.2 m). The deeper aquifer (monitored by PZ2) is only marginally influenced by the drainage conditions and tends to the undisturbed water level, located ~ 1.4 m below the street level (as measured locally at pumps shut down).
