# Extension of the Lisbon subway between Santos station and the Terminal of the Cais do Sodré station - assessment of excavation induced damage in buildings

F. Bernardo\*, S. Ferreira, R. Pistone  
*COBA, Consultores de Engenharia e Ambiente, S.A., Lisboa, Portugal*

**ABSTRACT:** The expansion of Lisbon’s Underground network through the Yellow and Green lines extension project is taking place in a densely urbanized area of Santos and Cais do Sodré. The area, close to the Tagus River, combines challenging ground conditions and a large diversity of vulnerable assets, including heritage listed buildings, residential buildings and major utilities companies’ assets. The project comprises the construction of the new Santos station and adjacent tunnels using the Conventional Method. The construction works will employ a sequential excavation method through poor ground conditions and low ground cover, including sections with less than one diameter of ground cover between the tunnels and the surface. In order to reduce the risk of damage to the buildings located in the zone of influence of the excavation works, a comprehensive damage assessment study was carried out in the initial stage of

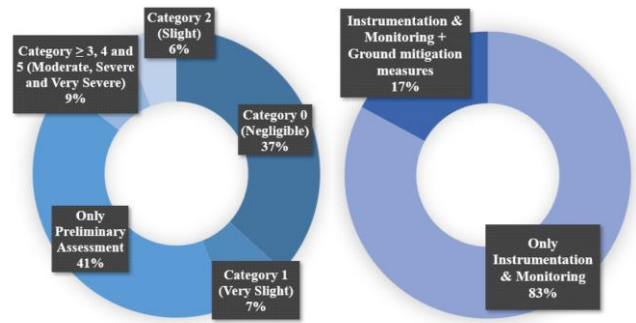
Figure 3. Assessed building damage categories (Burland, 1995) and ground movement mitigation measures.

A total of sixty-eight buildings were damage assessed and ten required a combination of ground movement mitigation measures and more precise instrumentation and monitoring equipment (Figure 3).

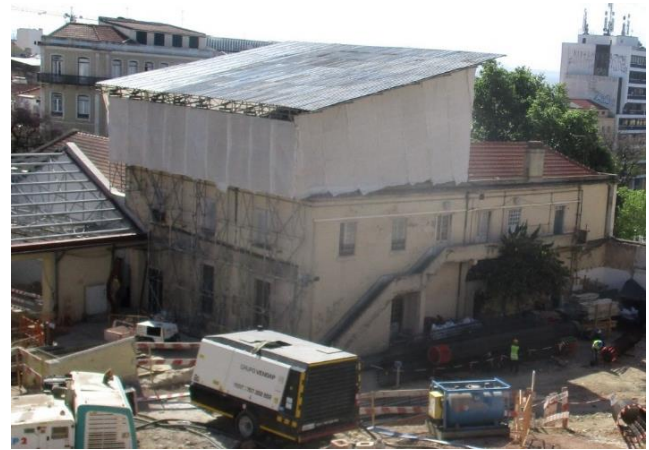
Figure 6. Low Choir (building’s exterior view).

This building was dated to the sixteenth century and it was part of a larger monastery where it was used as a lower choir. Over the centuries this building experienced several modifications to its architecture and to its use. However, the original columns, arches and ceiling paintings are still preserved (Figure 6 and Figure 7).

It was estimated that if no ground mitigation measures were implemented at this building, it could reach damage category 3 (Moderate), and considering the vulnerability of its architectural features, it would reach damage category 5 (Very Severe).

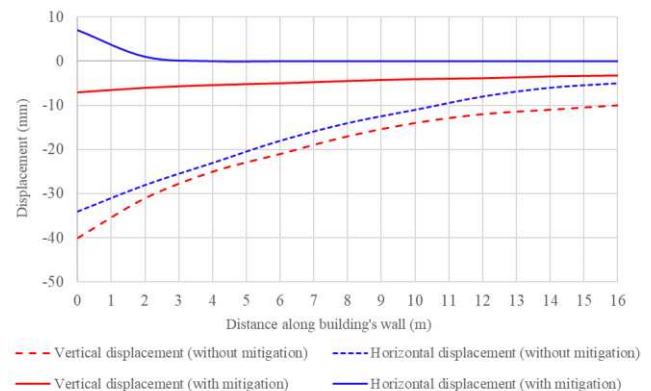
Figure 8. Ground movement profile along the most critical wall (with and without ground movement mitigation measures).

Due to its proximity to Santos’ station excavation works, the ground movements estimated at the location of this building were in exceedance of 40 mm (Figure 8).

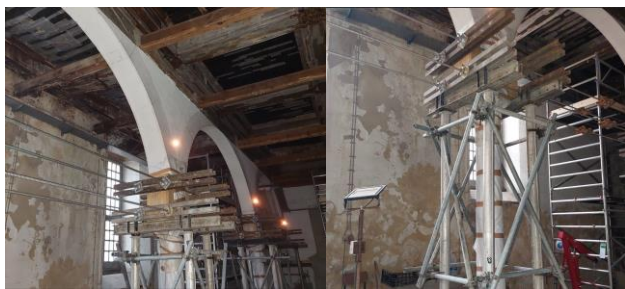
Figure 10. Internal bracing of the building's structure.

A desk study was carried-out to determine the most viable, safe and efficient ground movement mitigation measures. It was determined that the measures would be the installation of a ground movement reduction barrier, consisting of a bored piled wall (0,8 metre diameter piles, spaced at 1,0 centres) (Figure 9). and internal bracing of the building's structure (Figure 10).

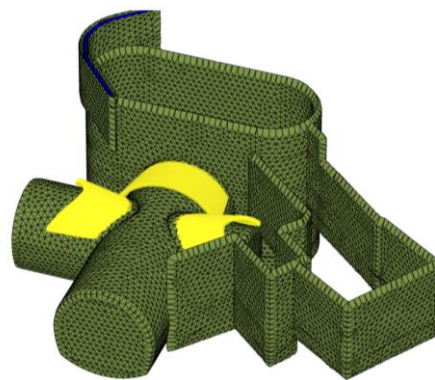
Figure 12. 3D FE model for Santos station (southern side) including primary lining and retaining walls elements.

The 3D FE model was developed to perform safety check calculations for all identified failure mode mechanisms. In order to reduce the calculation time, Santos station was analysed using two 3D FE models, one 3D FE model for the northern part and another 3D FE model for the southern part of the station. To assess the effectiveness of the ground movement reduction barrier, the southern 3D FE model was used. This model considered the heterogeneity of geological and geotechnical ground conditions, the groundwater conditions, the soil-structure interaction conditions, the construction sequence and the reinforcement elements, such as the primary lining and retaining walls (Figure 12).

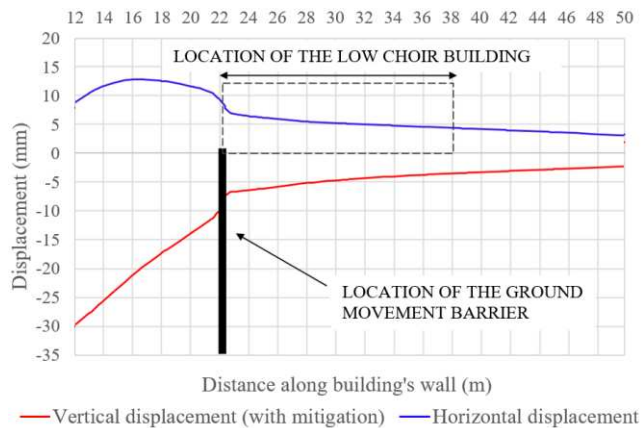
Figure 14. Ground displacement profile with ground movement mitigation measures (ground settlement profile).

The ground displacements were processed (Figure 14) and its analysis indicated that the inclusion of ground movement mitigations reduced the damage category to category 0 (Negligible), and considering the vulnerability of its architectural features, the damage category was estimated at damage category 2 (Slight).
