Industrial warehouse retaining walls and pavements strengthening at Quinta do Adarse, Alverca, Portugal

T.M.L. Paludeto*, M. Lopes, A. Pinto
JETSj Geotecnia, Lisbon, Portugal

The paper was published in the proceedings of the 18th European Conference on Soil Mechanics and Geotechnical Engineering and was edited by Nuno Guerra. The conference was held from August 26th to August 30th 2024 in Lisbon, Portugal.

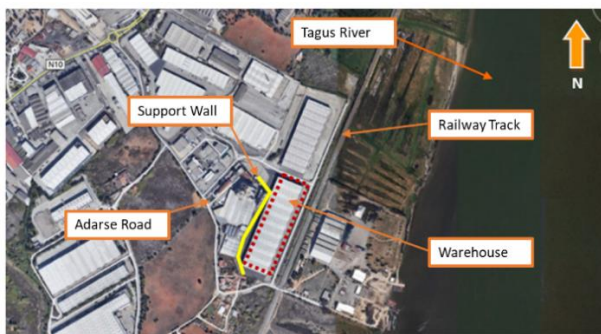
Figure 1. Aerial view of the site (Google Earth).

The site is a warehouse with an area of 20,250 m² (270 m x 75 m), built in the 1990's at Quinta do Adarse, Alverca, Portugal (Figure 1). The retaining wall is a reinforced concrete cantilever structure with 6 m of height extending over 320 m of length. The wall was designed to support the difference of approximately 4 m, existing between the lot where the warehouse is located and the adjacent areas.

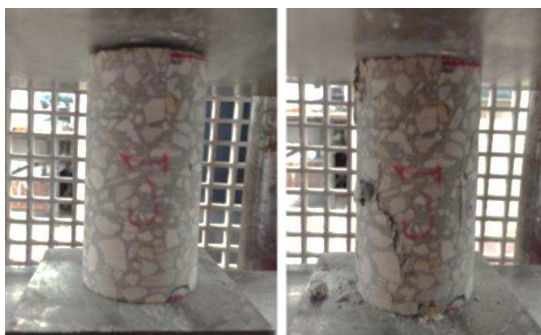
Figure 6. Uniaxial compression-strength testing – UCS.

Uniaxial compression strength (UCS) tests were carried out on five of the collected specimens (Figure 6) to measure the mechanical resistance of the existing

concrete wall. The uniaxial compression strength of the samples ranged between 16.56 MPa and 28.30 MPa.

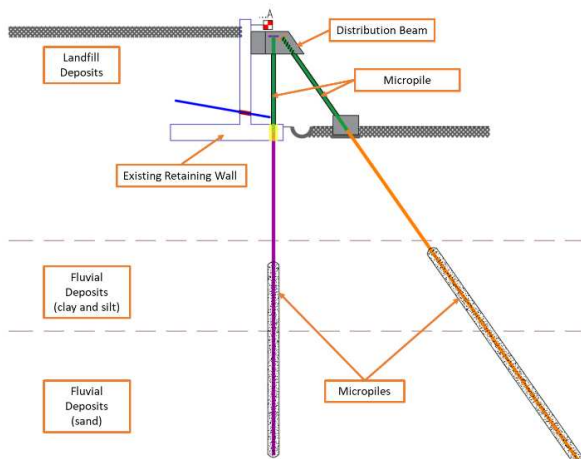
Figure 7. Cross section of the wall reinforcement solution

The proposed solution includes the construction of a bracing element with the aim of increasing the wall resistance to horizontal pressure. This element consists of a 0.45 x 0.70 m distribution beam at the wall's mid-height, which is designed to transfer the horizontal forces to inclined micropiles, with tubular section of $\text{Ø}88.9 \times 12.0$ mm and $\text{Ø}88.9 \times 9.5$ mm, spaced 4.50 m, in the direction of the wall's development. The micropiles had a variable length of between 14 m and 15 m, thus guaranteeing minimum sealing lengths of 8 m and 9 m in the ground layer (natural ground with a NSPT of more than 20 blows).

To accommodate the increased vertical load caused by the axial force on the inclined micropiles, capping and distribution beams, were also built. Vertical micropiles were installed, also spaced 4.50 m. The vertical micropiles had an estimated variable length of between 11 m and 13 m, thus guaranteeing minimum sealing lengths of 6 m and 8 m in the stiffer ground layer.

The boreholes for placing the micropiles were at least $\text{Ø}220$ mm, and the tubes were subjected to filling and sealing injection. The injection was carried out using an appropriate system – I.R.S. (Repetitive and Selective Injection), using non-return valves and a double plug, for the length corresponding to the sealing bulb.

As the beam is supported directly on the micropiles, part of the steel tube was exposed permanently. Therefore, the micropiles were properly protected against corrosion, with a sacrificial thickness, compatible with the conditions of the environment and the life of the structure. Figure 7 shows the typical cross-section of the proposed solution.
