Analysis of a potentially unstable slope in the context of climate change

ABSTRACT: The article presents the problem of a potentially unstable slopes in the context of climate change. Essentially, the aim is to show the possibilities of using climate data and forecasts of expected climatic changes in the design of geotechnical installations. The direct description of climate change used in climatology is too general and useless for geotechnical analyses. Therefore, climate change signals, effects and impacts are introduced for geotechnical processing, which can be evaluated based on climate data. The research results show that simple, nature-based solutions can successfully ensure long-term stability, even in the face of expected climate change. The costs of such measures, such as timely weeding and planting of trees and shrubs as well as proper surface water drainage, are generally quite low compared to the follow-up costs of landslide remediation.

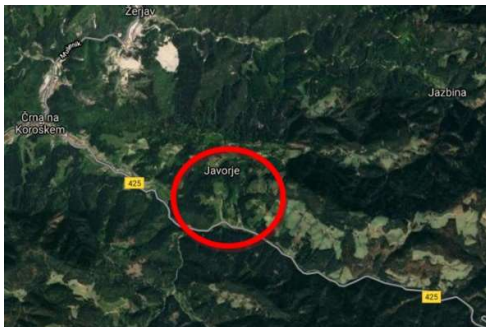
Figure 1: Location of mudflow.

Mudflow on the road, Javorje, Carinthia (see Figure 1 and Figure 2)

On the steep hill, grassy above and wooded at the bottom, 70 cm of snow fell during a heavy snowfall in winter. This was followed by 3 days of heavy thaw and very intense rainfall, which later turned back into snowfall. This triggered a mudflow that destroyed tall trees. The mud with the fallen trees quickly flowed onto the road below, where it blocked the culvert and spilled the material over the road and 80 m along the road.

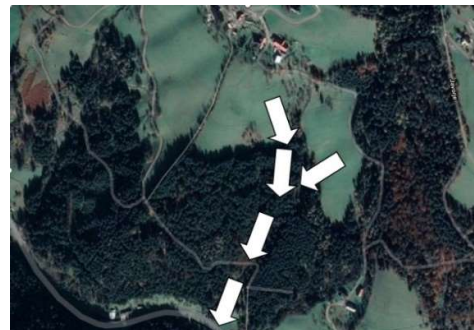
Figure 2: Direction of movement the mudflow.

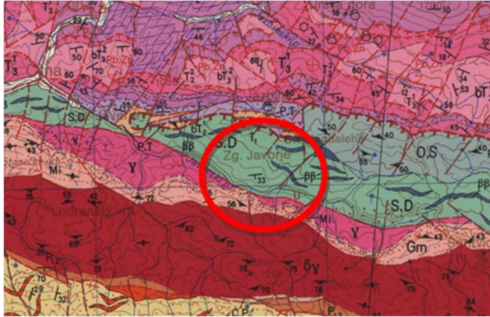
Geology: the hill is formed by a phyllidid schist with limestone inlays shown in Figure 3 and. The soil cover consists of layers of clay and sandy silt. On the steeper slope, the soil cover is quite thin; in the upper part, where the slope of the terrain is less steep, it is several meters thick. The ground cover is locally very moist and carries a lot of water.

Figure 3: Geology of the hill.

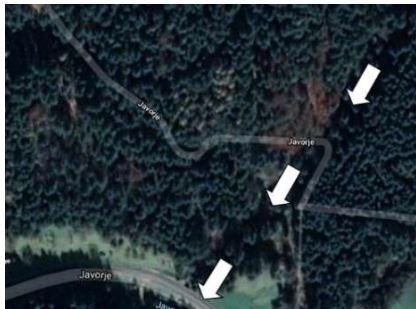
Figure 4: Movement of mudflow over the road.

- In the area where the slope becomes steep and forested, the branches of the watercourses merge into a torrent that runs along a very steep slope for about 500 m crosses the regional road with a culvert in the lower valley and flows into the Javorski potok.
- Earth from debris was mixed with water from the slope flows.
- The gorge of the Hudournica stream has damaged banks; traces of the flood flow and local landslides as well as the erosion of soil and fallen trees are visible.
- The mud flowed with the fallen trees to the lower regional road, where it blocked the culvert and the material spilled over the road and along the road for a length of 80 meters as shown on Figure 4 and Figure 5.
- The mudflow destroyed the road fences and the consequences for the culvert will be visible after the area has been cleaned.

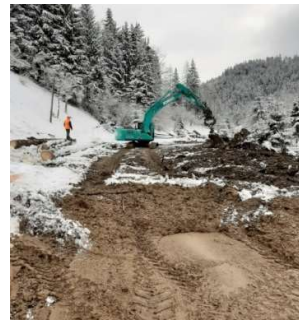
Figure 5: Consequences of mudflow.
