Case study - The rehabilitation of a sinkhole under hazardous conditions

ABSTRACT: The design and remediation of two sinkholes that formed within the road reserve of a major highway in Gauteng is summarised herein. Due to the location of the sinkholes underneath low hanging powerlines, and the proximity of the sinkholes to the road, somewhat unconventional methodologies were required to address the particularly restricted and hazardous nature of the site. This paper details the remediation strategies utilised when conventional strategies are not possible. The paper highlights the challenges encountered during the design and implementation phase and explores the solutions that were obtained through innovative collaboration between the engineering team and the appointed contractor.

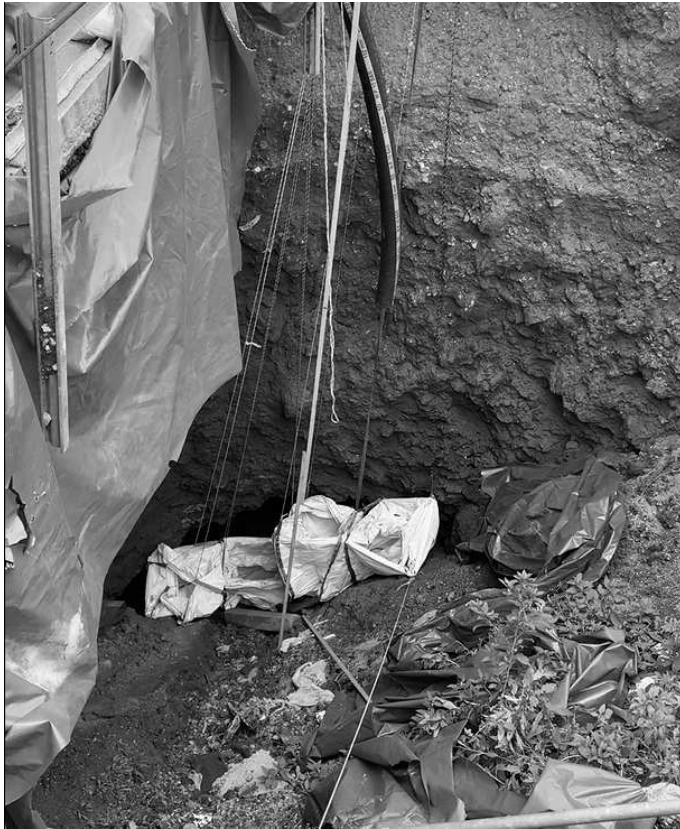
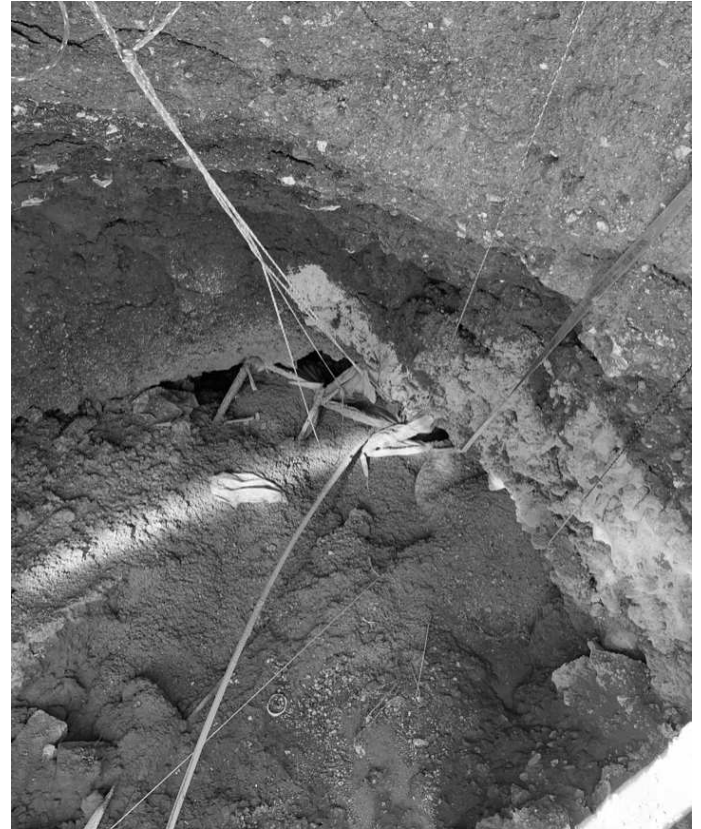
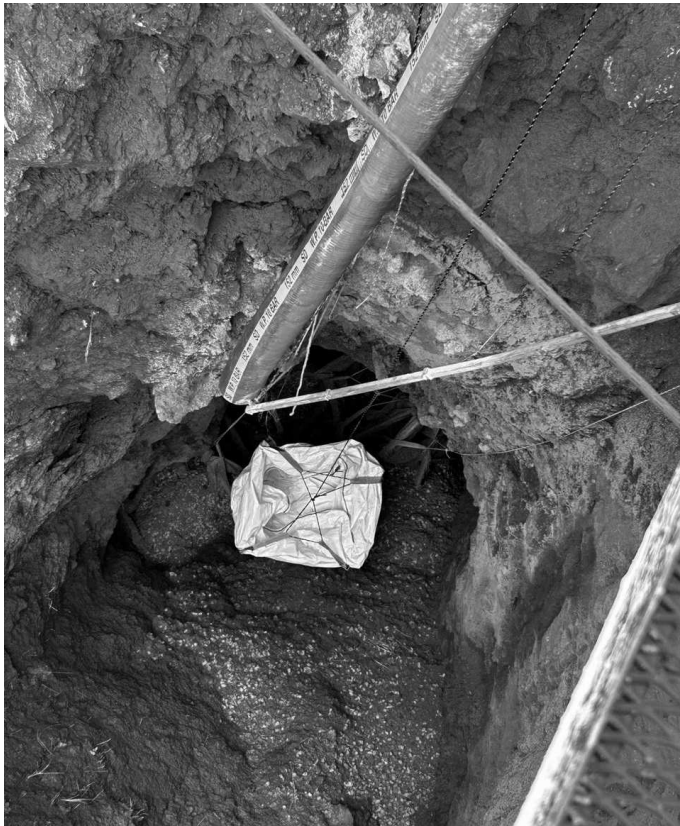
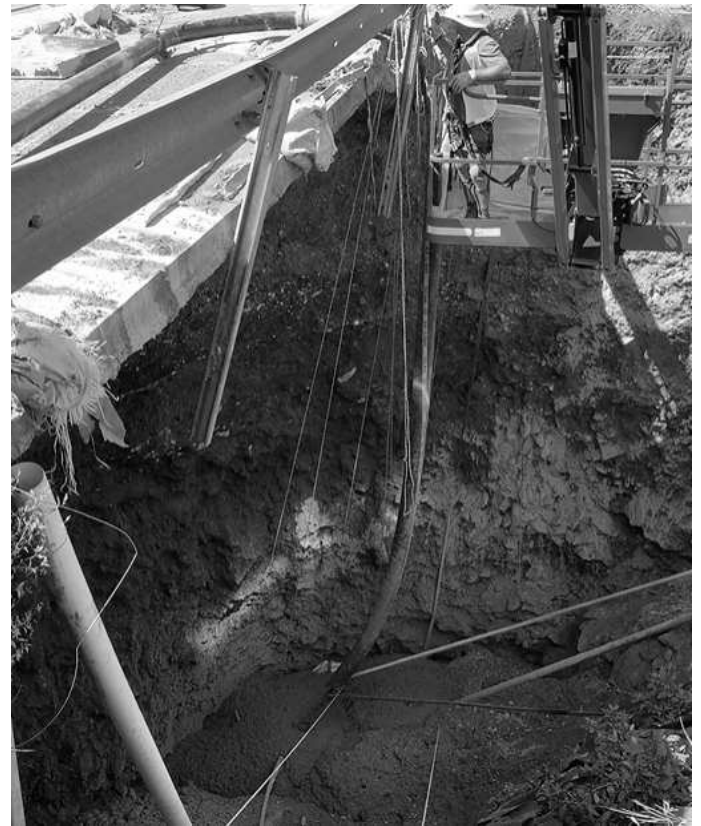
Figure 3. The process of blocking the throat with the grout bag method

Placement of the bags into the sinkhole was done by attaching ropes to each corner of the bag and hanging the grout bag from wooden cross beams that were placed over the opening of the sinkhole. A cherry picker was used to suspend the grout bags into the throat from above the sinkhole. The bags were carefully placed in the throat of the sinkhole in groups of three or four. Grout was then pumped into the bag using a flexible HDPE pipe. Once the bags were filled, additional bags were placed, and the process was repeated until the throat was blocked. Figure 3 shows the steps of the blocking of the throat with the grout bag method.

a) Initial placement of the grout bags in the throat of the sinkhole

b) Grout bags after they have been pumped full of grout

c) Placement of additional grout bags

d) Pouring of the capping layer over the filled grout bags

The grout bags used were 185 gsm Woven Polypropylene bags. The bags had a volume of approximately 1 m³ with a closed bottom and an open top. The bag had straps at the top and was fitted with a wooden frame to keep its shape when in the sinkhole.

Once the throat was blocked, an approximately 2 m thick layer of 20 MPa concrete was cast over the grout bags to serve as a capping layer. The rest of the sinkhole was filled with low strength concrete. For the sinkhole that was directly underneath the road, the low strength concrete was poured to underneath the level of the layer works, and the road was then reconstructed over the sinkhole. The sinkhole that was mostly outside the road reserve was filled with low strength concrete to 2 m below the NGL. The rest of the sinkhole was filled with G7 fill compacted to 93 % Mod AASHTO.
