# Historic and current practice of excavation along the Atlantic Seaboard, Cape Town

**ABSTRACT:** The Atlantic Seaboard, extending from the V&A Waterfront to Hout Bay, Cape Town, features steep topography that necessitates deep, unbalanced hillside cuts to create level platforms for construction preventing encroachment into neighbouring properties. This paper examines historical practices in the region for creating and supporting these hillside cuts and presents a case study as an example of the lateral support systems employed in the area. Additionally, the paper offers recommendations for approaching site development and lateral support in this area.

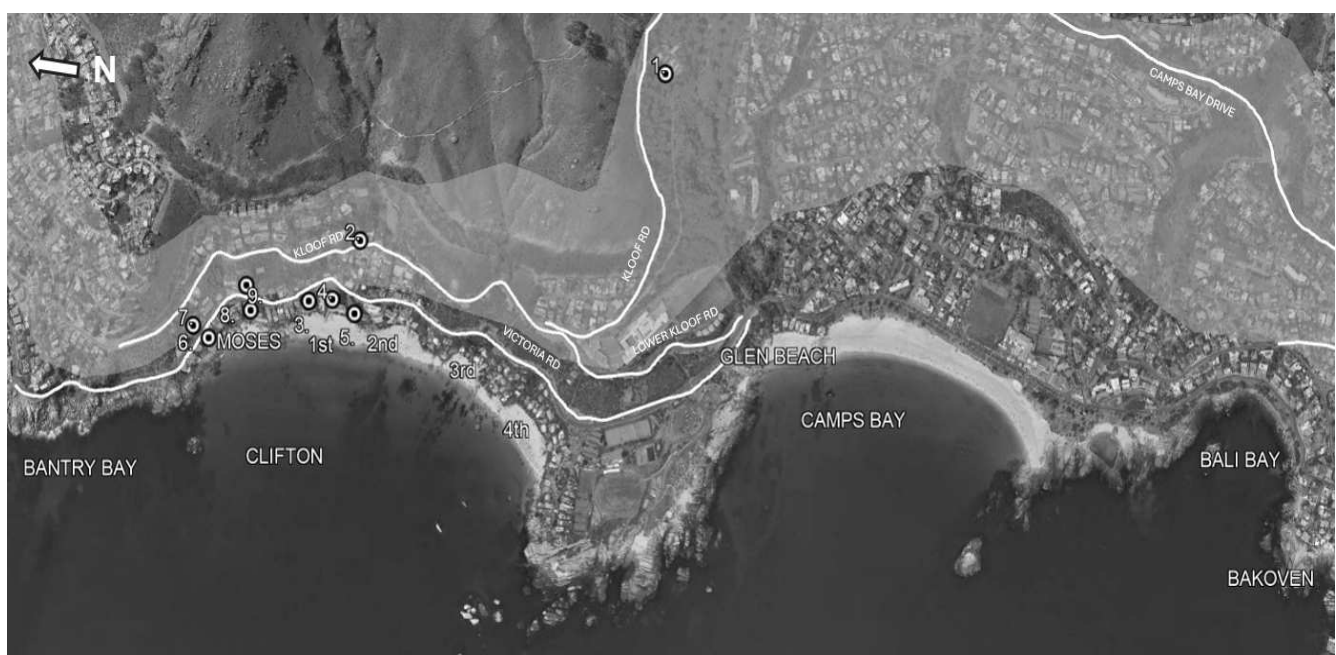
Figure 1. Areas and sites referenced in this paper (Google Earth Pro 2025)

will examine the region's history and current excavation practices for deep excavations along the Atlantic Seaboard. Figure 1 provides an aerial photograph of a portion of the seaboard and the areas and sites discussed in this paper.

In the early 20th century, modern transportation such as trams, trains, and motor vehicles made travel between these areas and the city feasible. However, parts of the region, like Greenpoint and Sea Point (to the north of Bantry Bay in Figure 1), lacked a reliable water supply. The construction of roads through steep terrain and access to water sources were key to the area's development (Schrire 2003).

By 1863, Greenpoint and Sea Point had a population of 700, which was expected to soon double, prompting a pipeline to be built from the Round House wells (Site 1) to Sea Point. Bantry Bay was granted in 1804 and included conditions such as water access to the public and public access to Kloof Road. Large boulders obstructed further development where Victoria Road is located today. By 1902, the land was subdivided into plots (De Beer 1987).

A feature of the area is the presence of remnants of the old African Erosion Surface (Maud and Partridge 1987) where it has not been totally or partially eroded away (see shaded area in Fig. 1). It is characterised by deep chemical weathering of the bedrock and of the older colluvia along a contour between the elevations of approximately 50 m and 150 m.

To the authors' knowledge, the first building in Clifton to use ground anchors was The Beaches (Site 6 in Fig. 1), completed in 1969 (SAICE 1994). Prior to this, buildings were typically constructed on terraced ground, which required small retaining structures, usually located in colluvium. Over time, some of these terraces have experienced significant rotation due to creep, leading to the need for stabilisation.

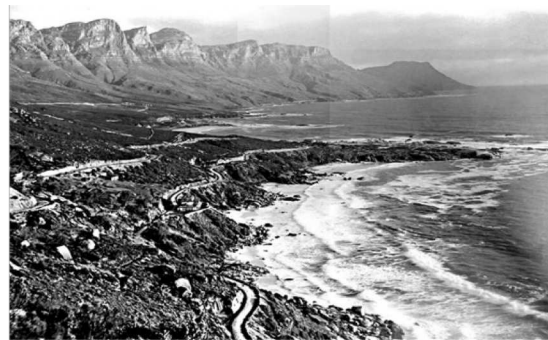
Figure 2. Historic photo of Clifton, early 20th century showing Kloof Road above Victoria Road

In the late 1800s, roads such as Kloof Road (higher road in Clifton) and Victoria Road (lower road in Clifton) were constructed to connect the area. Kloof Road was formalised by Thomas Bain for the Queen's Jubilee in 1887, and the work was done by convict labour. These roads, particularly in areas with soft granite rock, were built with steep cuts (see Fig. 2) (de Beer 1987). Some erosion and failures have occurred over time, but the roads have remained functional since then.

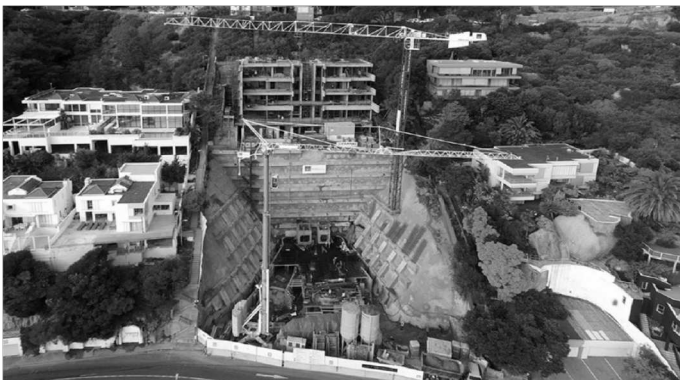
Figure 6. Photo of Clifton Terraces lower cut (H&I 2021)

Ground movement measurements were undertaken with accurate survey readings. The final total displacement measured, after construction of the building on the lower 25 m high eastern face was 41 mm which aligns well with that predicted from the Hoek Brown 2D analysis. A photo of the excavation is provided in Figure 6.
