# The tensile capacity of steel pipe piles drilled into the bedrock

R. M. Sirén

L. K. Korkiala-Tanttu

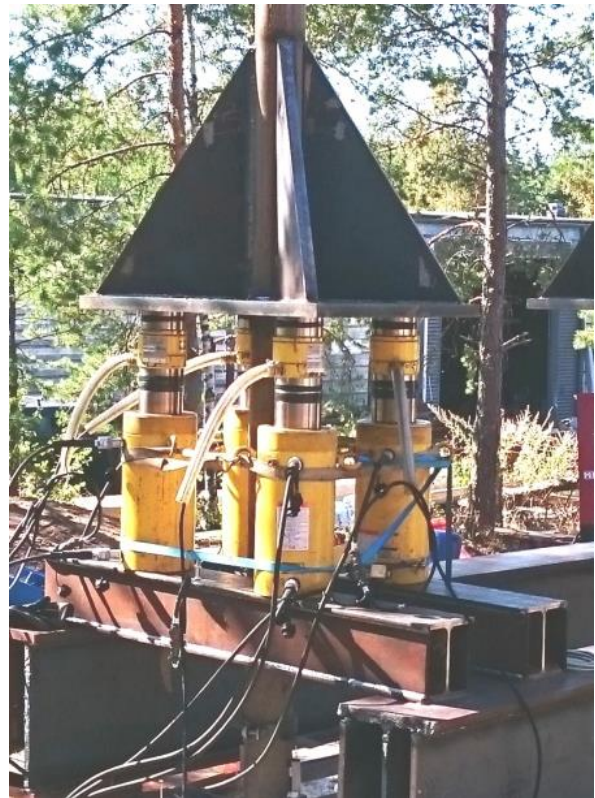
Figure 2 shows the load transfer system. The applied force for the piles was induced using four hydraulic jacks. On the pile surface was affixed a console part by longitudinal welds and the force was transmitted from the jacks, through the console to the pile. The reaction force was directed to the bedrock.

The force was monitored using separate stress sensors, load cells. The load cells were assembled between the jacks and pile consoles. Monitoring the load between the jacks and the pile console ensured that all the jacks transferred the same size load to the pile console. Hence, the force that was transmitted through the console to the pile was axial.

Figure 2 Load transfer structure
