Solutions for Various Obstacles Encountered with Laboratory Piping Tests

Montalvo-Bartolomei, A.M.

U.S. Army Engineer Research and Development Center, Vicksburg, MS, United States of America
axel.m.montalvo-bartolomei@usace.army.mil

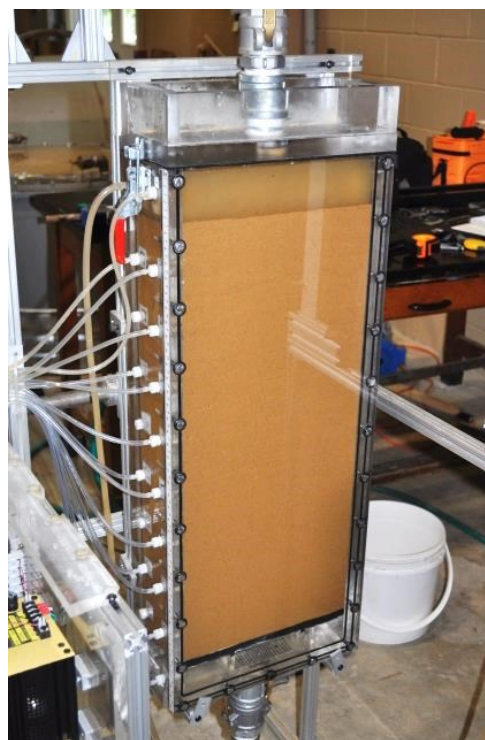
Figure 3. Small-scale flume in vertical position after sample preparation.

To ensure integral contact between the soil and acrylic, the flume was designed to be rotated 90° from an upright vertical position for filling (Figure 3) to a horizontal position for testing (Figure 4). This is similar to the tests performed by van Beek et al. (2011), whereas the flume used by Townsend et al. (1981) used a rubber bladder to apply pressure and ensure contact between the sand and the acrylic top. After testing, the flume could then be rotated an additional 90° to empty the flume by gravity. The flume was mounted to a custom frame designed for its rotation. This frame was built with aluminum t-slotted framing (80/20). The design of the frame took into consideration its capacity to sustain the weight of the flume, hoses, soil, water, and instrumentation. A rod and bearings made it possible to rotate the flume smoothly a full 180°.

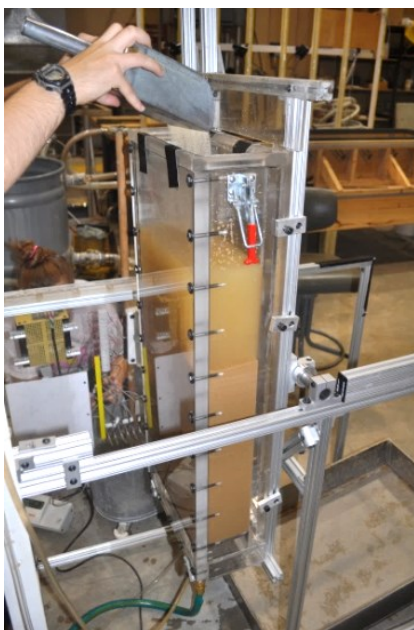
Figure 5. Pluviating sand for the preparation of test sample.

At the beginning of sample preparation, the outlet wall (downstream side of flume) was removed and the flume was rotated to the vertical position. Full saturation of samples was obtained by first filling the flume with water and pluviating (or “raining”) the air-dry sand into the flume (Figure 5). This method was used to prevent trapped air in the soil sample. Typically, about half of the flume was filled from the inlet with water before placing sand, and this was sufficient for full saturation of the sample. For the majority of the tests, a constant head water tank was used for supplying constant flow. This tank supplied water through a hose attached to the inlet wall of the flume with a 3.81-mm NPT (National Pipe Thread) stainless steel male-female coupling connector.

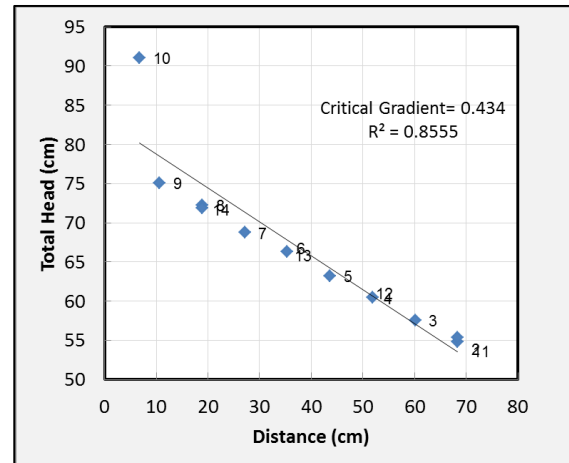
Figure 6. Piezometric data points showing head loss due to filter wall.

Reviewing the piezometric data showed a disproportionate head loss between the pressure transducer upstream (behind the sample and the plate) of the filter and the next transducer when compared with the head loss occurring generally in the sample. This loss increased proportionally with flow. This indicated that the filter fabric and plate geometry used was much less permeable than the material tested, as it was getting clogged with fines from the tested sands and from the water supply. This considerable head loss caused an inaccurate value for the average global gradient calculated from the upstream and downstream manometer measurements. Replacing the filter fabric periodically was not enough, therefore, the solution to this problem was to determine the hydraulic gradient by a linear fit of the hydraulic heads (converted from the measured pressure from each transducer) along the sample. The slope of this plot (Figure 6 and Figure 7) determined the hydraulic gradient across the sample. The time at piping initiation was

recorded, and the critical hydraulic gradient was calculated using this method. Figure 6 shows the significant head loss due to the upstream wall between pressure transducers 9 and 10. Figure 7 shows the linear fit of piezometric data points without the total head obtained from pressure transducer 10 for the calculation of a precise value of hydraulic gradient.

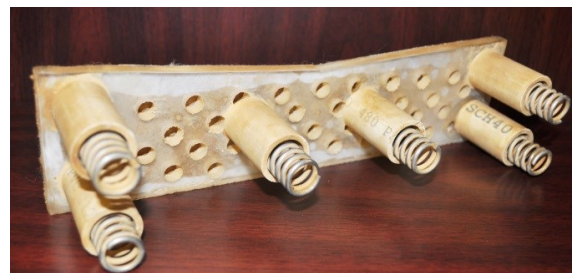
Figure 8. Filter wall plate with v-notch.

To correct this issue and ensure the pipe developed through the center of the sample in every test (or close to the center), a shallow 1:12 v-notch was cut into the half wall where the slope is formed (Figure 8). This shape caused a natural arc to form in the exit slope due to the sand coming to equilibrium at the angle of repose (Figure 9). The deepest portion of the notch was at the sample center, which forced the shortest path length to be in the center as well. When setting the flume from the vertical to the horizontal position, the newly formed exit slope of the sample was arc-shaped with the shortest flow path in the center. The shortest path distance was measured at the beginning of every test.

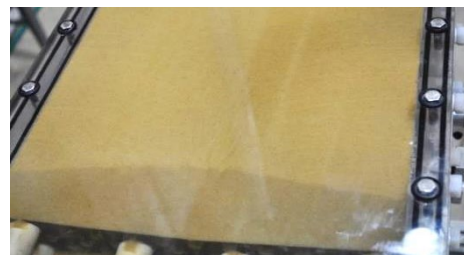
Figure 9. Arc-shaped slope formed by v-notch.
