Complex foundation analysis of network arch bridge and adjacent embankments founded on grouted columns

O. Mitrosz

Technical Office, Keller Polska Sp. z o.o., Gdansk, Poland

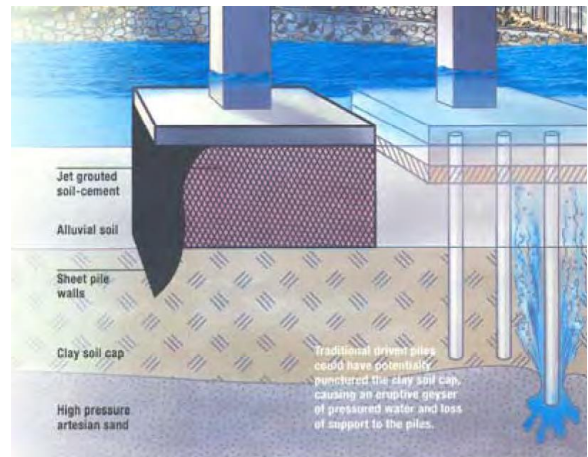
Figure 1. The applied soil improvement under the foundations of the bridge over the Huron River and an exemplary illustration of the failure resulting from the hydraulic puncture of artesian waters (Byrum 2008).

One shall mention a case of bridge construction over the Huron River in Michigan in US (Byrum 2008) where the confined aquifer was punctured causing huge technical problems and delays on contract. This project was related to similar ground and water conditions as the presented MS-15 bridge. The only difference was the top layer, represented by loose grain soils instead of non-bearing organic soils. Already at the initial design stage the lightweight bridge construction was adopted and the deep foundations basing on long piles was rejected as dangerous (Figure 1).

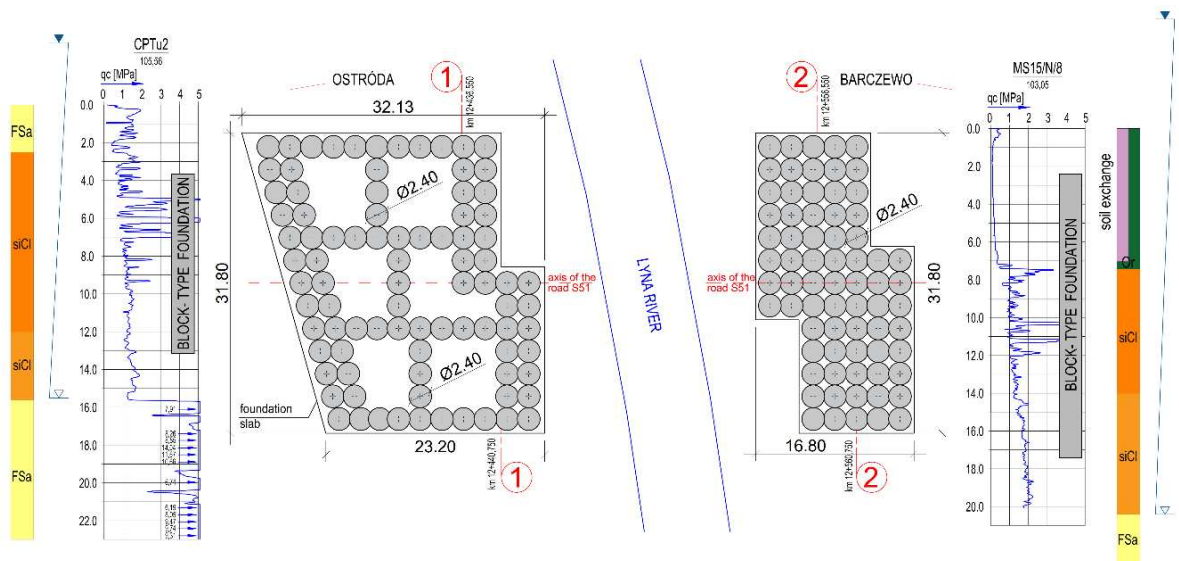
Figure 3. Layout of grouted columns with a typical geological cross-section

Taking into account the highlighted threats, it was decided to place the engineering object on the massive blocks of improved soil, made of grouted columns with a diameter of 2.4 m. The authors introduced a floating foundation system, suspended in low-bearing soils (*clay IIB*), without puncturing the artesian layer. Therefore, the risk of uncontrolled outflow was significantly mitigated. The adopted method allowed to improve the mechanical parameters of the soil as well as its tightness. The technology was non-impact and vibration-free, which eliminated the possibility of 'cracks' of impermeable soils (clay), and thus their hydraulic puncture and uncontrolled outflow of artesian waters.

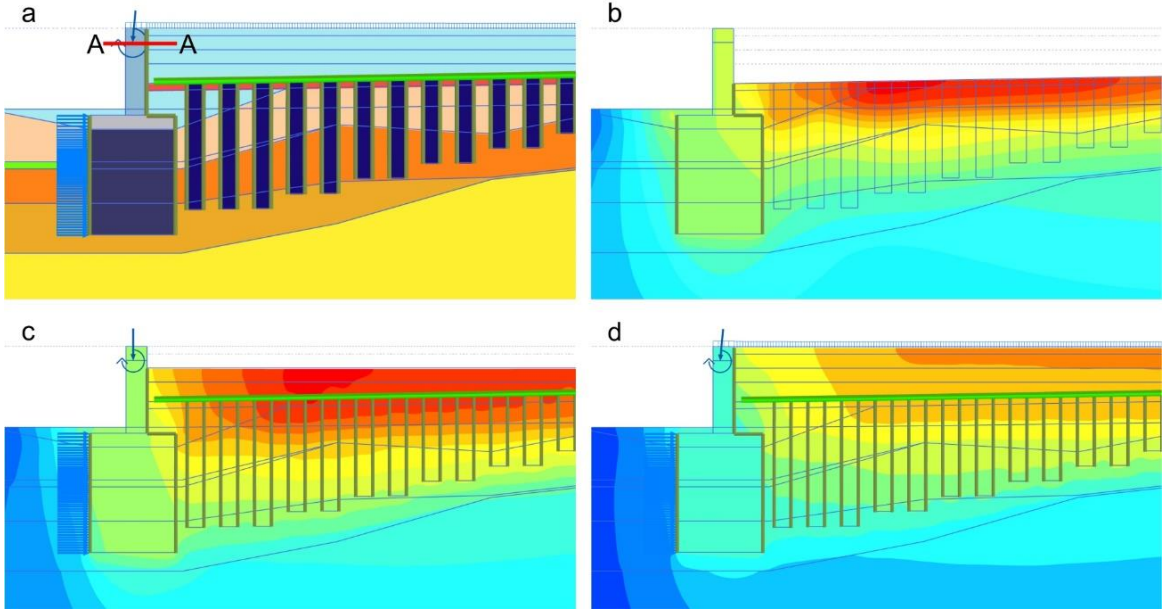
Figure 4. Plane strain model in Plaxis 2D software (a). Map of vertical displacements after execution of: Phase 1 - engineered fill to level 107.0 m A.S.L. (b), Phase 2 - span and engineered fill to level 112.0 m A.S.L. (c), Phase 3 - engineered fill to final level 115.0 m A.S.L. and application of service loads (d)

For each support, finite element method (FEM) models in the longitudinal section were prepared in Plaxis with simulation of subsequent stages of superstructure and adjacent embankments installation. For the purpose of comparative analysis with monitored values on real structure, the results of calculations are presented in three crucial

construction phases (Figure 4). Thus, the total displacements in the representative A-A section (Figure 4a) were estimated as following: **3.5 cm** after execution of engineered fill to level 107.0 m A.S.L. (Figure 4b), **6.8 cm** after execution of span and engineered fill to level 112.0 m A.S.L. (Figure 4c), **9.9 cm** after final leveling to 115.0 m A.S.L. and application of service loads (Figure 4d). In separate calculations, the value of residual settlements resulting from consolidation of compressible soils was determined to be 3-5 cm in 12 months after completion of works.

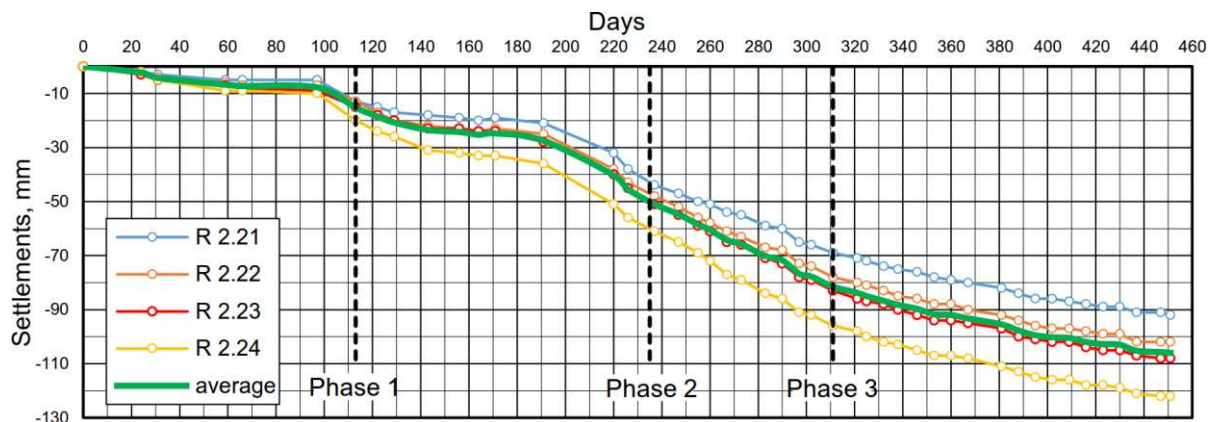
Figure 6. Settlement curves of monitored benchmarks with highlighted construction phases – P2 foundation

As a part of the design work related to the foundation system, Keller has introduced a detailed guideline for measuring the bridge abutments deformations. The long-term monitoring commenced from foundation execution and is still proceeded. The analysis of settlement curves (Figure 6) indicate good convergence of average results with calculations made in Plaxis software (Figure 4). The last phase of loading the structure took place at the end of October 2018 (Phase 3 - day 311, see Figure 6). Despite systematic and reliable monitoring, too short period after the completion of works does not yet allow to observe the full stabilization of settlements. However, significant pace reduction of monitored values in the last 3 months is a promising result. Monitoring is still continuing and a further slight increase in settlements in coming months is expected resulting from the consolidation of cohesive soils under the deep foundation block.
