Landslide monitoring by using ground-based millimeter wave radar system

T. Deguchi, T. Sugiyama, and M. Kishimoto
Nittetsu Mining Consultants Co., Ltd., Tokyo, Japan

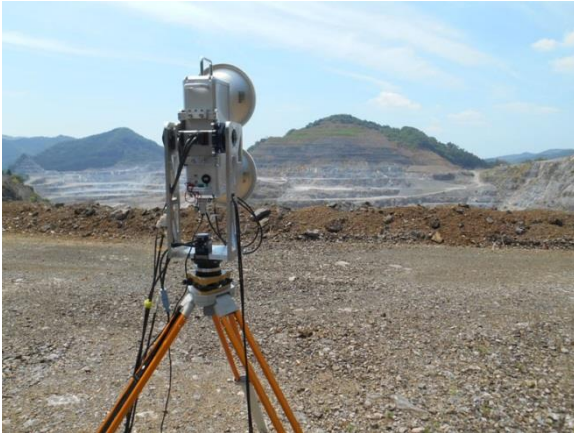
Figure 1. Appearance of ground-based millimeter wave radar.

The monitoring system of the millimeter wave radar developed by the authors is installed at a

certain distance away from the target (slope or infrastructure) and constructs observation routine by remote sensing technology. The radar device rotates in both the horizontal and vertical directions. The system can acquire 2-D images without contacting the target object while repeatedly transmitting and receiving millimeter waves when rotated on a stage installed on a base such as a tripod.

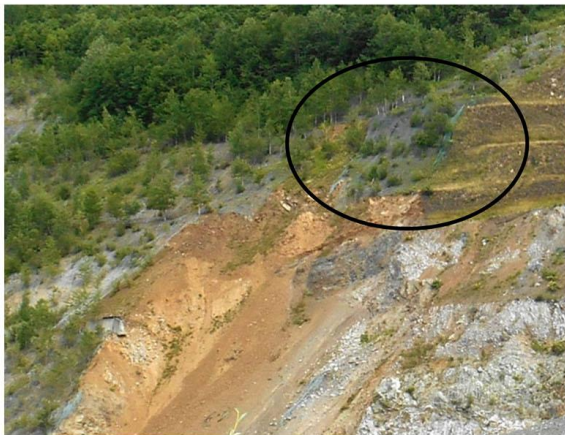
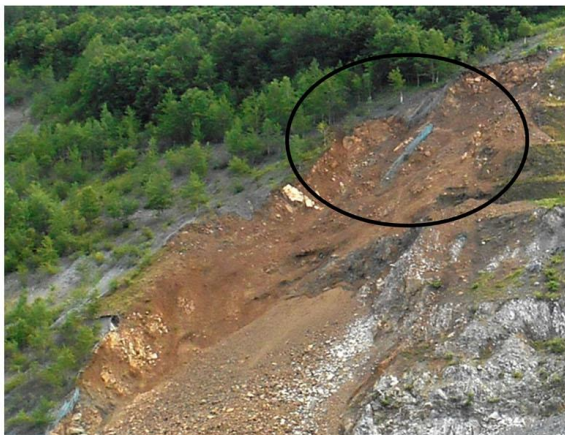
(a) before slope failure

(b) after slope failure

Figure 4. Pictures before and after slope failure.

The photographs in Figure 4 show the slope before and after the slope failure occurred. The 3-D image in Figure 5 (a) displays the displacement measurement results recorded over the course of about one month before the slope failure. The green shading in the figure indicates no change, warm colors indicate displacement toward the

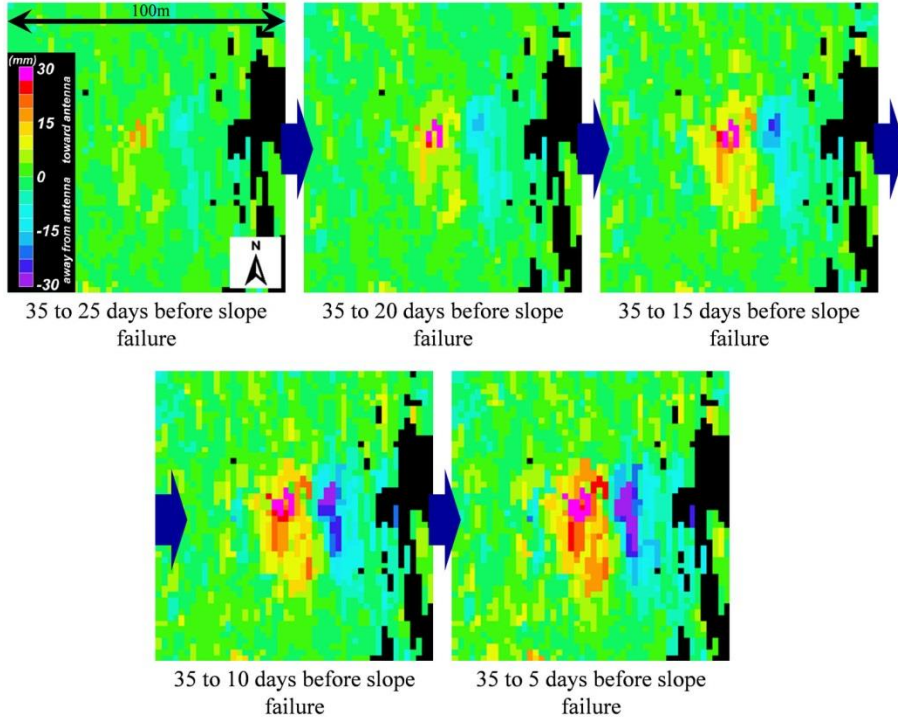
In Figure 6, the plan view of the area where the precursor phenomenon of the slope collapse was detected in Figure 5 (a) was enlarged and displayed. This is a diagram showing the cumulative amount of displacement until the slope collapse every 5 days. It is possible to easily recognize the appearance of warm color anomalies extending from the center of each image over time. In addition, a cold-colored anomaly gradually expanding on the east side (corresponding to the upper part of the slope) is captured clearly.

Figure 6. Three-dimensional displacement map before and after slope failure.
