# Design and construction of an excavation under railway bridges at Reading, England

C.J. Toms

**ABSTRACT:** In order to construct a concrete U-trough for a new carriageway a deep excavation was required beneath two existing rail viaducts and a rail overbridge, northwest of Reading Station, Reading, England. A temporary sheet pile cofferdam, embedded into chalk, was installed over much of the length of the excavation, but at the location of the viaducts and the overbridge alternative measures were required due to limited construction envelope which prevented sheet pile installation. The ground conditions at the site consisted of the made ground overlying Alluvium and River Terrace Deposits which was underlain by structureless chalk, but the solution was complicated by the fact that groundwater was typically 1.0 m below the existing road level, and an existing road link and rail lines, supported by the bridge and viaduct, were to remain operational during the works. This paper describes the solution developed to overcome the site constraints. This comprised grout injection between piled foundations and at the cofferdam interface, an array of dewatering wells and a controlled const

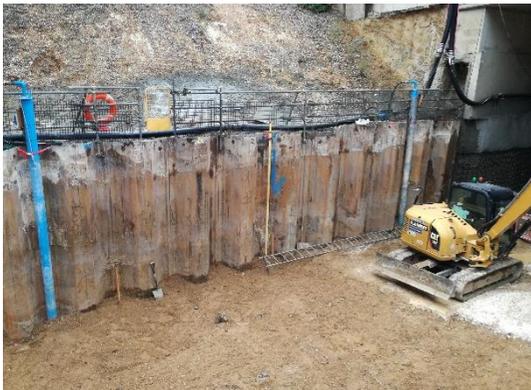
Figure 5. After concreting at interface shown in Figure 4.

excavation progressed water ingress was observed and it was evident that the grouting had failed to adequately reduce the permeability of the gravels at this location. This also occurred on the southwest interface but to a lesser degree. To rectify the seepage, the road was closed and excavation from existing road level was carried out. The loose material was cleared out behind the sheet pile and the void was backfilled with concrete. Shotcrete was only carried out within the MLN overbridge foundations on the exposed contiguous piles (Figure 5). Resin was used at formation level to mitigate areas of small water ingress and at interface with the central line viaduct pile cap and the sheet piles.
