A case study of soil-pile interaction in soft soils

J. Kania Corresponding / primary author
cp test a/s / Aarhus University, Vejle / Aarhus, Denmark

ABSTRACT: The results of soil-structure interaction of driven steel piles installed through soft soils are presented. Two instrumented, 12 m embedment, 406 mm diameter steel piles were installed at a construction site in Esbjerg, Denmark. One of the test piles was bitumen coated. The test piles were driven through 3.5 m of reclaimed sand and 3.6 m of soft soil into underlying sand layer. To investigate the soil-pile interaction due to pile installation and surcharge loading adjacent to the piles after installation, the test piles were instrumented with distributed fibre optic strain sensors along the full length of the piles. It was found that the test piles experienced compression loads after installation and lateral deflections due to surcharge loading in the soft soils. This case study documents the existence and magnitude of residual loads in driven steel piles after installation, the influence of bitumen coating and the effect of lateral thrust on the piles in an upper soft soil layer.

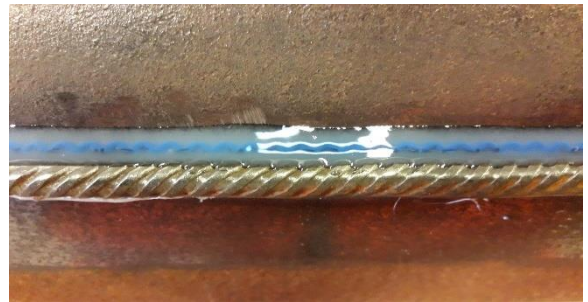
The steel test piles were instrumented with two opposite mounted strain distributed fibre optic sensors (DFOS). As presented in Figure 2, Brusens V9 cables were used as strain DFOS. All DFOS were placed along a welded (one side chain intermittent) Ø12mm steel rebar, pre-stressed to about 1000µε and glued using Araldite 2012 epoxy. Additionally, both steel test piles were equipped with one set of vibrating wire strain gauges (VWSG) installed at five different depths: 1.0, 4.8, 6.4, 7.6 and 11.5 m respectively on each steel pile. The VWSG were protected by welded on angle iron. One of the steel test piles was coated along 7.5 m (0.5-8.0 m depth) with a 1 mm thick, 80/100 penetration bitumen coating. Both steel piles were supplied with point-end pile shoe.

Figure 2. Installation of strain DFOS on the steel piles.

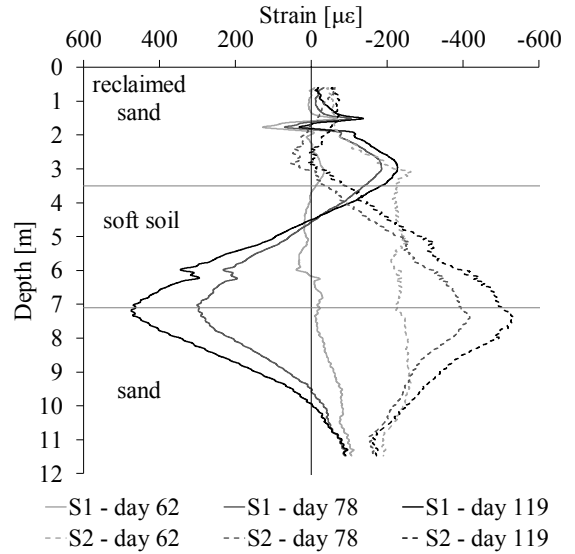
Figure 8. Measured strain distribution of opposite mounted DFOS on the uncoated steel test pile at selected days after pile installation

As shown in Figure 8, there was a significant difference between strain profiles obtained at day

62 and 78 after installation of the piles. The strain profiles obtained from the sensor S1 and S2 62 days after installation of piles indicate arc-shape deflection of the uncoated pile. At day 78 and later (day 119) the strain profiles indicate an S-shape deflection of the uncoated pile having an intersection point located around 4m depth and two local maximum tension and compression values located around 3.0 and 7.5 m depth. The strain profiles presented in Figure 9 indicate a deflection change of the coated pile. At day 62 the coated pile experienced an S-shape deflection with an intersection point at 8 m depth. At day 119 the deflection type was still S-shaped, however the intersection point had shifted to 3.5 m depth. The local maximum tension and compression values were located at the former intersection point around 8.0 m depth. Interestingly, above 3.5 m depth (intersection point at day 119) and below 8m depth (intersection point at day 62) the individual sensors S3 and S4 reversed its position e.g. S3 from tension to compression side at the top and from compression to tension side at the bottom.

To assess the influence of one sided surcharge loading adjacent to the test piles, the strain distributions were used. Figure 8 and Figure 9 present the measured strain distributions of opposite mounted distributed fibre optic strain sensors on

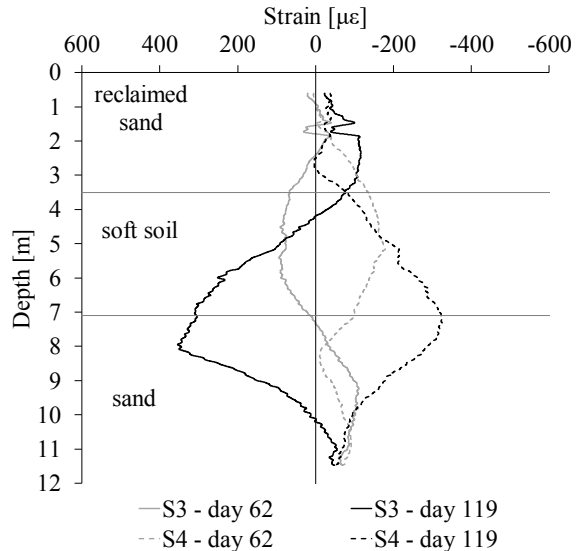
Figure 9. Measured strain distribution of opposite mounted DFOS on the coated steel test pile at selected days after pile installation
