Water table fluctuaction and impact on the remains of Maya Devi Temple, the Birthplace of the Lord Buddha, UNESCO World Heritage Site (Lumbini, Nepal)

C. Margottini

ABSTRACT: Maya Devi Temple is the major archaeological heritages in the Lumbini Sacred Garden (Nepal). The Temple is currently suffering for the rising dampness into the foundation and general weathering of the masonry bricks. Geotechnical and geophysical investigation were carried out on Spring 2016, defining the geological stratigraphy of the area and the possible aquifer. In the period June 2015 - November 2015 a manual monitoring of water table (WT) was conducted on a daily base on existing 5 shafts and 3 pipes. The data, integrated with direct survey in other periods, show the rapid onset of the water table, just after the rainfall, but also the declining and low disappearing of such WT in dry season. Based on 2017 field mission it was possible to establish (clearly and unequivocally) that there is a direct relationship between rainfall and water table in the surrounding of the Maya Devi Temple. The water table shows an ephemeral character, emerging only in monsoon period, with the aquifer possibly localized into

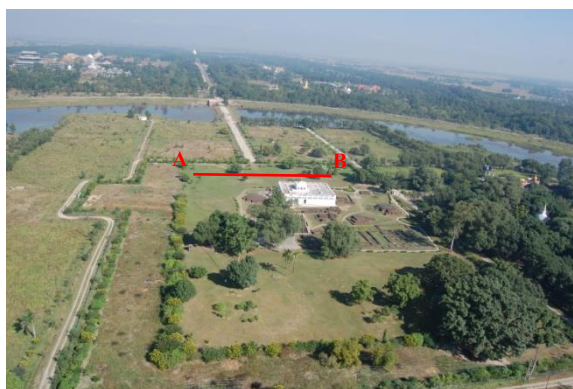
Figure 2. Maya Devi Temple, the sacred garden and a detail geological section marked A-B (in red).

The site of Lumbini, includes numerous artefacts, archaeological structures and a series of gardens (Coningham et al., 2013). Most relevant is the Maya Devi Temple, constructed in 2002 to protect the archaeological structures by the action of weathering effects; it is a large, enclosed structure, constructed mainly of iron beams and concrete, and equipped with two entrance doors and some windows for ventilation (fig.2).

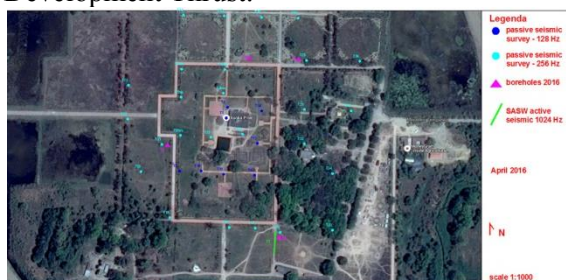
Figure 4. Geotechnical and geophysical prospection implemented in Lumbini in April 2016.

In order to increase and to detail the available lithological and hydrogeological information, three boreholes have been planned, jointly with a geophysical prospection based on passive seismic analysis. The position of the boreholes and the geophysical prospection is reported in the following figure 4. The boreholes were executed far away from the Maya Devi Temple, according to the risk map for cultural heritages prepared by Coningham (2013). In this way we are probably missing the real stratigraphy of the Temple but we did not damage any valuable heritage. All the boreholes were executed with the support of archaeologists of the Lumbini Development Thrust.

In one case, the boreholes found some brick remains and it was agreed to abandon this position (n. 4 in the figure 3). The three boreholes resulted in similar alluvial materials with a limited vertical variability. The first boreholes is drilling an alternation of alluvial deposit, mainly silt, reflecting different flooding

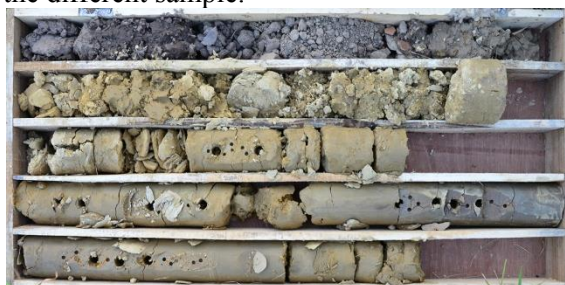
Figure 5. The stratigraphy in borehole n. 1 (box n.1).

Two piezometric surfaces were recovered, the first at 6,1 and the second at 8,2 from the surface. The third borehole, in the Northern part, is exhibiting the same alternation of alluvial deposit, but without water until the depth of 7,5 m from surface. The following figure 5 is an example of material recovered in borehole n. 1. It is possible to notice, in a predominant silty material the different color of layers and the presence of small gravel.

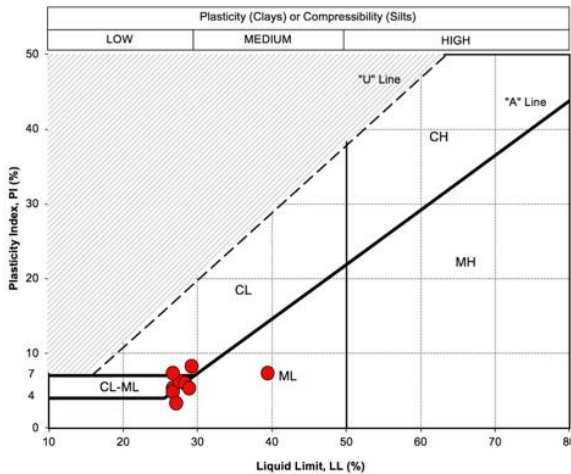
Figure 6. Plasticity chart for the investigated samples.

In figure 6 we report the Plasticity chart for all the investigated 9 samples, from the three boreholes. Similarly is in the grain size distribution. There is no major differences from the investigated samples. Only in one case a layer of sand was clearly identified in Borehole n 3 (-4,3 m from surface). In conclusion, the area is interested by cross bedded layers, with palaeo-channels, but the geotechnical properties are almost constant among the different sample. Some small layer of sand may appear but with a very limited thickness. Such sand layers are responsible for the three limited water tables we found in borehole 1 and 2

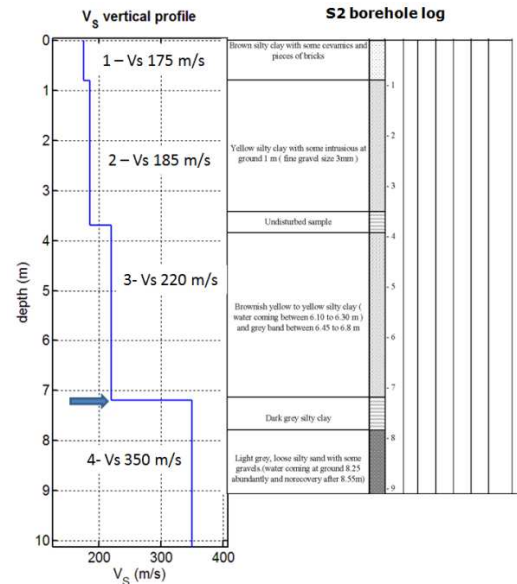
Figure 8. S2 borehole stratigraphy log compared to the V_s final model.

The first 3 layers seems to not differ very much as the increase in V_s value is less than 50 m/s in about 4 m (from 175 to 220 m/s). waves impedance contrast is absent.

A little more significant increase of V_s value is located just below 7 m in depth where the shear wave velocity reaches 350 m/s (fig. 8 blue arrow). The deeper seismic layer is poorly constrained, nevertheless as described below,

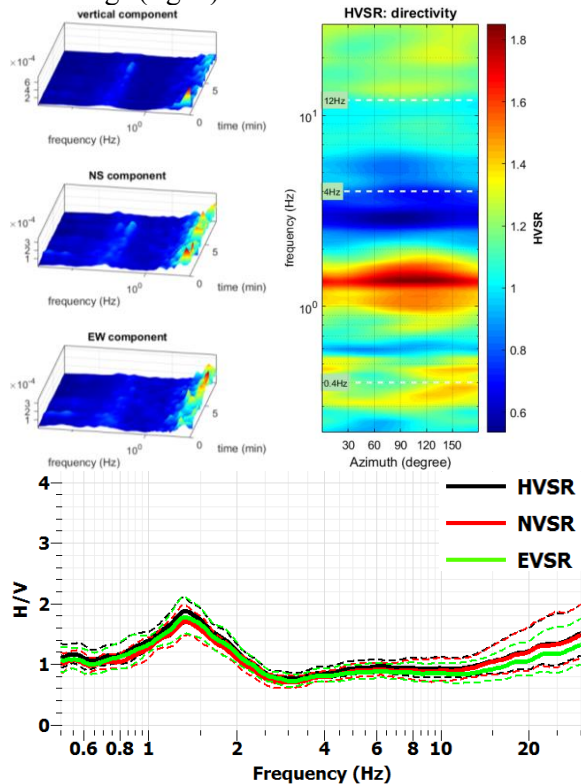
Figure 9. Example of HVSR processing: directivity analysis (up) and mean HVSR curves from the 32 ambient recordings while considering each horizontal component (NVSR, EVSR) also separately (down).

Exactly 32 noise ambient vibration recording has been acquired for a fast and preliminary inspection of seismic site response (April 2017 filed survey). The horizontal-to-vertical spectral ratio curves have been elaborated for all the recordings (fig. 9).

characterisation. The main peak frequency is located at about 1.3 Hz suggesting the presence of a seismic impedance contrast located very deep, nevertheless the mean amplitude of the peak not exceed the value of 2 (i.e. it does not meet the SESAME 2004 criteria). Since based on ambient vibration recordings, the outcomes of the survey should be confirmed by means of further investigations (e.g. HVSR using earthquakes recordings) before to 1) infer the fundamental frequency of the site and 2) to assess the possibility of stratigraphic amplification of ground motion. The spectral ratio curves are quite similar along the whole area, no significant variation in shape has been observed even when considering each single horizontal component with the respect to the vertical one (no directivity).

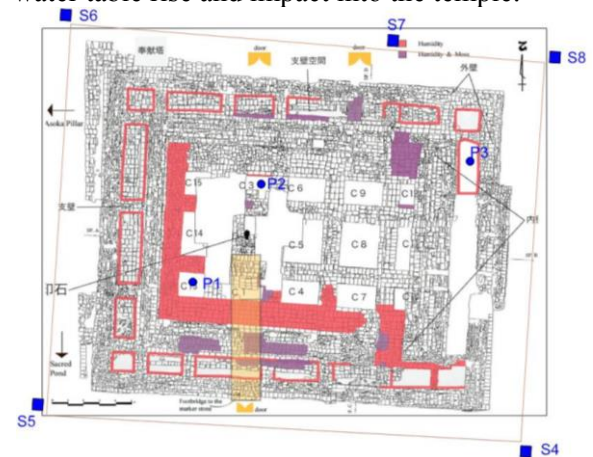
Figure 11. The monitoring network around the Maya Devi Temple location, composed by 5 shafts (blue squares) and the 3 small pipes (blue circle). (Foreground image from Atzori, 2006).
