Difficulties of vibrodriving in till -causing cost intensive measures.

K. Viking; O. Båtelsson

Swedish Transport Administration, Stockholm, Sweden

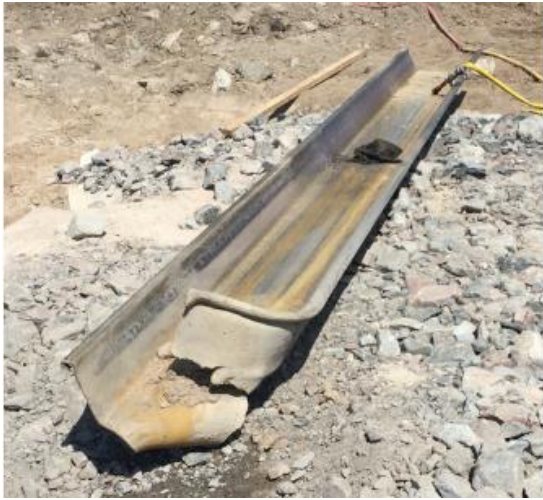
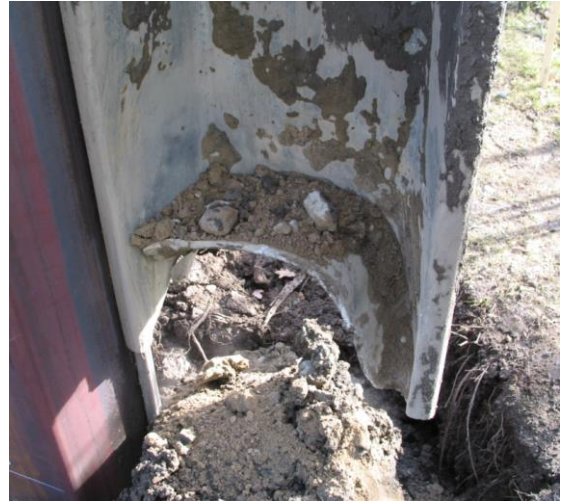
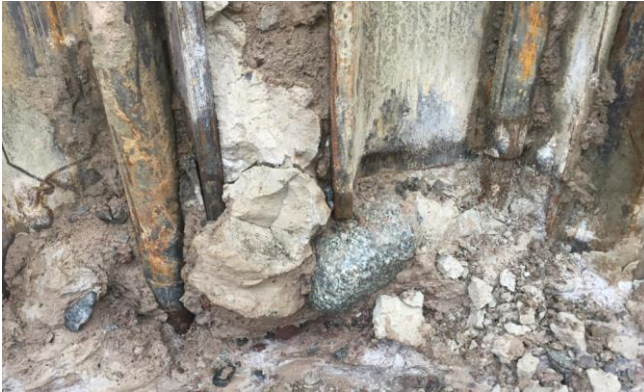
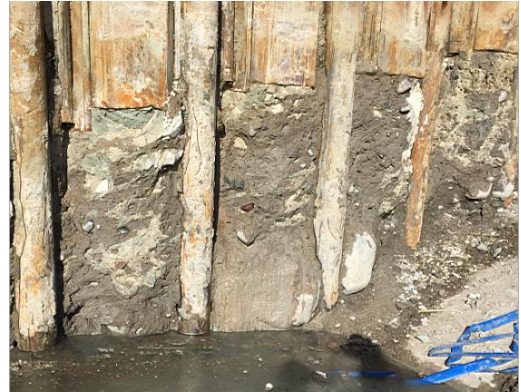
Figure 1 Photo's above show example evidence of local buckling of steel sheet pile toes, two photo's below show unearthed toe of sheet pile wall. Photo: P. Björgúlfsson & K. Viking.

However, if the toe fails or buckle as illustrated in Fig.1, it leads to the need of extensive complementary work to achieve a stable and waterproof retaining wall. Situations of hard driving leads to discussions if the vibro-method needs to be aided with pre-boring and/or switching to stronger SSP sections to minimize the complementary work.

If AB is analyzed to be high, i.e. $> 20\%$, then it's recommended to analyze how a stop driving criteria should be defined. With purpose to minimize the probability of causing local buckling of the SSP toe, as shown in Fig.1.

The driving capacity of a modern leader mounted vibro, has a capacity above $F_d > 1000$ kN. The contact force of the vibrodriven SSP to the right in Fig.1 have encountered a boulder of a size equally them with of the SSP web, i.e. roughly 300 mm. When the driving force of the vibro is compleatly resisted at the toe, the static toe stress of a web with a thickness of 10 mm, can be statically calculated to ~ 300 MPa. Although the estimated stress at the toe is not in excess of static yield stress (assumed to 330 MPa for the 10 mm thick web material), the dynamic yield stress is off course much higher.

However, if the entrepreneur do not observe that the toe have encountered a boulder of granite (and just continue driving), the toe will end up looking like the SSP's in Fig.1.

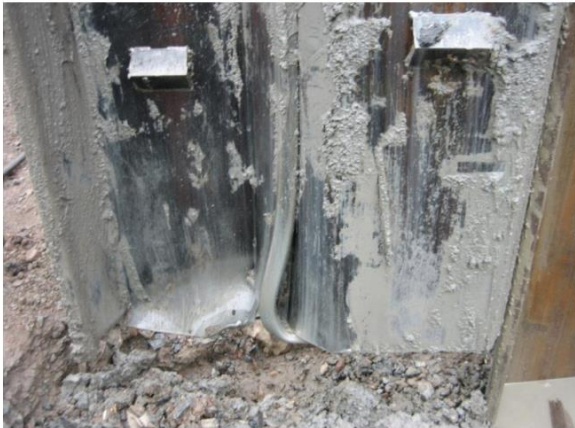
Figure 3 Damaged toe, from Guillemet (2013).

On the other hand, if the entrepreneur is observant, damages of pile toe can be limited to a minimum, as illustrated in Fig.3.
