Consolidation behaviour of quick-clays. The deposit area at the Follobanen Project (Norway)

T.Mateos

Acciona Ingeniería, Madrid, Spain

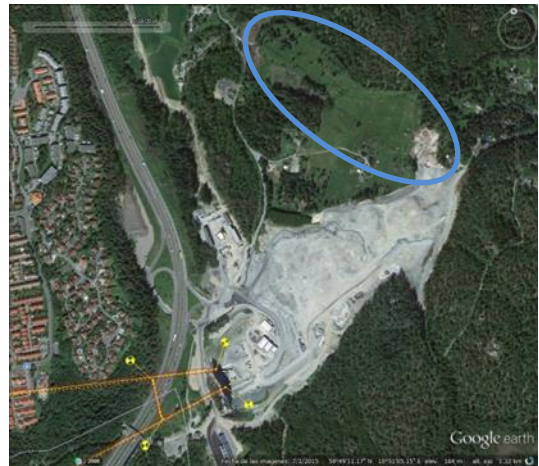
Figure 1. Location of the deposit area in Åsland site.

The deposit area is located close to the main entrance for the tunnels construction (Åsland site). The selected valley is a sedimentary basin filled by soft soils and originally excavated by glacial dynamic (Figure 1).

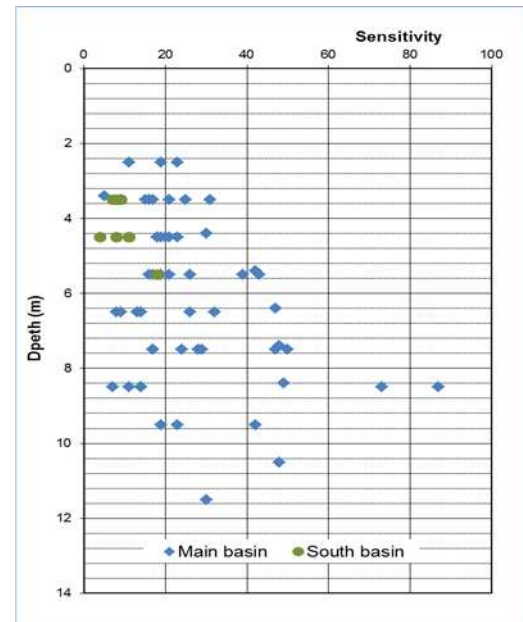
Sensitivity of the quick clay layer found in the area is not extreme, although enough to classify the clays as “quick” according to the Norwegian standards (NVE, 2014). The sensitivity values from fall cone tests are shown in the next picture. It also highlights that clay in the south basin is less sensitive than the clay in the main basin.

Figure 4. Sensitivity values from fall cone tests.

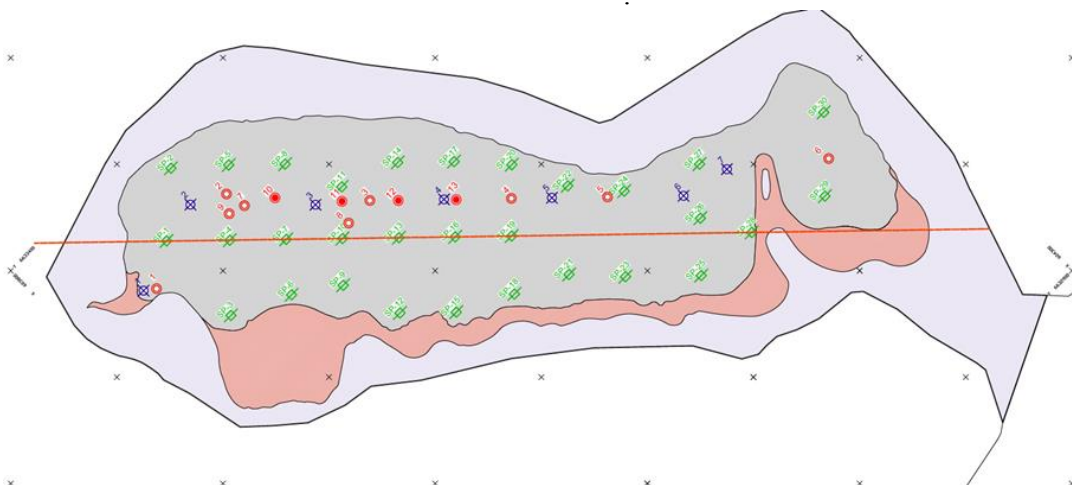
Initially 30 settlement plates, seven inclinometers and 6 piezometers were set up. After a year of data recording, another 7 piezometers were installed and some of the initial ones were replaced due to different record problems (Figure 5).

Figure 5. Monitoring plan (green square: settlement plate; red circle: piezometer; blue circle: inclinometer).

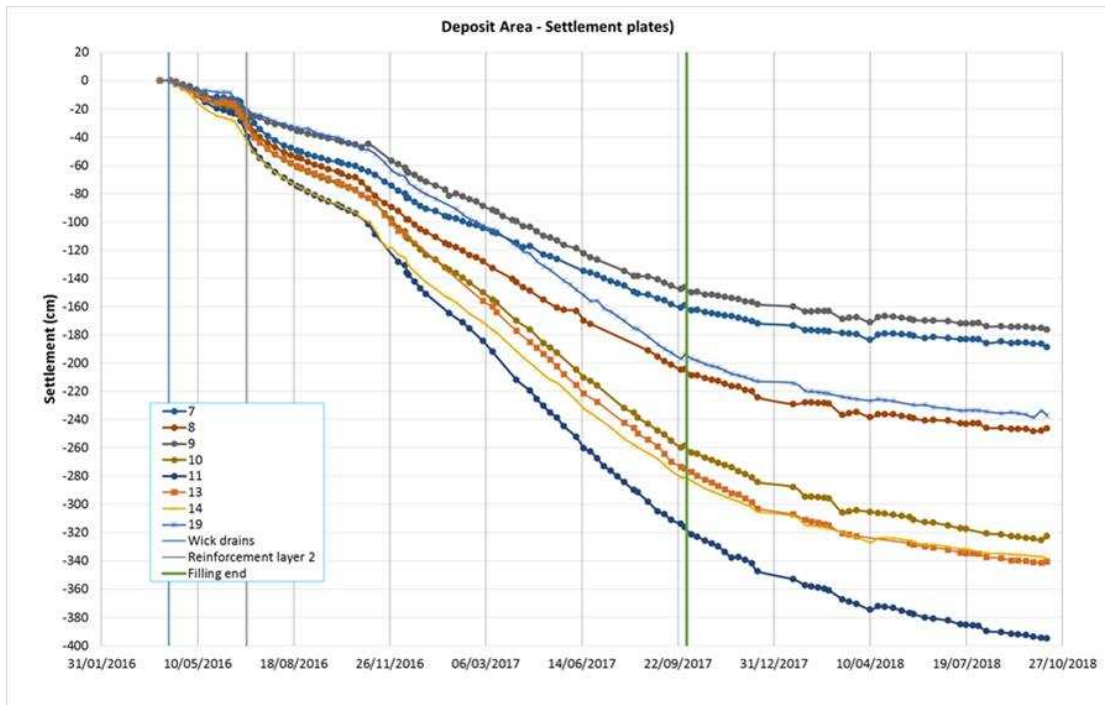
The next figure shows data from the settlement plates located in the central part of the valley, where the thickness of the quick clay layer is bigger. The maximum settlement recorded is around 4m. The current fill height in the area is 15m higher than the initial; it means that the overload corresponds to a fill up to 19m high, taking account of the maximum settlement recorded.

The shape of the settlement curves points out that primary consolidation is almost over in all the points. The worst one is settlement plate 11, however this plate is located close to the new fill which is being currently constructed and probably the results are influenced by this new construction stage or maybe due to a deeper position of the moraine layer, as the piezometer data also denote.

Figure 7. Complete settlement plates record.

The data from the settlement plates have been analyzed by the Asaoka method (Asaoka, 1978). The main results are shown in the next table. The value of both the horizontal and the vertical consolidation coefficients have been estimated for two periods of the fill execution: the first one corresponds to summer 2016, between the execution of the reinforcement layers and the beginning of the construction of the TBM muck layers (Figure 8). The second one resembles the final section of each curve, once the main filling of the landfill was over (green line in Figure 7).

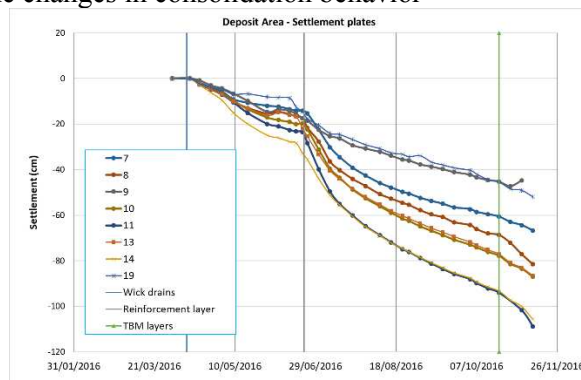
Figure 8. Initial settlement plates record.
