# Geotechnical and Hydrological Modeling of a Landslide at Lajedo Parish – Flores Island (Azores Archipelago)

Leticia Moniz

*Laboratório Regional de Engenharia Civil dos Açores, Ponta Delgada, Portugal*

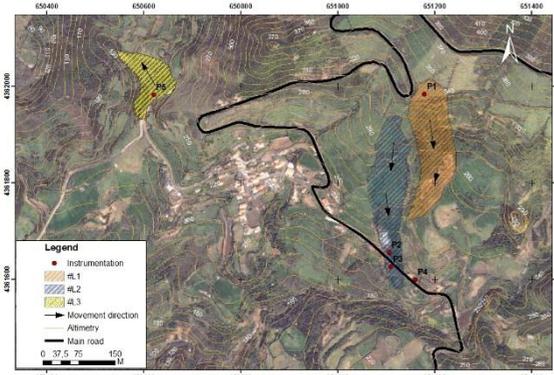
In December of 2010, after a rainy winter, several geomorphological instability situations occurred in the south-west zone of Flores Island, particularly affecting terrains localized at Lajedo parish. Figure 2 presents the mapping of landslides observed in Lajedo and the monitoring zones implemented.

Figure 2. Landslides inventory observed in Lajedo and the monitoring zones implemented.

The monitoring network is distributed by the three geomorphological instability situations identified in Lajedo parish (#L1, #L2 and #L3) (Figure 2). In #L1, two biaxial tiltmeters of the Geosense brand, IPTM-2-420 model and the vibrating wire piezometer (VWP) were installed. In this place, a rainfall station was also installed, because it is the highest and more representative site of the zone. In #L2 the equipment installed was: three inclinometers casing, two Casagrande piezometers and two vibrating wire piezometers, distributed by three places (P2, P3 and P4). One of these locations is outside of the unstable mass (P4). In #L3 only a Casagrande piezometer and an inclinometer system were installed. Given the absence of coverage for telecommunication transmission in this local, it was not possible to install a vibration wire piezometer.

From the inclinometers measurements obtained until September 2018 at Lajedo, the one that presents a relevant displacement is P2i, situated downstream of the #L2 geomorphological instability situation (Figure 2). Figure 4 shows the more relevant observations performed by P2i inclinometer, during the monitoring period.

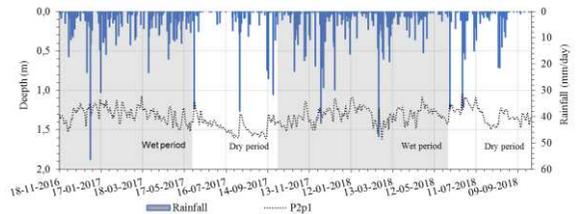
Figure 3 shows the water level fluctuation obtained from the pressure registered by the

vibrating wire piezometer P2p1 installed in #L2 in function of accumulated daily rainfall. Since November 2016 until September 2018, the measured water level is near the ground surface, between 1.04 m and 1.62 m.

Figure 3. Ground water level fluctuation (P2p1) and accumulated daily rainfall (November 2016 to September 2018).

The ground water level is very close to the ground surface and is subject to extremely rapid variation in response to rainfall (Figure 3).

This suggests that materials, in this place, present a high to moderated permeability or there are cracks in the soils that allow a quick recharge of water level on the subsoil.

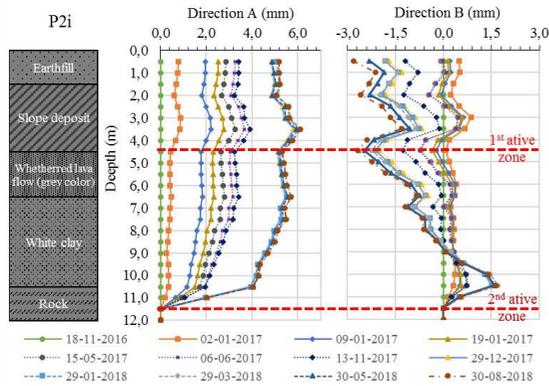
Figure 4. Manual inclinometer readings on P2i (November 2016 to September 2018).

Inclinometer data reveals alternating phases of start-stop motion. The results obtained until now show two active zones in deep, with different displacement rates. The more superficial zone is situated at approximately 4.5 m. This occurs in the interface between the slope deposit and the weathered lava flow with grey color layer. The second active zone is located at 10.5 m, in the transition of a white clay to a basaltic rock, where is located the base of the inclinometer. The maximum displacement was detected in slope deposit with a quantitative of 6.0 mm, with a mean velocity of 4.8 mm/year.

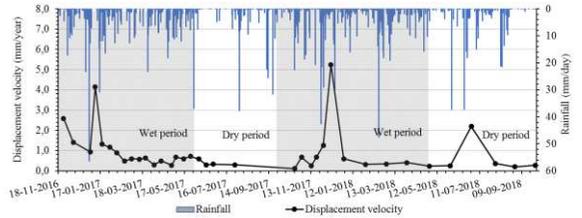
Figure 5 presents a projection of the velocity of the movement and the accumulated daily rainfall. From this figure it is possible to verify that the test site #L2 consists of an instability with reactivation periods in rainy months (October to May), and deceleration periods in dry months (June to September). This aspect can also be seen in Figure 4, where a continuous displacement exists during wet months (18-11-2016 to 06-06-2017) in response to rainfall events, ceasing the displacement until 13-11-2017 measurement, occurring a new reactivation from this day. The three reactivations periods occurred with values of rain between 40 to 60 mm/day. The subsequent 10 days did not show significant increase in the accumulative rainfall, with values between 76 to 121 mm, revealing a rapid response of the landslide system to rainfall infiltration.

Figure 5. Relationship between displacement velocity and accumulated daily rainfall of the P2i.

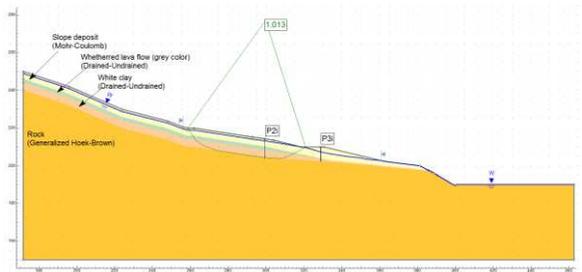
The geological and geotechnical profile (Figure 6) was obtained during the geotechnical prospecting campaign carried out to install the equipment. The existing water level at the site was considered, which is being monitored since then.

Figure 6. Geotechnical model of #L2. Safety factor of calibration model.

Based on the obtained information, the stability analysis was performed. The mechanical parameters used in the modeling were obtained by triaxial compression tests. However, in order to calibrate the geotechnical model, the parameters were adjusted, namely the cohesive component of the white clay so that the critical slip surface reached a safety factor equal to one ( $SF = 1.0$ ) at the more conditioning position of the water level during the calibration period (Figure 6).

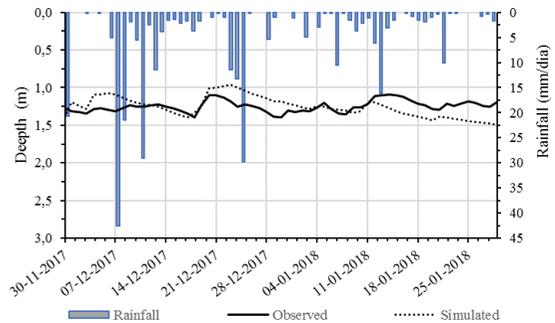
Two months (61 days) were analyzed for the calibration of the model. Figure 7 shows the response of the observed water level and the simulated water level for the precipitation recorded in that period of time.

Although the modeling was not able to include all the characteristics of the site, because it was a two-dimensional analysis, a good approximation was achieved between the variations of the measured water level and the one of the model.

Figure 7. Water level variations monitored vs modulated, between 30-11-2017 and 29-01-2018.

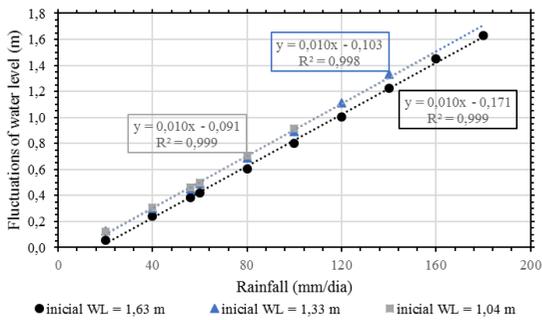
This analysis allows to estimate the variation of the water level for a certain quantity of precipitation, being known the position of the water level that precedes a precipitation event. Furthermore, it is possible to see that for the mean and minimum depth of the water level position, the influence of a given precipitation on the water level fluctuation is the same (Figure 8).

Figure 8. Fluctuations of the water level in function of accumulated daily rainfall.

After the definition and calibration of the models, it was intended to evaluate the influence of an amount of precipitation of 20, 40, 60, 80, 100, 120, 140 and 180 mm/day in the water level variation. This analysis was carried out from three initial depth positions of the water level (WL): maximum depth (1.63 m), minimum (1.04 m) and mean (1.33 m) registered until 09-30-2018. The higher amounts of precipitation, depending on the level at which the water level is located, may cause the saturation of the terrain. In addition, these are plausible values, since they have already been registered in metrological stations near the area that is now being monitored.

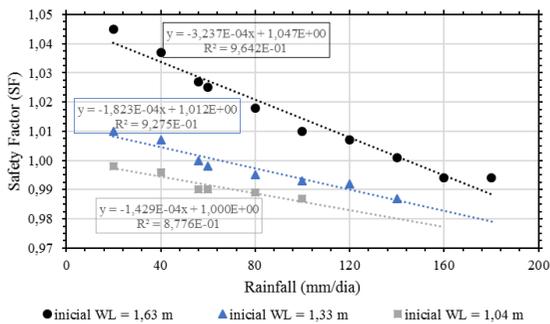
For the three WL positions mentioned above, from this analysis it was still possible to estimate the SF for a given accumulated daily precipitation scenario and for a known position of the water level (Figure 9).

Figure 9. SF decreasing in function of accumulated daily rainfall.

Thus, when the SF is lower than the unit, this indicates that the scenario in question can reactivate the system, causing its instability.
