Eemdijk full-scale field test programme: sheet pile pullover tests

H.J. Lengkeek

ABSTRACT: Dikes in the Netherlands have traditionally been constructed with soil. Climate change and subsidence requires heightening and or reinforcing of these existing ground dikes. Traditional reinforcements demand additional space, which in some cases conflicts with existing buildings. Applying sheet pile walls in dikes allows for strengthening while minimizing the increase in footprint. However, a validated design approach that complies with relevant regulations lacks. To enable the validation of a proposed design approach, a full-scale field test programme (Eemdijkproef) was performed near the town of Eemdijk, The Netherlands. It consisted of a step wise approach: 1) sheet pile pullover tests, 2) ground dike stability test, 3) sheet pile dike stability test. All tests were loaded until failure occurred. The full-scale pullover tests (POT) consisted of 4 sheet pile configurations. The length of the sheet piles varies between 13 and 16m and the width of the panel varies between 1.8 and 4.2m. Both Z- and U-profiles have been tested. This paper presents the test setup, monitoring, measurements and

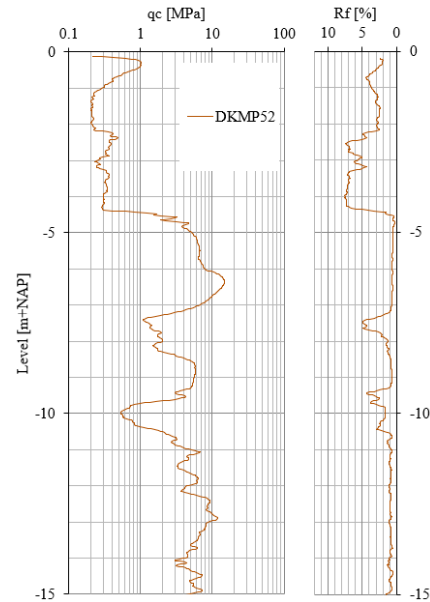
Figure 1. Representative CPT at POT site

The ground conditions at the test site are homogeneous, consisting of peat and clay layers on top of a sand layer. In Figure 1 a representative CPT is presented and Table 1 presents the stratification. The “Eemdijkproef” comprised an extensive field and laboratory testing programme. A more detailed description of the geotechnical conditions is presented in (Lengkeek, 2019b). During

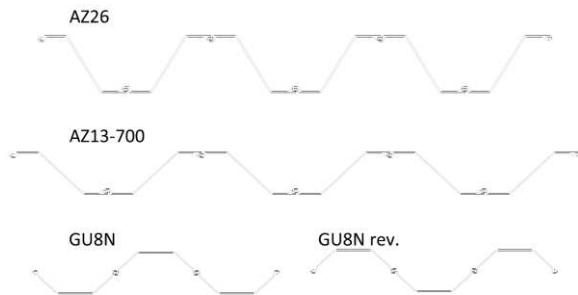
Figure 2. Sheet pile profiles

Four sheet pile configurations are tested in the POT (see figure 2):

- GU8N triple is a class 3 profile according to the (EN 1993-5, 2007) and the same type as used in the FST sheet pile dike. To assess the influence of the loading direction, this profile is also tested in the reversed direction (GU8N-rev).

- AZ26 profile is tested to validate the plastic bending capacity since this profile is a class 2

profile according to the (EN 1993-5, 2007) and therefore is expected to reach the full plastic bending capacity with additional plastic rotation capacity.

- AZ13-700 is a class 3 profile according to the (EN 1993-5, 2007) and is tested for comparison with the AZ26 profile. It is expected to reach the expected elastic bending capacity (plastic resistance in term of Eurocode) but not the full plastic bending capacity.

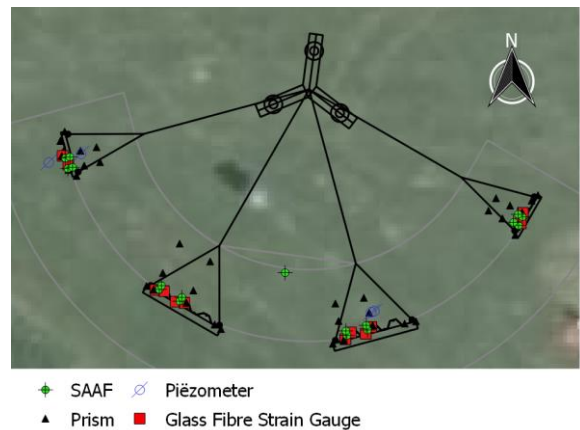
Figure 3. Top view POT site with monitoring instrumentation

The test setup is presented in figure 3. Four sheet pile configurations are placed in a circular formation around a reaction frame. This reaction frame consists of 3 tubular piles interconnected with a steel Y-frame. To prevent any soil interaction between the sheet piles and the reaction frame the sheet piles are installed at a 15m distance of the tubular piles.

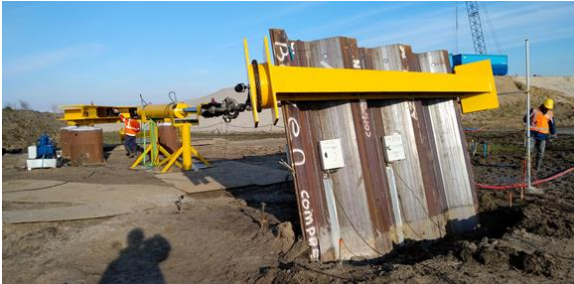
Figure 4. Photo of AZ13-700 during the test

Between the reaction frame and the sheet piles a hydraulic jack is placed 2m above surface level, see Figure 4. This jack can generate a pull-force of 1200kN and has a stroke of 2m. This jack is placed on a sliding table to support the jack and prevent the self-weight of the system to influence the behavior of the sheet pile. The jack is connected to a steel cable to both sides of a waling on the sheet pile. This connection is such that the pull-force is evenly distributed over both sides of the waling and the pull force remains centric on the waling even for large rotations of the sheet pile wall.

The AZ13-700 three double-Z is a relative wide panel in respect to the GU8N triple-U profiles, see Figure 4. Since the wall is wider and has a higher bending moment capacity than the GU8N

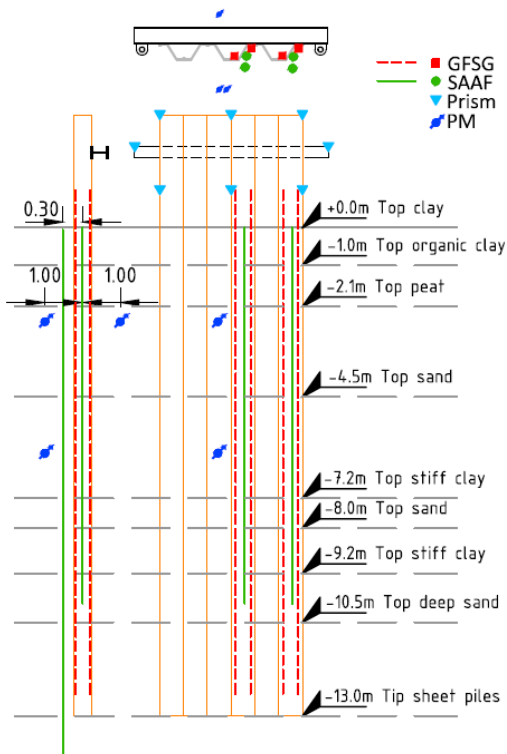
Figure 5. Top, front and side view of instrumented AZ26 sheet pile panel.

To monitor the horizontal displacements of the sheet pile, prisms are placed at three levels on the sheet pile and are monitored with total stations. Two SAAF's (Shape Accel Array Field) are

installed on the sheet pile wall and two SAAF's in the ground at 0.3m in front of the wall center-line to monitor the deflection and horizontal displacements over depth. The total pulling force applied by the hydraulic jack is measured by a force gauge and the stroke of the hydraulic jack is measured by an optical sensor. On the sheet pile wall glass fiber strain gauges (GFSG) are installed.

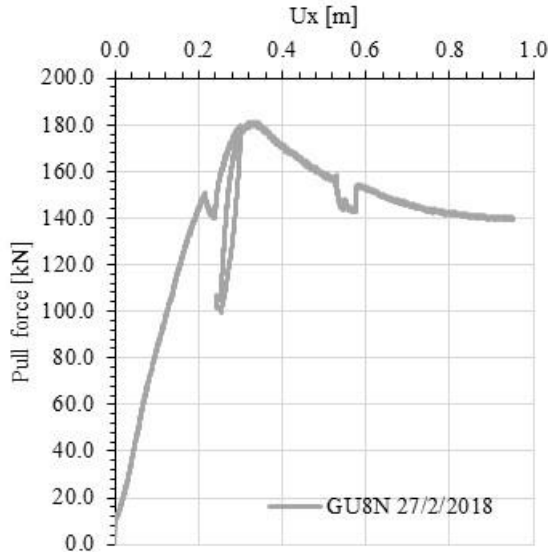
Figure 6. Force-displacement diagram GU8N.
GU8N 2018-02-27 12:47:00

The maximum pulling force reached during this test is 180kN. The fixation level where rotation starts is about -2.0m NAP. Upon reaching 30cm of displacement the SAAF's on the sheet pile wall are removed to prevent any damage due to local buckling of the sheet pile. For this the pull-force is temporary lowered to 100kN. A similar procedure is also followed for the other tests. The obtained force-displacement diagram for the GU8N is shown in figure 6. In figure 7 the horizontal displacements measured by the SAAF and prisms are plotted just before removal of the SAAF. In this figure the SAAF's in front of the wall are also shown with an offset of 1m, in reality they are placed at 0.3m distance of the center-line of the sheet pile wall.

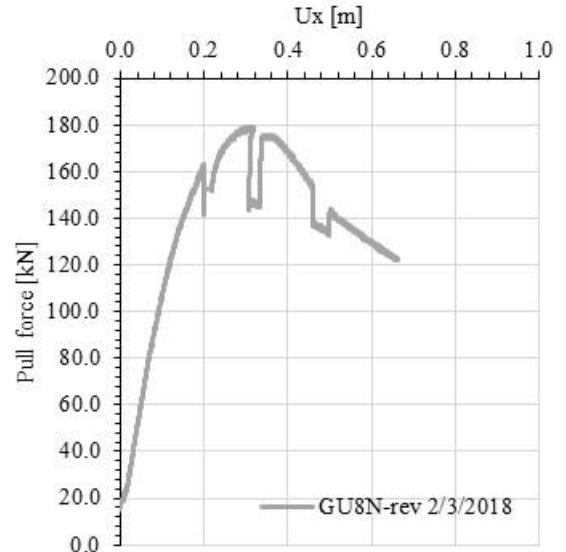
Figure 8. Force-displacement diagram GU8N-rev
GU8Nrev 2018-03-02 13:53:00

Figure 8 shows the maximum pull-force is almost 180kN, which is approximately the same as the GU8N triple-U profile. The reduction in pull-force after reaching the peak is however significantly larger compared with the GU8N triple-U profile. Figure 9 shows the deformations of the GU8N-rev triple-U profile and the layout is similar to figure 7

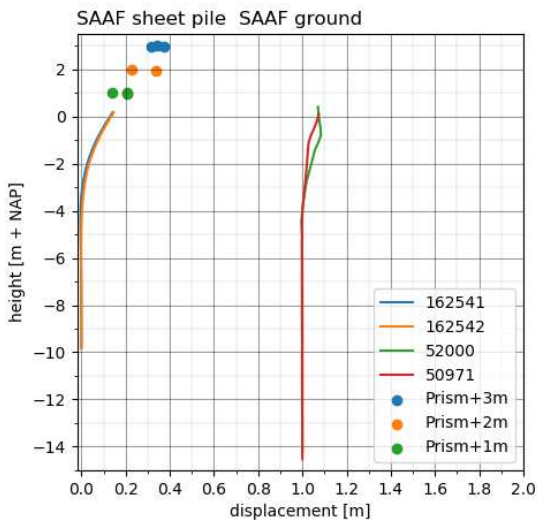
Figure 7. Horizontal displacements over depth of the SAAF and prisms at the GU8N sheet pile.

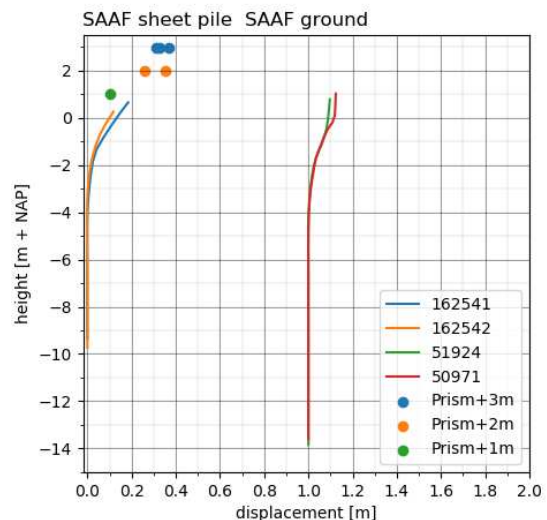
Figure 9. Horizontal displacements over depth of the SAAF and prisms at the GU8N-rev sheet pile.

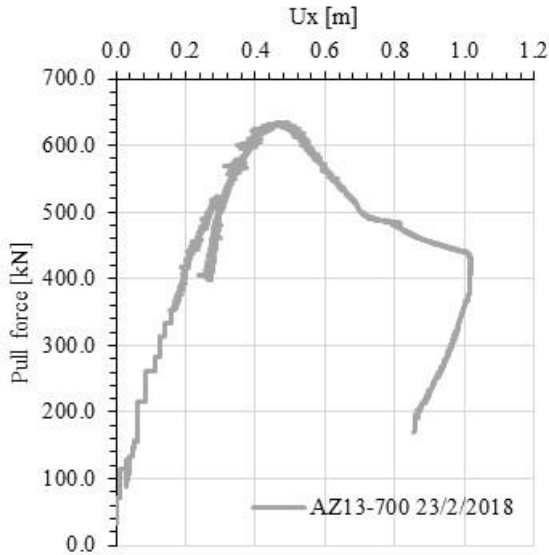
Figure 10. Force-displacement diagram AZ13-700
AZ13-700 2018-02-23 14:04:00

triple-U, the maximum pulling force is also higher at 634kN (figure 10). The AZ13-700 three double-Z profile is stiffer than the GU8N profile. This is also reflected in horizontal displacements (figure 11). The fixation level where rotation starts is about -4.0m NAP due to the higher stiffness.

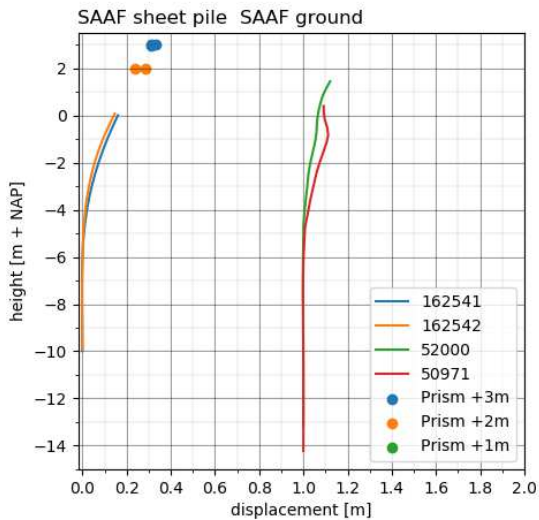
Figure 11. Horizontal displacements over depth of the SAAF and prisms at the AZ13-700 sheet pile

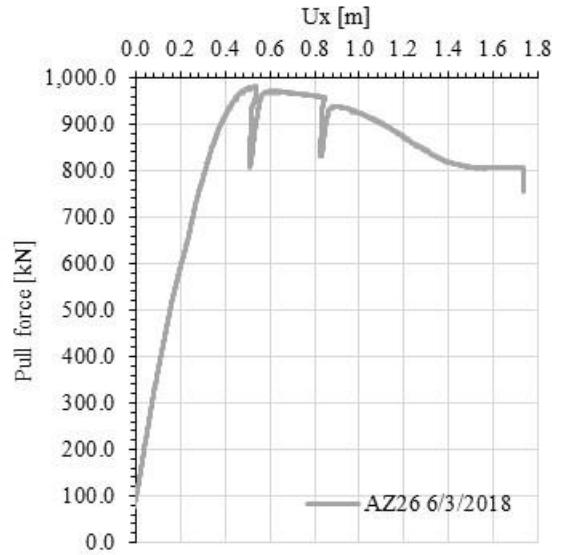
Figure 12. Force-displacement diagram AZ26
AZ26 2018-03-06 12:34:00

The AZ26 three double-Z is the strongest profile that has been tested as part of the pullover test program, a maximum pull-force of 982kN is reached. The fixation level where rotation starts

is about -6.0m NAP due to the high stiffness. The results in figure 12 also show that after reaching the maximum pull-force this profile allows for large additional displacements with little reduction of the pulling force relative to the other tested profiles. This setup of three double heavier profiles represents also the typical configuration

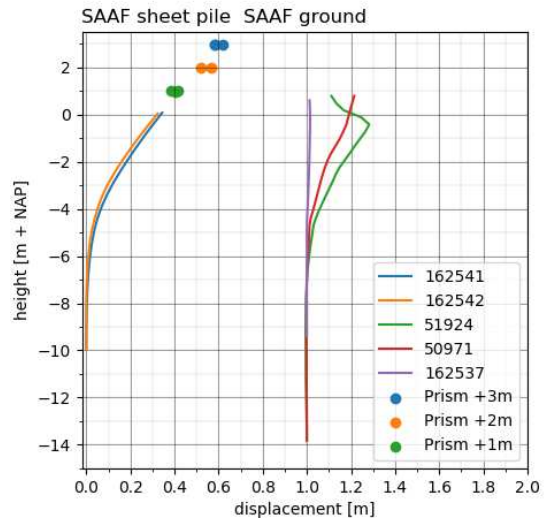
Figure 13. Horizontal displacements over depth of the SAAF and prisms at the AZ26 sheet pile.

Figure 13 shows the deformations of the AZ26 three double-Z-profile. The larger horizontal displacements relate to the deeper point of rotation, compared to the other profiles. In addition, one SAAF is placed at 5m distance of the sheet pile wall to measure the displacements of the soil on a larger distance.

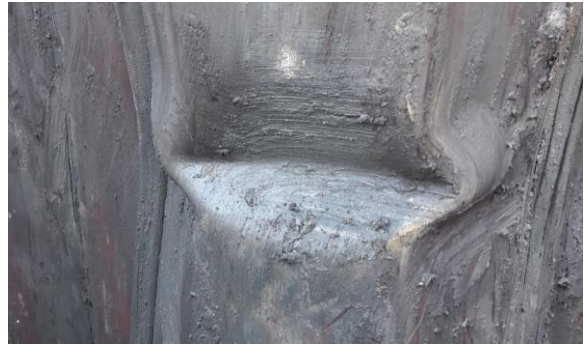
Figure 14. Excavated GU8N-rev with local buckling

After performing the pullover tests the sheet piles have been excavated to investigate the failure mechanism. Figure 14 shows as example the buckled compression flange of the GU8N-rev triple-U.

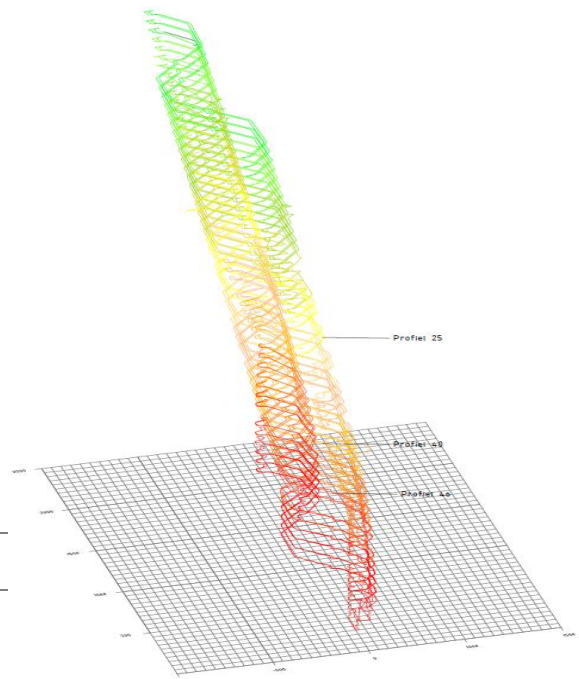
Figure 15. 3D scan of deformed GU8N-rev

In addition to the visual inspection of the excavated sheet piles 3D scans have been made to record the deformed shape of the entire profile, see Figure 15. Based on the 3D-scans it is observed that the buckling and plasticity is limited to approximately 0.5m height. The shape of the rest of the profile did not change significantly.

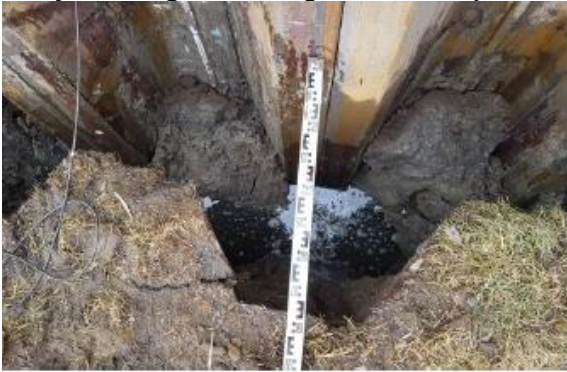
Figure 16. Gapping behind sheet pile wall AZ26

During the pullover test the sheet piles are pulled forward resulting in a gap at the back of the sheet pile wall. Due to the undrained behavior of the cohesive soil the soil remains almost perfectly vertical and the water level in this gap drops significantly below the original water table effectively reducing the loading on the sheet pile.
