The influence of thrust faulting on deep-seated slope gravitational deformation in southern Taiwan

R. F. Chen

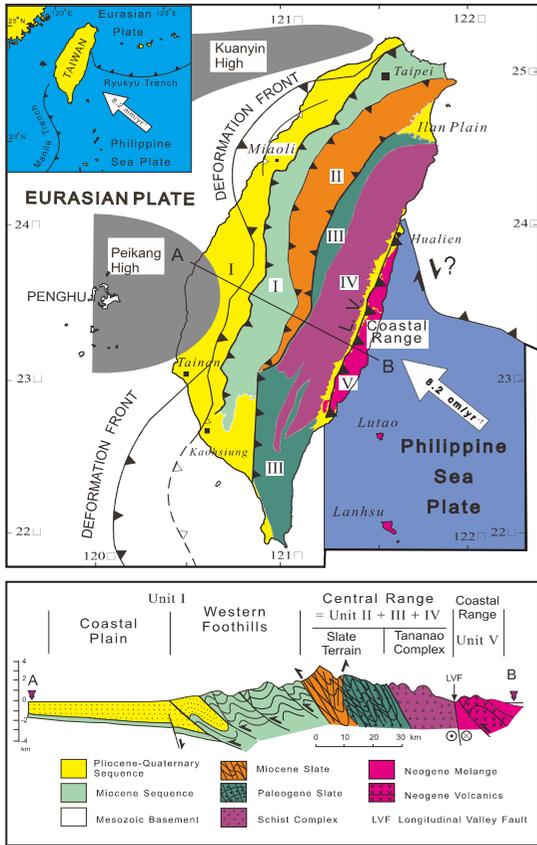
Figure 1. The geodynamic relationships of Taiwan indicate the major tectono-stratigraphic units (Teng, 1990).

Taiwan is located between the Philippine Sea plate and Eurasian plate, with two opposite-verging subduction system of the Ryukyu arc-trench and Luzon arcs to the east and south respectively. Figure 1 indicates the major tectono-stratigraphic units of Taiwan from the

east to west (Ho et al., 1986), including the Coastal Range (V); metamorphic Basement (IV); Backbone Rang (III); Hsuehshan Range (II); Western Foothills (Ia) and Coastal Plain (Ib). During tectonic deformation, intensively fractured and pulverized rocks are commonly associated with the development of thrust-faulting on a regional scale.

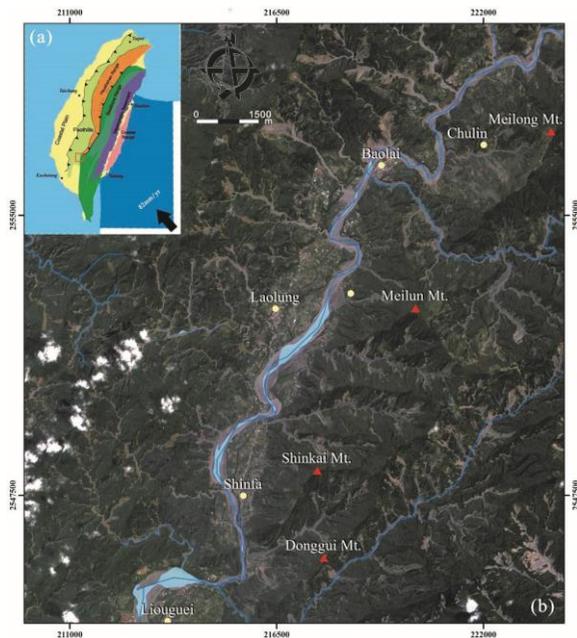
Figure 2. (a) Bathymetric and tectonic framework around Taiwan. (b) Orthoimage of Formosat-2 satellite, showing severe landslides that occurred during the 2009 Typhoon Morakot in the study area.

Chulin, a region of about 25.2 km² in Paolai District of Kaohsiung City in southwestern Taiwan, was selected as the study area. Within the study area, we mainly focused on the Meilong

River catchment due to its better exposures in fault outcrops (Figure 2). Meilong River is an east-to-west flowing small river with a total length of about 2800 m. The Meilong River catchment is about 5.62 km² and elevation of its catchment is from 430 m to 1350 m.

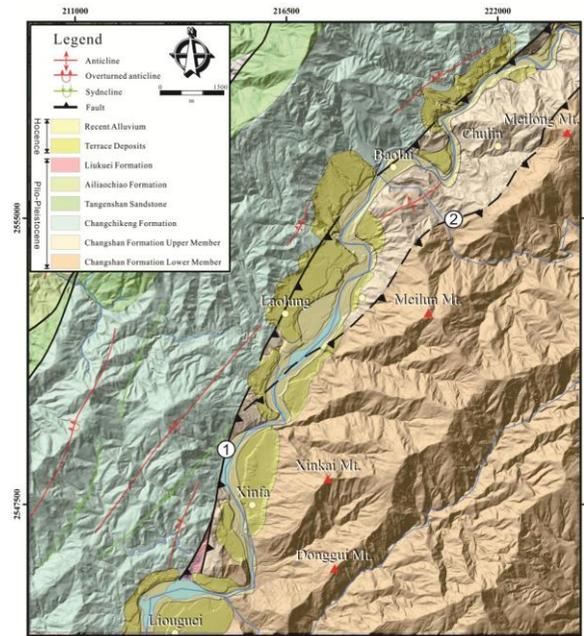
Figure 3. Geological map of the study area (modified by Sung et al., 2000).

The study area is nearby the intersection of two geological provinces, Western Foothills in the west and Central Mountain Range in the east. The fault contact between Western Foothills and southern Taiwan is Laonung River Fault. There are two faults, the Laonung River Fault that passes through the northern corner and the Meilongshan fault passes through the center of study area (Sung et al., 2000). The Laonung River Fault is an eastern dipping high-angle reverse fault that separates the Miocene sedimentary Changchikeng Formation in the west and the Miocene metamorphosed Changshan Formation in the east. The Changchikeng Formation is primarily composed of grey to dark grey shale with thin bedded sandstone or interbedded thin

layer of shale and sandstone, and the Changshan Formation mainly consists of argillite or slate with thin bedded metamorphosed sandstone. The Meilongshan Fault is an inferred fault because no outcrop had been discovered in precedent field surveys (Figure 3).

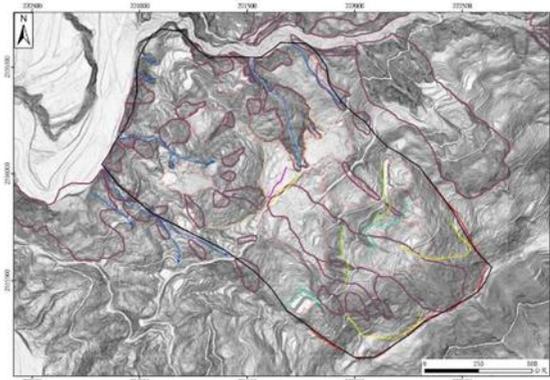
Figure 4. The identified deep seated landslides with an area over 10 ha and less than 10 ha are marked by black and purple line, respectively. The identified shallow landslides are marked by blue lines.

Within the Meilong River catchment, thirteen deep-seated landslides, which are over 10 ha respectively and about 3.78 km² in total, were identified within the study area of 5.2 km². Five deep-seated landslides with an area less than 10 ha respectively and 0.17 km² in total were also discerned. Additionally, 57 shallow landslides with a total area of 122.5 ha were also recognized. One deep-seated landslide was selected to elaborate the details of its morpho-tectonic features recognized in LiDAR derived DEM (Figure 4).

Sized around 150 ha, the site is 870 m wide and 1,600 m long, and has an average slope gradient of 29° and elevation difference of 660 m. Within the deep-seated landslide, 33 shallow landslides with total area of 44 ha can be easily discerned by vegetation stripped off in aerial photos. The main escarpment of this deep-seated landslide is on the ridge and extended about 700 m with a maximum scarp height of about 20 m. A multiple ridge with

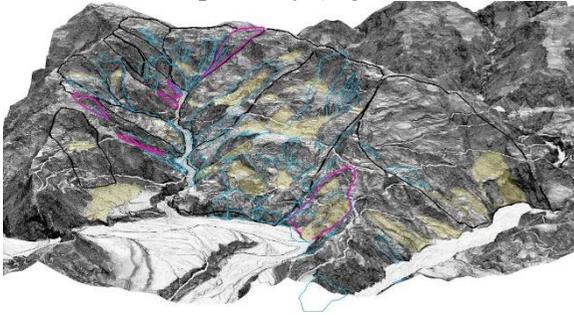
Figure 5. 3D view of identified deep seated landslides and shallow landslides in the study area.

a meter depression extended about 200 m was also recognized in middle of the slope. Two main gentle slopes previously covered by landslide deposits were also identified at the height of 890 m and 700 m respectively (Figure 5).

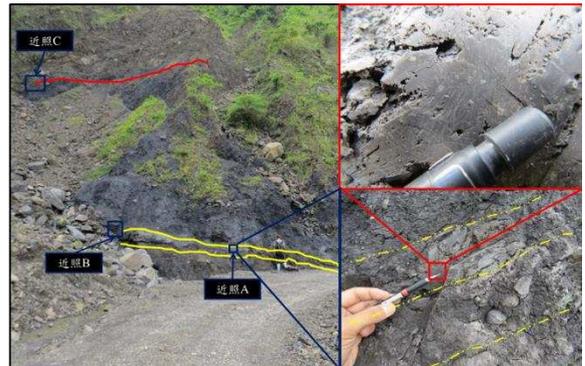
Figure 6. Field observation of faulted material in the study area.

In Figure 6, a 50 cm thick fault gouge exposed in areas between the yellow lines, and fault breccia zone was identified in an area below the lower yellow line. Area between the yellow and red lines is a 30 m thick fault breccia zone, whereas area above the red line was recognized as highly-fracture zone.

In this study, a fault zone is divided into fault gouge zone, intensively fracture and fault breccia zone, fracture zone, and undeform wall rocks. Fault gouge consists of very fine crushed materials that are generally over 70% in volume and it usually appears in the field as a narrow dark color belt; fault breccia zone contains more crushed rock debris and its very fine materials are less than 70%; the intensively fractured zone is formed by intensively fractured rocks.
