Small diameter jacked piles to stop long lasting differential settlements on fine peaty soils

G. Bosco

ABSTRACT: The paper describes a successful application of slender jacked piles to underpin a residential building, having a compact and regular r.c. structure with open ground floor, two stories and a top loft for ten apartments. Settlements were noticed at finishing of the structure (2007) when a rotation of the stiff r.c. foundation slab was detected; they have continued ever since and today the differential settlement is 0.28 m. Soil investigation showed layers of very soft clays, peat, organic clays, silty clays, to depths of 27-30 m. The eleven steel pipe piles, 114.3 mm o.d., have been placed along the shorter side of the slab, where the largest settlements occur, and jacked to depths of 27-30 m into a firm sand layer. Two piles have been equipped with a load cell to register load increase with time; presently tilting has stopped and a slight recover is measured.

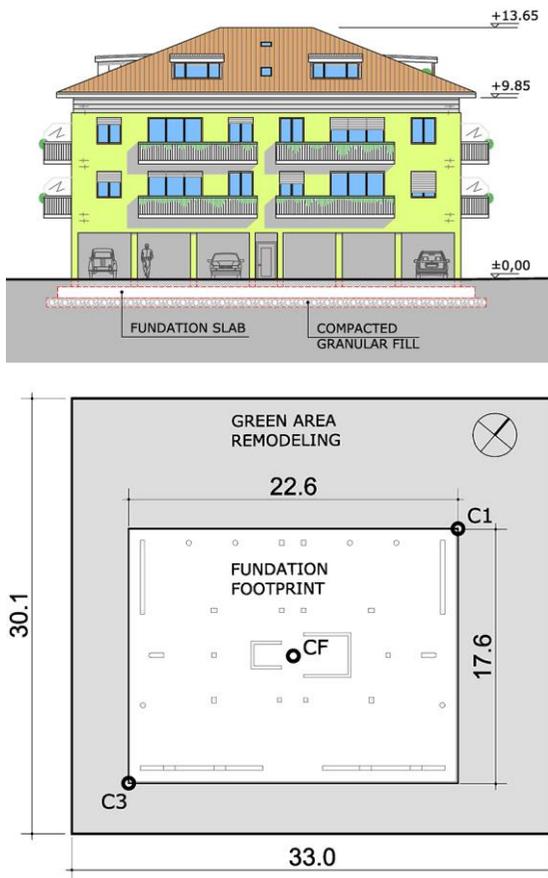
Figure 2. The longest façade, looking North, and the area of the building and the foundation slab (C1, C3, Cf: points where settlements have been calculated)

Thus a regular and compact shape, with two axis of symmetry and an almost square footprint was adopted (Figure 2). The living area was arranged around the central stairway, opposite the lift block, to obtain an even distribution of dead and variable loads to exert an essentially vertical action to the foundation.

The final design includes an open ground level, for storage rooms and parking spaces, two floors divided into 4 apartments each, a top loft with 2 apartments. The maximum height reaches 13,5 m atop the roof (Figure 2).

The structure is a reinforced concrete frame, rigidly connected to a stiff base slab measuring 17.6x22.6 m² and having a thickness of 0.55 m. This r.c. slab was placed near the South-Western corner of the appurtenant area, 30.1x33.0 m². The slab, and its blinding layer, 0.1 m thick, rest on a granular fill, compacted in an excavation, 0.5 m deep below natural ground, whose base was lined with a geotextile+geomembrane. Atop the slab, a heavy-duty industrial pavement, with thickness of 0.25 m, was placed to resist the vertical and shear forces of parking vehicles.

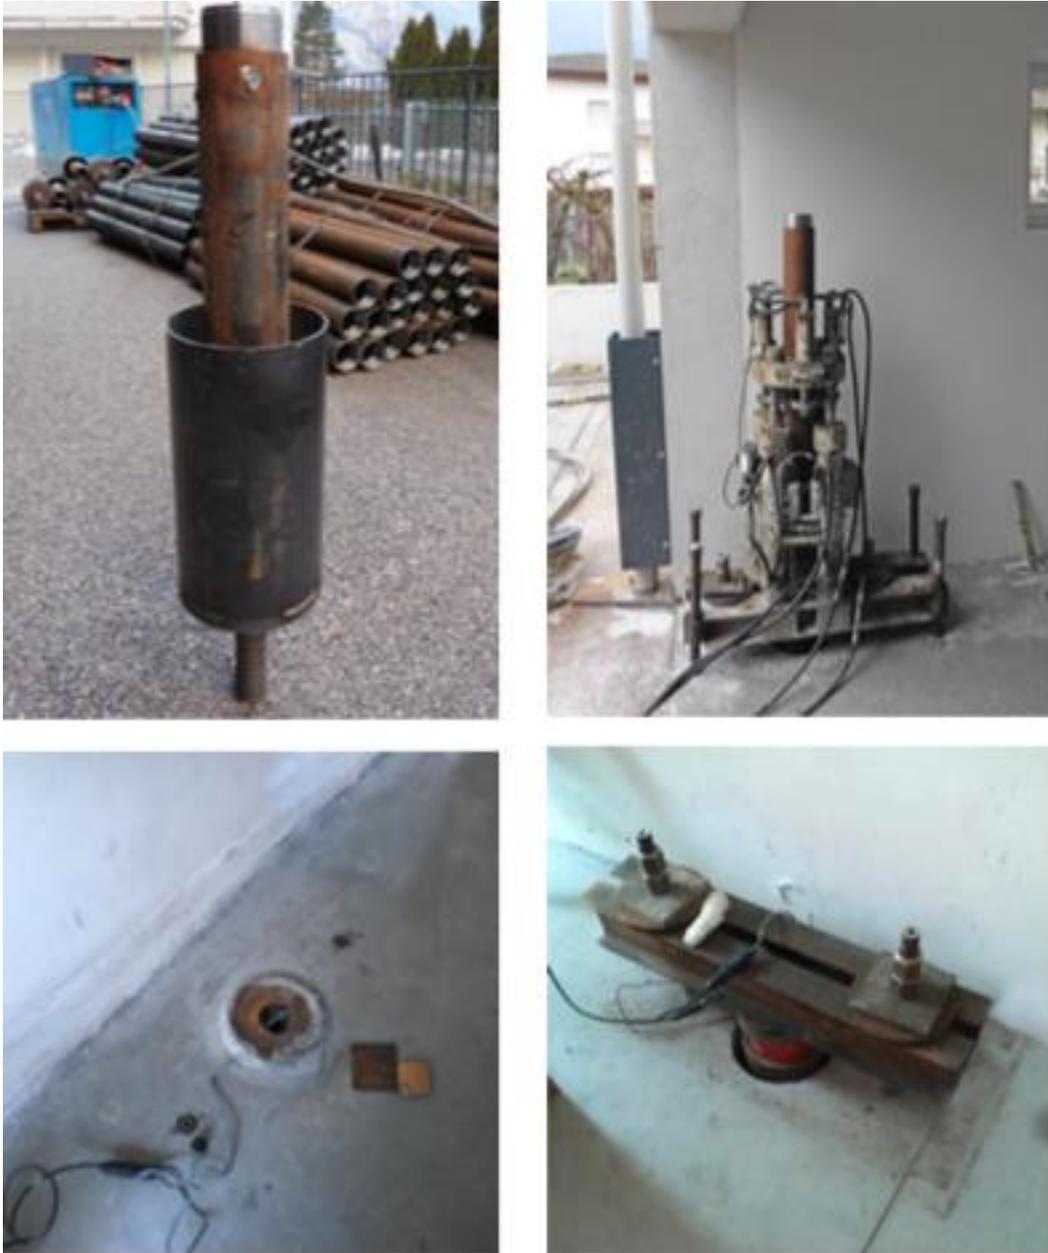
Figure 6. Steel tube and base bucket (top left); pushing equipment with micropile (top right); load cell embedded into the slab foundation (bottom left); removable load cell between head of micropile and reaction frame (bottom right)

Figure 6 describes the selected underpinning system. Micropiles are made of steel tubes, 10 mm thick and outer diameter 114.3 mm, in 2.0 m long pieces screwed together when jacked. A steel bucket, 220 mm o.d. and 700 mm high, is welded to the base tube, which is slotted in order to grout the pile hole. When the piles are pushed downward, the bucket displays the soft soils laterally and leaves a 220 mm hole behind. This hole is kept open using water, rarely bentonite mud; both have a stabilizing effect and prevent the soil, compacted and smeared by the bucket, from caving in. Here, water was sufficient.

Jacking continued till refusal, occurring as the enlarged base was set firmly in the deep sand layer. Thence, cement grout was poured in the pipe column until it was seen emerging at the base of the slab; at this stage the 220 mm hole had been filled and the micropile completed.

The equipment used (Figure 6) comprises a reaction steel frame with four piston jacks welded on two base beams. When oil pressure is applied, the pistons slide inside the cylinders to pull the pile downward. Reaction was provided by 4 threaded bars, 40 mm, fixed into the base slab with a special quick-set cement grout. Push capacity is 400-500 kN, corresponding to a unit pressure at pile base $p = 10.5-13.2$ MPa. In this case a max force of 400 kN was applied.

In mid January, the installation of the 11 piles was completed in less than 2 weeks. Piles are 27-30 m long, except for one pushed to 34 m. Two piles have been equipped with an electric load cells to monitor load build up.

The usual survey yields an increase of the differential settlement C1-C3 to 290 mm in mid February and a reduction to 287 mm on 27-09-18. The two load cells indicate a load increase, from March to September, from 43 to 56 kN and from 50 to 64 kN for piles n.2 and n.11.
