# INTERNATIONAL SOCIETY FOR SOIL MECHANICS AND GEOTECHNICAL ENGINEERING

*This paper was downloaded from the Online Library of the International Society for Soil Mechanics and Geotechnical Engineering (ISSMGE). The library is available here:*

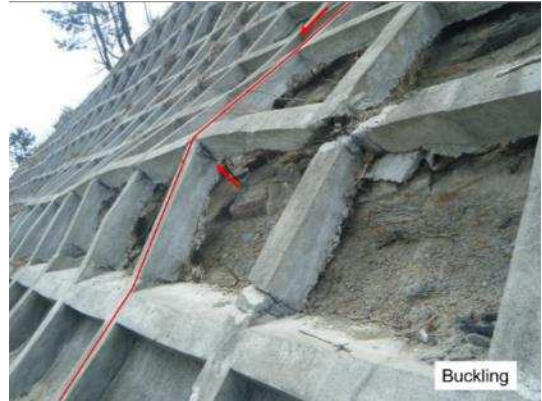
Figure 5: Collapse of shotcrete grating crib work in Kuji City after the earthquake. Buckling and shearing of the concrete ribs are observed.

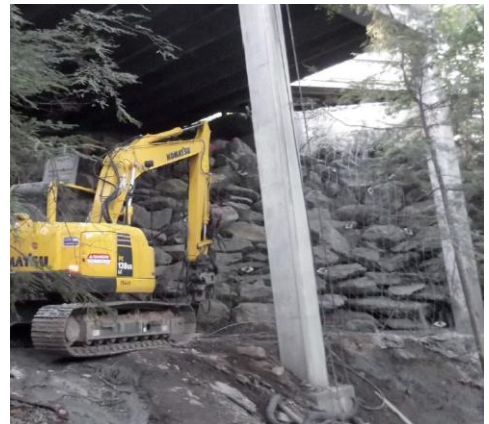
Figure 9: Slope stabilisation under a newly built residential car park. No damages were observed during and after the earthquake. The potential damage of slope failure would have resulted in the collapse of the residential compound and the car park.

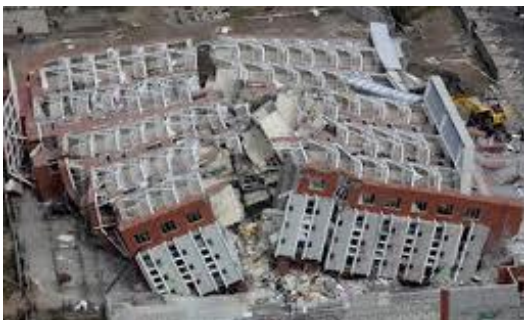
Figure 11: Damage in Caleta Tumbes, Talcahuano after the earthquake.

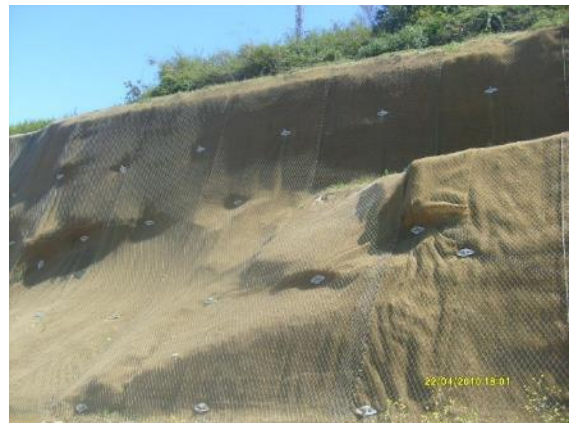
Figure 12: Previously installed Tecco system, which did not sustain any damage during and after the earthquake. The slope remained stable.

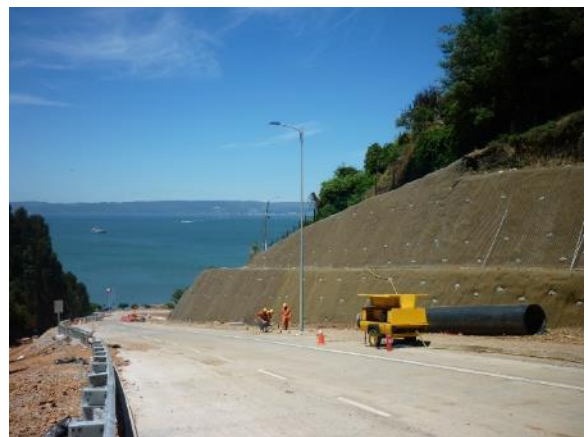
Figure 13: Overview of the stabilised road stretch being. No deformation or failure after the earthquake.
