Timber compaction piles as part of seismic retrofit for a 110-year old railway bridge

J. D. Williams

Klohn Crippen Berger Ltd., Vancouver, Canada

Keywords: Ground Improvement; Timber Compaction Piles; Liquefaction

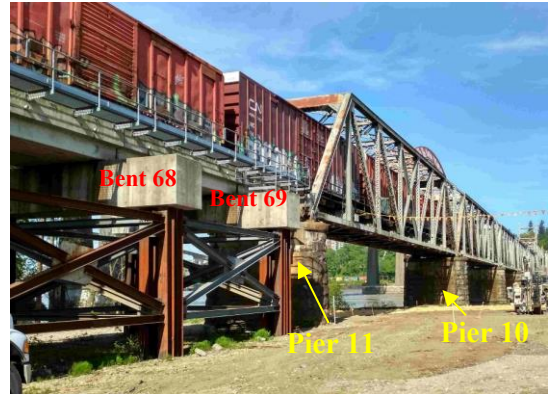
Figure 2. Pier 11

Pier 11, which is the main focus of this paper, is located at the southeast bank. Figure 1 shows an aerial view of the south side of the bridge and Figure 2 shows the south riverbank.

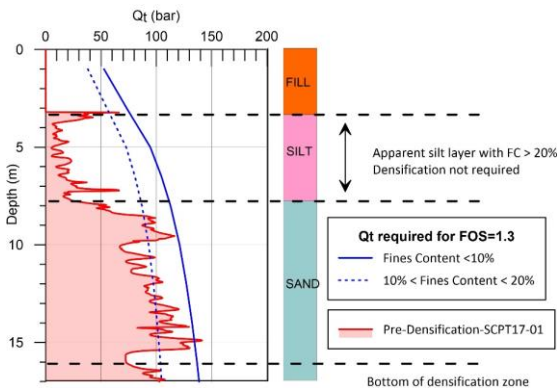
As part of the liquefaction assessment, the minimum CPT tip resistances required to prevent liquefaction were calculated and are presented on Figure 4. Resistance criteria for sand with less than 10% fines (i.e. materials finer than 0.075 mm) and with 10 to 20% fines are given. The CPT tip resistances are based on a factor of safety of 1.3 against liquefaction triggering.

Figure 4. Required CPT tip resistance

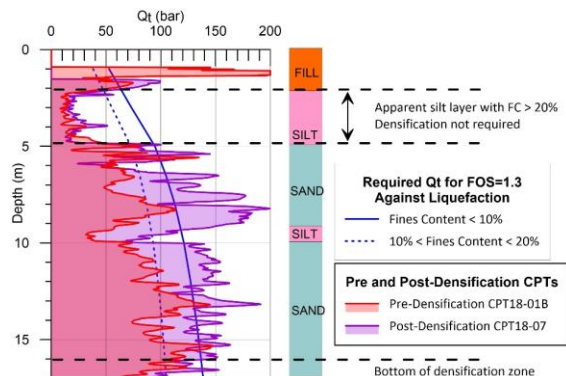
Figure 6 shows a comparison of the pre and post-densification CPTs in the test area. It also shows the cone tip resistances required to prevent liquefaction with a factor of safety of 1.3 for clean sand and sand with 10-20% fines content.

Figure 6. Test Area –Pre/Post Densification CPTs

Based on the results from the test pile program, the same pattern and spacing and methodology (equipment and procedure) was used for piling in the production areas.

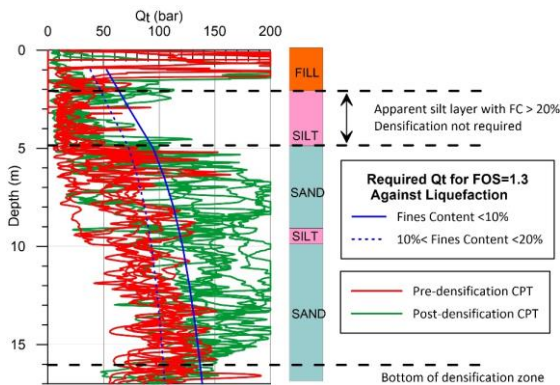
Six post densification CPTs were conducted in the production area to quantify the effectiveness of the densification. The CPTs were located in the centroid of the compaction piles. Figure 7 shows a comparison of the pre- and post-densification CPT tip resistances.

Figure 7. Production Area - Pre and Post Densification CPTs

In general, the specified tip resistances were achieved, and the design intent of the densification satisfied.

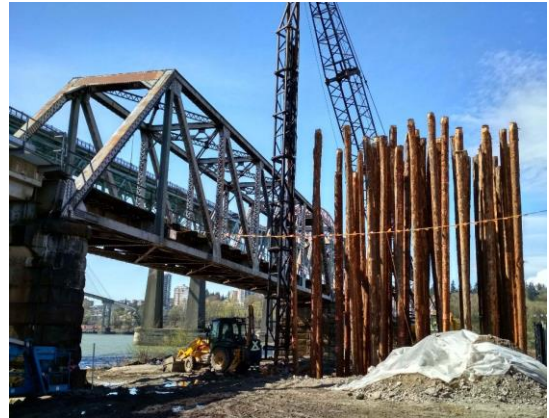
The owner required that the railway bridge remain in operation during the ground improvement work. As such, the pile installation immediately adjacent to the track had to be paused as trains were passing. The frequency of trains ranged from 30 to 35 trains per day. The diesel piling hammer was able to be shut down immediately when a train was approaching. Figure 8

shows the proximity of the piling equipment to the operational track.

Figure 8. Pile driving adjacent to railway track

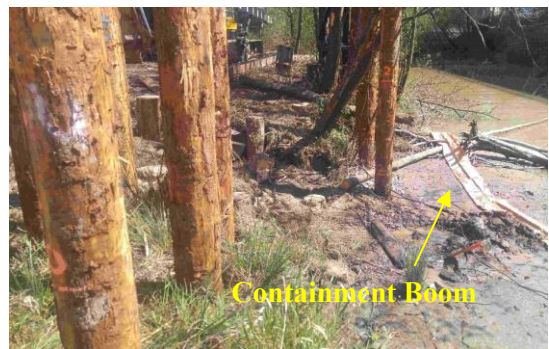
The GI area southwest of the rail track had multiple timber piles located on the riverbank and within a tributary of the Fraser River. Materials or surface water from the GI area were not allowed to enter the watercourse. These timber piles were installed during low tide with containment booms surrounding the working area. Timber piles were driven between trees on the riverbank rather than removing the trees. The integrity of the bank was maintained during pile driving.

Figure 9. Pile driving adjacent to the river bank

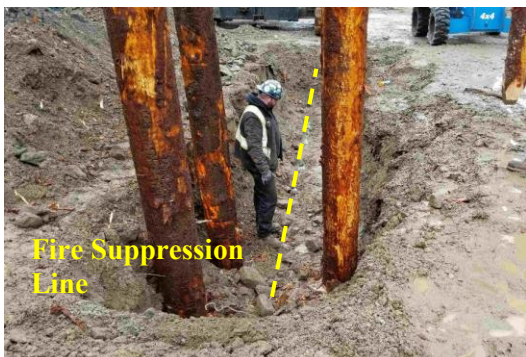
Both underground and overhead utilities were in the vicinity of the GI area. Underground utilities including a fire suppression water line (Figure 10) and a power supply line for the bridge

were located and daylighted prior to pile driving. The layout of the timber piles needed to be adjusted and one pile eliminated to avoid impacting the fire suppression water line. An overhead communication cable which intersected the GI area had sufficient slack to be held away from timber piles during driving.

Figure 10. Pile driving adjacent to utilities

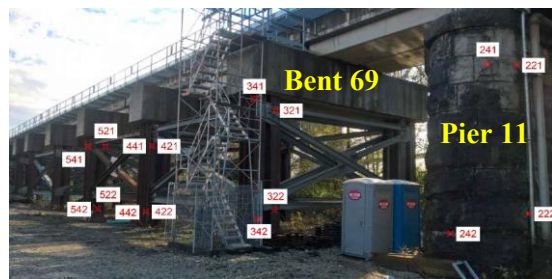
Monitoring points were installed on the structure near the ground and close to the track level on both sides of the track. Typical locations of the monitoring points are shown on Figure 11.

Figure 11. Typical monitoring points

The monitored settlement of Pier 10, Pier 11, Bent 67, Bent 68 and Bent 69 were less than 5 mm after the completion of piling. The measured horizontal movement either in the northing or easting direction at Piers 10, Pier 11, Bents 69, Bents 68 and Bent 68 were less than 17 mm. The greatest movement was observed at Pier 11 and Bent 69, which are located nearest to the GI area.
