# Geosynthetic-reinforced earth walls and slopes in extremely challenging applications

O. Detert/ HUESKER Synthetic GmbH/ Gescher, Germany

**ABSTRACT:** The application of geosynthetic-reinforced steep slopes and walls in extremely challenging applications, respectively under extreme boundary conditions, has successfully been demonstrated in various projects. This paper presents a technically expedient and practically feasible solution for the use of geosynthetic-reinforced retaining structures on project subjects to extremely difficult geotechnical and topographical conditions. Within the paper different cases are reported on projects with special requirements. The last case study presents in a great extent a very complex situation in the alps, where an existing road had to be replaced within a creeping slope.

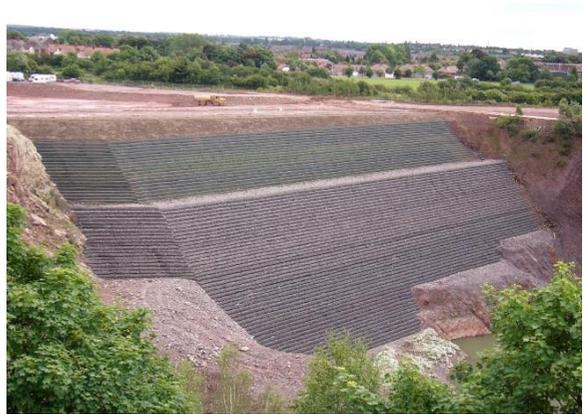
Figure 1. GRS wall after completion of construction

The slope face is formed using a wraparound type structure (Figure 1). At Midland Quarry, due to the presence of the quarry lake, the risk of wave action on the slope face required the use of gabion stone, installed within the front section of the slope face for the lower two thirds of the slope height. The upper third of the slope comprises a topsoil face to aid vegetation above the water line (Figure 2). The wraparound face construction is formed using a temporary climbing shutter system.

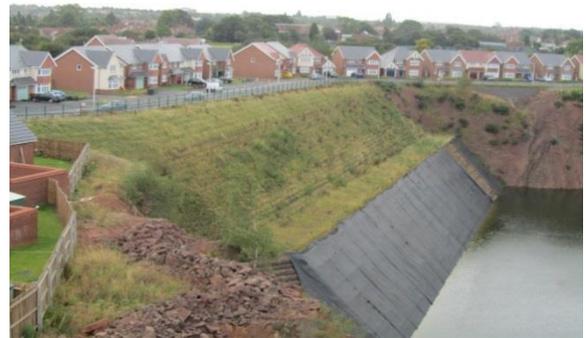
Figure 2. GRS wall after vegetation

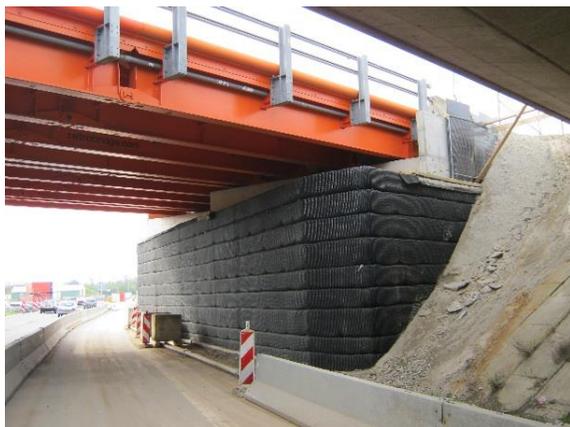
Figure 3. GRS wall as highly loaded temporary bridge abutment

GRS walls are also more commonly applied as bridge abutments (Figure 3). By the use of GRS walls, the construction of a bridge abutment can be done much faster by the use of light construction vehicles and in many cases with local fill material. Due to the high sensitivity of bridges regarding deformation, such as settlements of the abutment or tilting of the sill beam, real scale tests had been performed, to analyze and check the load bearing behavior. The load from the bridge is transferred to the bridge abutment via the sill beam, which has a limited width of 2 to 3 m located very close to the facing of the GRS wall.

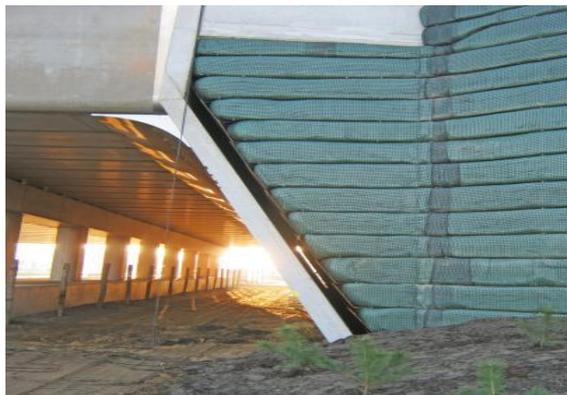
Figure 7. Executed overstep GRS Wall in the function as bridge approach and earth pressure relief to protect slender concrete wing walls of an ecoduct

Instead of strengthening the inclined side walls of the reinforced concrete frame, which would have been quite complex, an overstep geogrid reinforced soil wall was planned and constructed on either side of the concrete frame (Figure 7). The intention of the construction of the overstep geogrid reinforced soil structures was to eliminate the earth pressure from the inclined side walls by leaving a gap of about 20 cm between the facing of the reinforced soil structure and the inclined side walls. The reinforced soil structure acts as a “total earth pressure relief structure”.

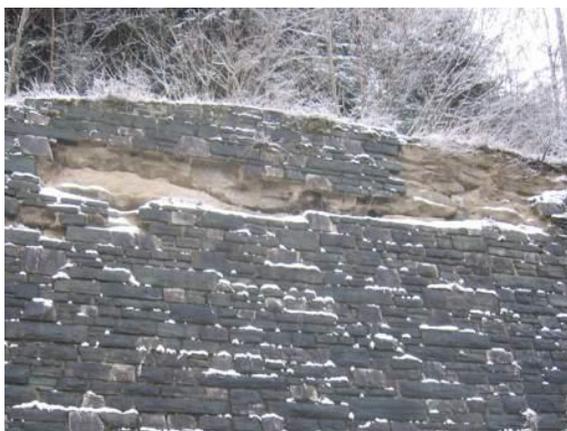
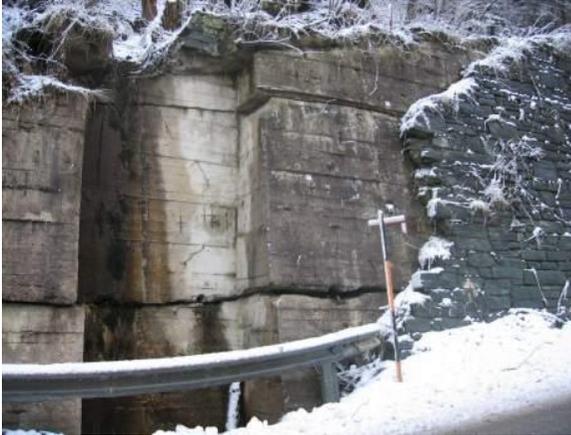
Figure 9. Damage to retaining walls along "old" route

Until recently, the damage caused to retaining structures, slope bridges and the pavement construction by creep movements in the slope necessitated major rehabilitation at regular intervals. Despite this, the condition of the road section continued to worsen noticeably: the pavement surfacing and lateral retaining walls exhibited substantial cracking. In places, this even led to the detachment of retaining wall facings or the destruction of rock bolts/anchor heads (Figure 9). Apart from the risks posed by localized problem areas, even the possibility of

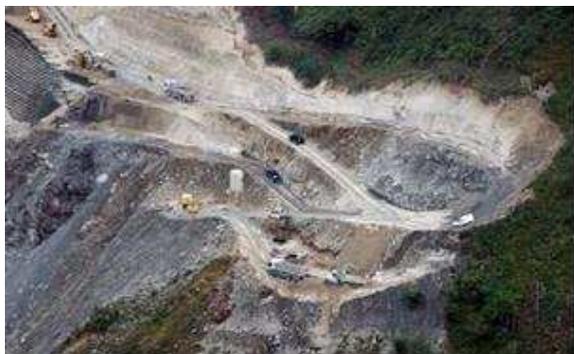
Figure 11. Haul roads

Most of the works were performed in extremely difficult, steep terrain. The haul roads had to be built with very tight widths, steep gradients and small curve radii (Figure 11). Every

effort was therefore made to maximize efficiency in the complex process of transporting soil and materials. The flexibility of the specified geogrid product (Fortrac®) played a key role in simplifying transportation. The geogrids were cut to size, folded and palletized at a central location on the basis of detailed placement plans. This allowed problem-free movement of the geogrids along the narrow haul roads to the work location.

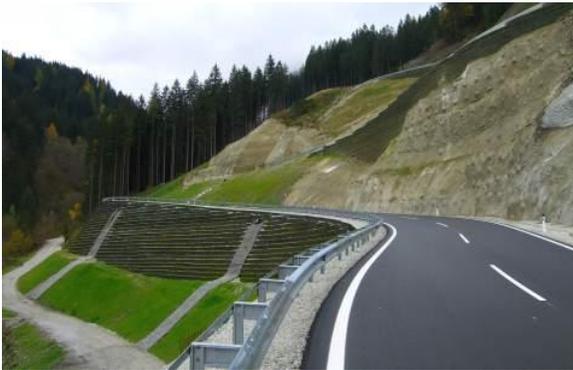
Figure 14. Constructed GRS walls
