Contamination of made grounds

Krzysztof Traczyński

Geotest Sp. z o.o. / Warsaw University of Technology, Poland

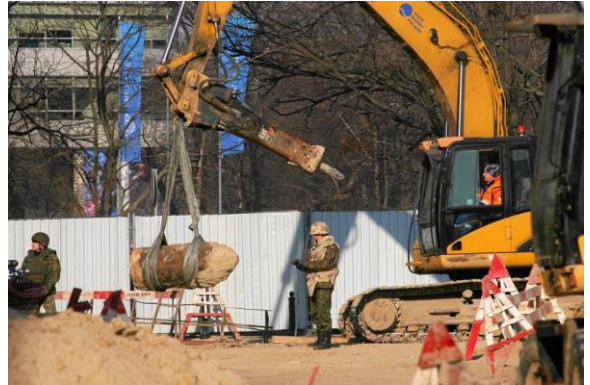
Figure 1. Karl missile discovered in the excavation

Although 74 years have passed since the end of the war, we can still find the effects of the war efforts. In 2012, during the construction of the second metro line in Warsaw, a 2-tonne Karl missile was excavated in the city centre at a depth of 6.0 metres. Fortunately, it was safely taken out of the city and disarmed.

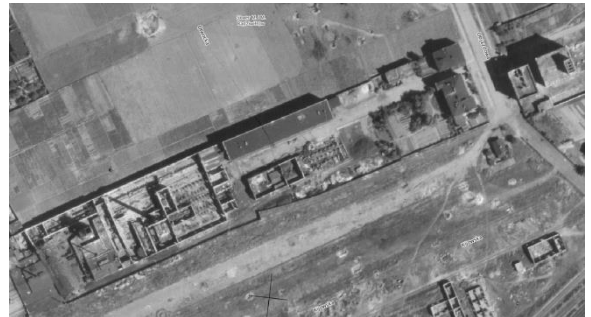
Figure 6. Objazdowa Street in 1945

factory created by the Belgian Joint Stock Company of the Warsaw Wire, Sticks and Nails Factory. During the war, the factory was destroyed in 60 percent. Post-war photographs show the destroyed buildings and bomb craters. The factory was rebuilt, and production restarted. Over the years, the factory stopped working and the whole area was used for housing construction.

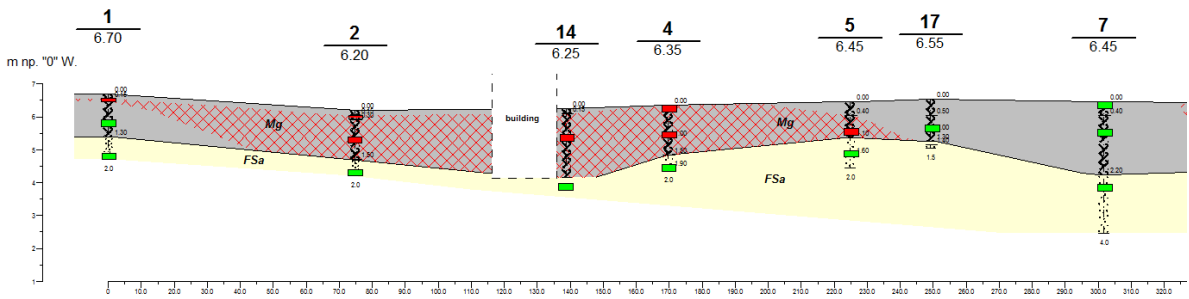
Figure 8. Cross-section at Objazdowa Street

The purchaser of the plot of land has carried out sozological research. In accordance with the new regulations from 2016, the area was divided into sections, and samples were taken from each section, with special attention paid to anthropogenic soils. In the area of 4.1 ha, a large part of which was covered with old factory buildings, 44 samples were taken, of which 11 were surface samples and 33 plunge samples. The anthropogenic land on the plot reached

the depth of 1.60 - 2.30 m below ground level. The samples were mainly contaminated with cadmium, lead, barium and arsenic. Samples taken from loose soil were polluted. Only one sample of native soil was characterized by values higher than acceptable. Detailed research made it possible to determine the areas of land intended for remediation. The amount of contaminated soil was estimated at 22.6 thousand tons^[3].
