# Remediation measures for motorway bridge piers damaged by rock sliding in the Republic of Kosovo

**ABSTRACT:** The rock sliding occurred in the Republic of Kosovo, in February 2017, on the part of motorway under construction. Landslide mass, in the area of 0.9 ha, came down the slope above viaduct piers in construction and pushed on them. The immediate result was the tilting and structural failure of viaduct's pier. Following the event, extensive soil investigation works were carried out and remediation were proposed. Rock slide happened on mountain section, where terrain is composed of tectonically crushed gneiss rock and weakly bound and unbound deluvial sediments and colluvium masses. Accepted solution included removing damaged piers and construction of new ones, with protection, retaining structures, which would resist sliding mass and protect piers from its influence (Szavits-Nossan, 2009). In designing, 2D geotechnical and 3D structural models were used to predict behaviour of arch shaped retaining structures. Designing was supported with monitoring from site and the works successfully continued.

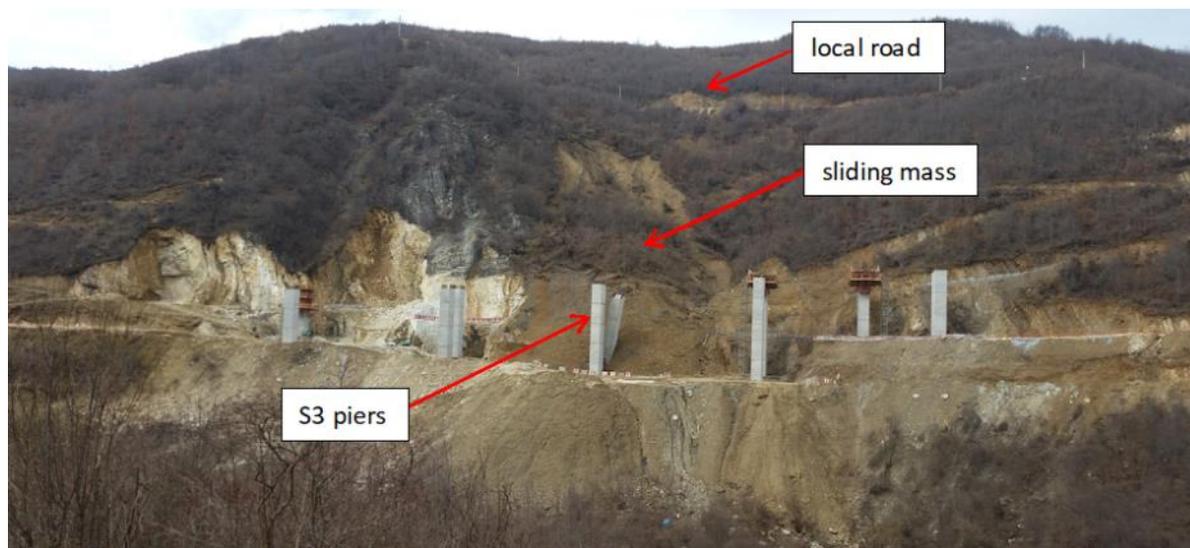
Figure 1. View on the landslide above piers S3 of the viaduct B055 from the opposite hill

Landslide occurred on 07.02.2017, when the sliding mass moved down on the excavation cut for the foundation, pressed the piers and caused the tilting of pier S3D (see Figure 1 and 2).

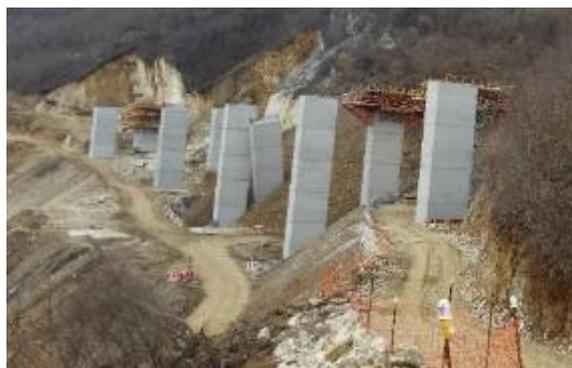
Examination after the accident indicated that concrete pier closer to slope cracked at the level of foundation slab due to pressure of the sliding mass.

Figure 2. Landslide mass causing structural failure and tilting of viaduct's pier

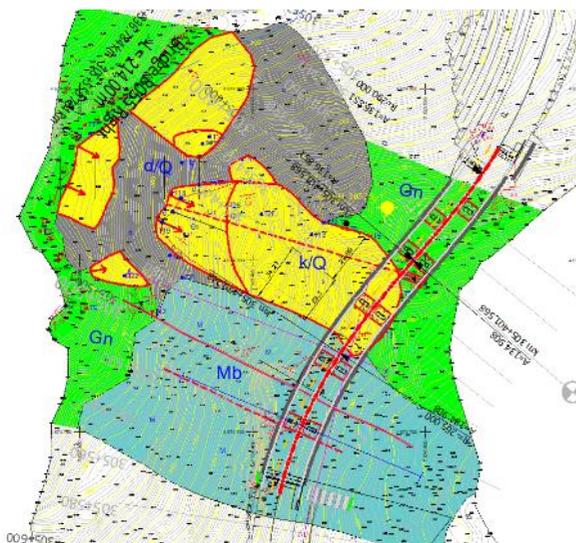
Based on the engineering-geological mapping and existing borehole and geophysical data, the landslide area is composed of intact rock: gneiss (Gn) and marble (Mb), overlain by weakly bound and un-bound deluvial sediments (d/Q) and colluvium masses (k/Q) (see Figures 3 and 4).

Figure 3. Geological Mapping following Landslide

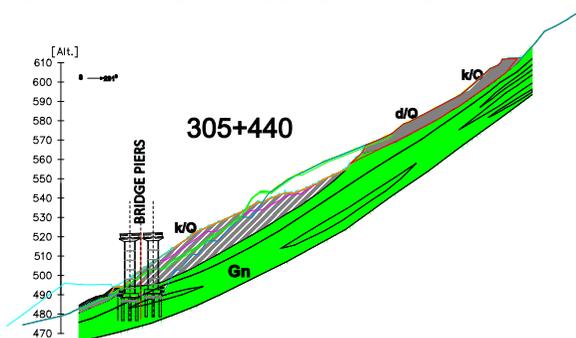
Figure 4. Geological Cross-section of landslide on S3 pier position

Dominant reason for the sliding is the increased saturation of deluvial sediments by intense precipitation and snow melting, as well as

the lack of appropriate slope protection during excavation. Other factors that had impact on sliding are the morphology of the terrain (steep slope), the existence of unfavourable discontinuities (cracks), with a drop identical or close to the fall of the slope and the presence of decomposed gneiss to the north of the landslide (Milanovski, M. 2018).

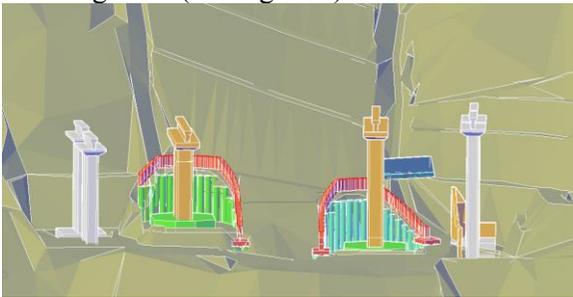
Figure 5. Protection walls R3\_1 and R3\_2 for new piers (3D View)

New piers were to be protected with protection wall / retaining structure (RC wall on piles) constructed at the side and above the piers in a semi-circular configuration. In that way sliding mass is left in the current (stable) state, while allowing any potential future slide to pass between the proposed new piers, without affecting them (see Figure 5)

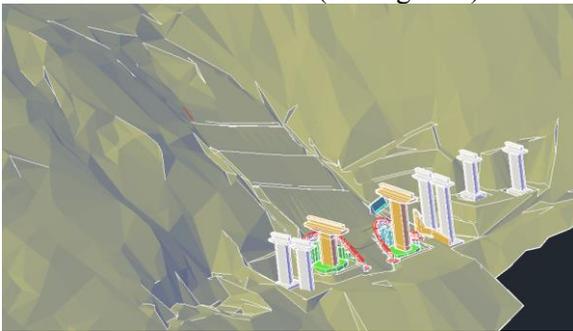
Figure 6. Re-profiling of slid mass (3D View)

The final solution adopted re-profiling of slid debris with several drainage measures within and above the slide, mitigation measures for adjacent pier S2 and mitigation measures on local road above landslide (see Figure 6).

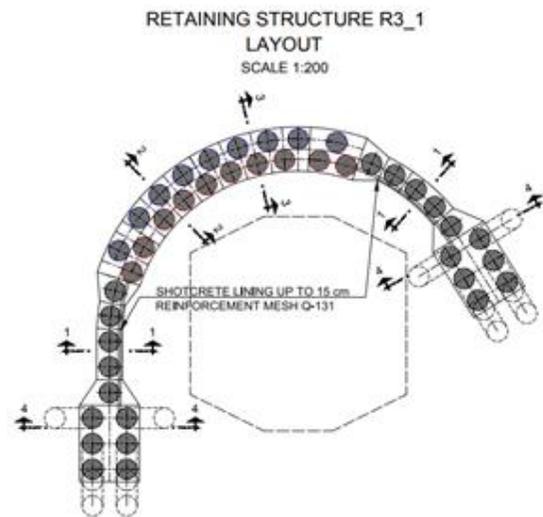
Figure 7. Protection Pile layout for S3\_1 retaining structure

Retaining structures R3\_1 and R3\_2 consist of vertical and inclined bored concrete piles in the diameter  $d=120$  cm, placed in one and two rows on different heights to create retaining structure

for excavation for new viaduct piers. Inclined piles (inclination  $5^\circ$  to vertical axis), positioned at the toe of the structure (arch), provide lateral stability. On the left side of retaining structure R3\_2, where piles enter marble rock material, transfer of structure loads is ensured by concrete foundation block. Two rows of piles are placed at the crown of the arch in order to resist large bending moments. Face of the pile wall is to be lined with shotcrete in the thickness from 10-15 cm, in order to prevent fall off the material.

Piles are connected together by concrete capping beam. Capping beam follows the contour of the terrain and is providing the load transfer in the arch form towards toe of the arch.

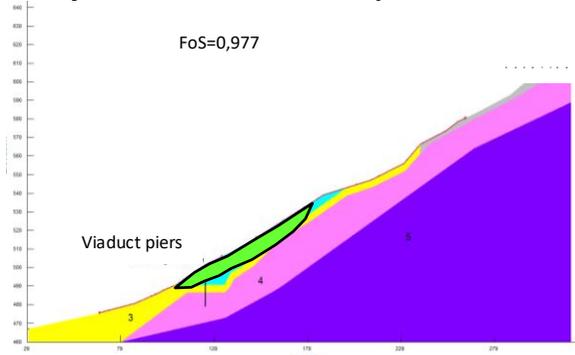
Stability calculation analysis where carried out in Geostudio/Slope 2D, on current landslide situation to check on global stability and establish strength parameters of sliding mass for further calculations (see Figure 8).

Figure 8. Establishing FoS  $\sim 1,0$  for state after landslide

Pore pressures which appear as natural seepage process were not detected during investigation works and in the inconsistent rock/soil materials are difficult to determine. In the analysis Ru values were selected as  $Ru=0,1 \div 0,2$  for deluvium and highly weathered and disturbed rock mass, and for deeper layers, more compacted and less disturbed rock mass as  $Ru=0 \div 0,1$ .

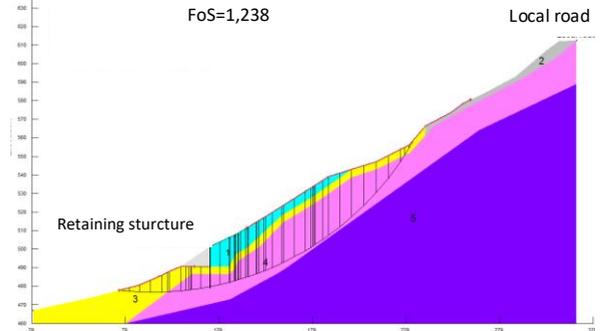
For design situation where retaining structure protects piers from sliding mass influence, satisfactory factors of safety were reached, both in static and pseudo-dynamic analyses (seismic).

Figure 9. Global stability analyses for designed state

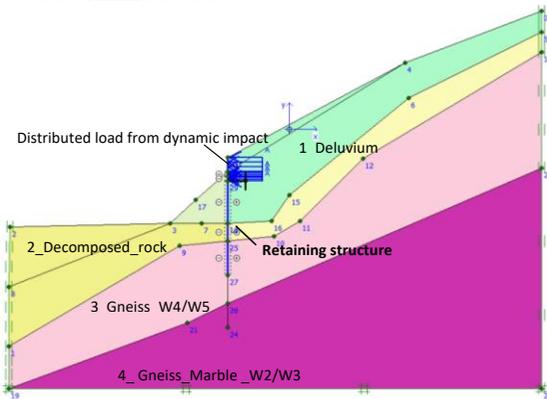
The main objective in stress-strain 2D calculation Plaxis models was to obtain forces - total normal stress (earth pressures at failure state on c/fi reduction analyses), which act on retaining structure from the foundation level to the top of the wall. In the c/fi reduction analysis approach the cohesion and the tangent of the friction angle are reduced in a step-by-step procedure until failure occurs (non-convergence of calculation). The reduction of strength parameters is controlled by the total multiplier  $\Sigma Msf$ . The safety factor is then defined as the value of  $\Sigma Msf$  at failure (see Figure 10).

For calculation purposes, three calculation 2D models were made on each retaining structure, respectful of position in retaining structure (excavation height 14 m, 11 m and 8 m), as an input for 3D analyses.

Figure 9. Plaxis model of retaining structure

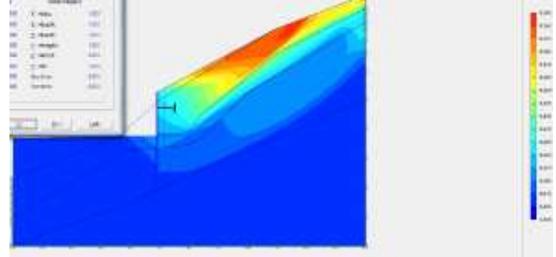
In critical design situation ( $\phi/c$  reduction) resulting pressures develop at failure state of soil pressing on the structure. Pressures acting on

retaining structure, obtained in  $\phi/c$  reduction, are bigger than the lateral earth pressure at rest  $k_0$  or active earth Rankine pressures  $k_A$  and are getting closer to passive earth Rankine pressures  $k_p$ .

Figure 10. Plaxis model - deformation at critical state

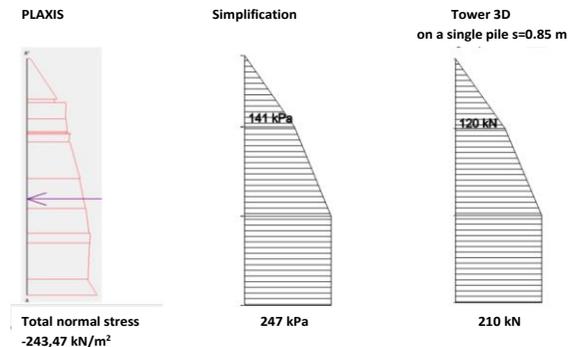
For further structural analysis total normal pressures from design situations have been simplified and adjusted to fit load curve from Plaxis calculation (see figure 11).

Figure 11. Example of pressure simplification for 3D model input

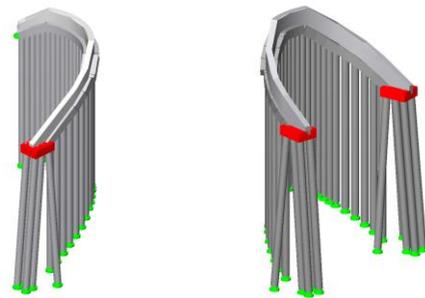
Figure 12. Structural 3D model of retaining structures Retaining structures R3\_1 and R3\_2 were modelled in 3D structural program (see figure 12).

Total normal stresses are input data for static analysis. Behaviour of the structure is monitored through various load cases (see Table 1).

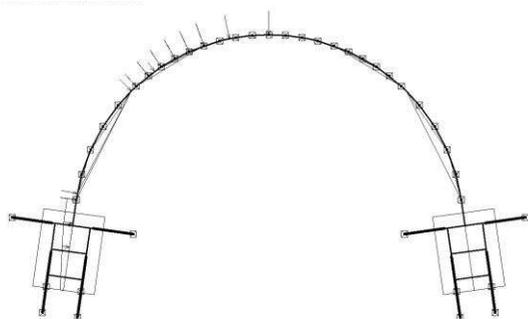
Figure 13. Asymmetrical loading scheme (LC2)

Different loading schemes enabled insight into deformations and internal forces, in cases when sliding mass acts on structure asymmetrically. Also, transfer of loads through arching effect was proven (see Figure 14).

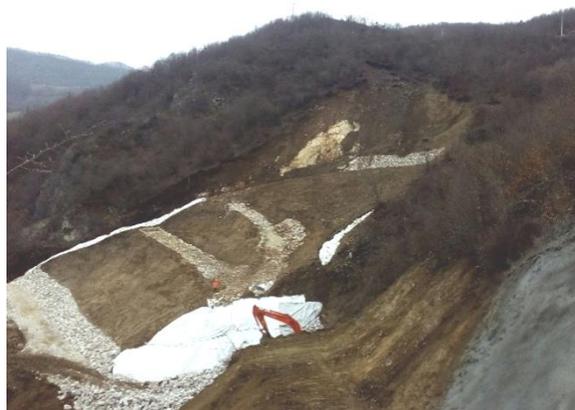
Figure 15. Reshaping and drainage works on landslide

Remediation works started in the autumn of 2017, with reshaping of sliding mass and installation of drainage channels (see Figure 15).

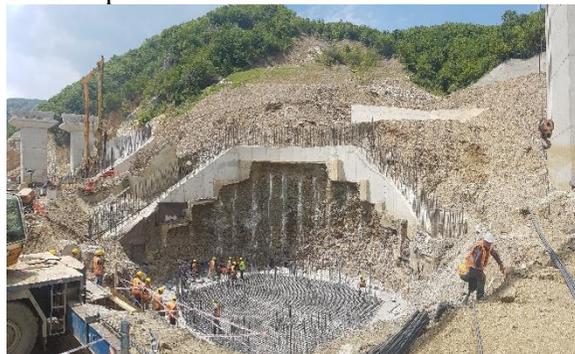
Figure 16. Excavation under retaining structure for new pier construction

After partial removing of damaged piers, piling of retaining structures proceeded. Capping beam on top of piles was constructed, connecting piles within the structure into arch form which can take soil pressures. At that point, excavation for new piers could be done.

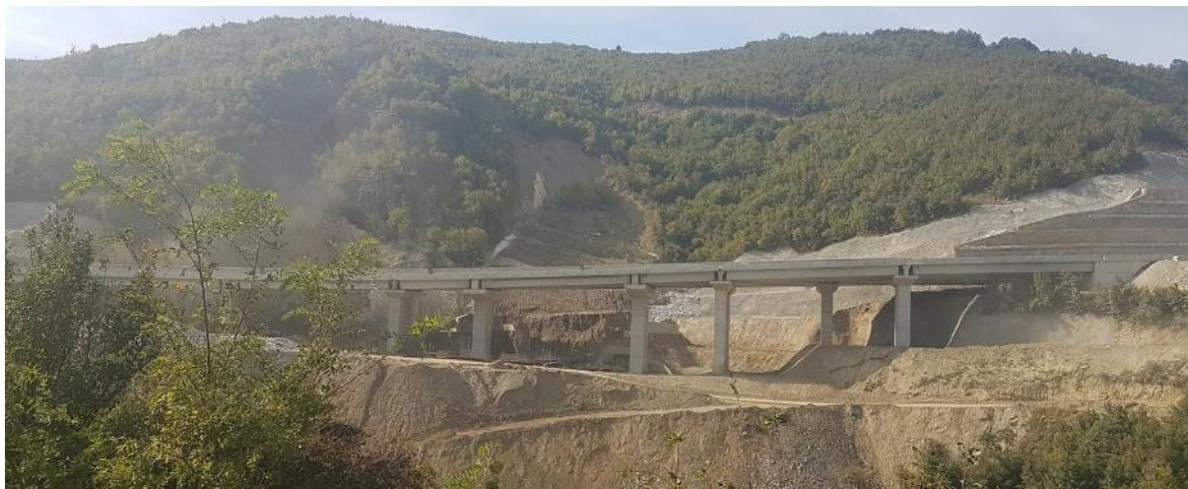
Figure 17. Viaduct B055 under reshaped landslide in final construction stage (November 2018)

New piers for viaduct were successfully constructed and span was placed.
