Impact of operation of hydropower reservoir on slope stability. Comparison between manual and automatic inclinometers.

Ani Xhagolli - Kosho
Statkraft/ Albania

Thomas Schönborn
Statkraft/ Norway

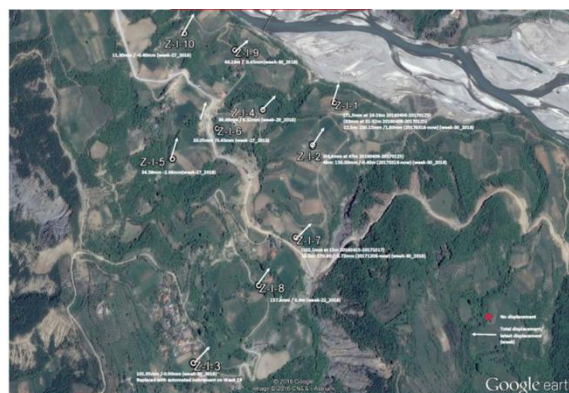
Figure 1. Location of Inclinometers and Piezometers

During the Detail Design phase of the Banja HPP it was detected that there are areas around the reservoir which are actively creeping. In order to monitor these area, as monitoring system was implemented. As a results, there were installed 14 Inclinometers, 17 Piezometers and 48 Surface markers installed at at the Banja Dam. At the other active creeping area of Zgjupe, 10 Inclinometers, 10 Piezometers and 51 Surface markers were installed. This paper will focus on the active area of Zgjupe and the impact on dam operation.
