*The paper was published in the proceedings of the 17<sup>th</sup> African Regional Conference on Soil Mechanics and Geotechnical Engineering and was edited by Prof. Sw Jacobsz. The conference was held in Cape Town, South Africa, on October 07-09 2019.*

# Flexible slope stabilization in Cowichan bay, BC – using a high-tensile steel mesh to stabilize a steep eroding soil slope

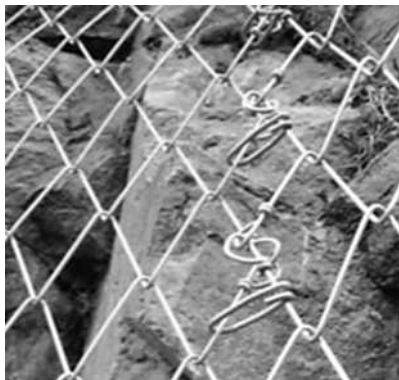
Figure 3. T3 Clip used to connect TECCO® panels vertically in rock (left) and in soil application (right).

TECCO® systems utilize T3 connection clips to allow for 100% force transmission at the seams and the system therefore has no weak links (Fig. 3).

The T3 clip is made from the same high-tensile steel wire and the same corrosion protection as the TECCO® itself. The connection clip has a wire diameter of 4 mm and has two reversed end hooks on the one side of the clamp. It can easily and quickly be installed by hand without any power tools. No overlap of the mesh is required saving significant materials and can be connected longitudinally and laterally with only 1 clip per diamond.

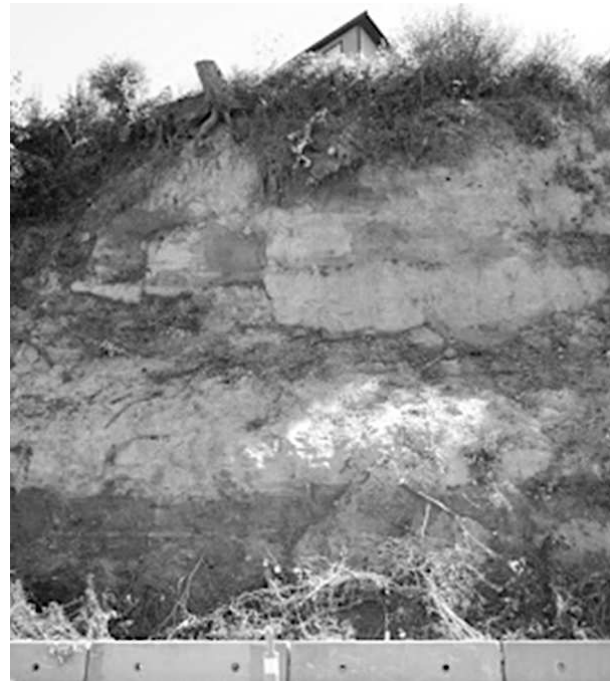
Figure 8. Roots and granular soils at the crest.

When shaping, the major focus was a root mass at the crest of the slope directly above the highest and steepest area of sloughing (Fig. 8). It was decided to cut the trees as close to the ground as possible, such that the stumps could be covered by the erosion mat and tensioned into the slope by the mesh.

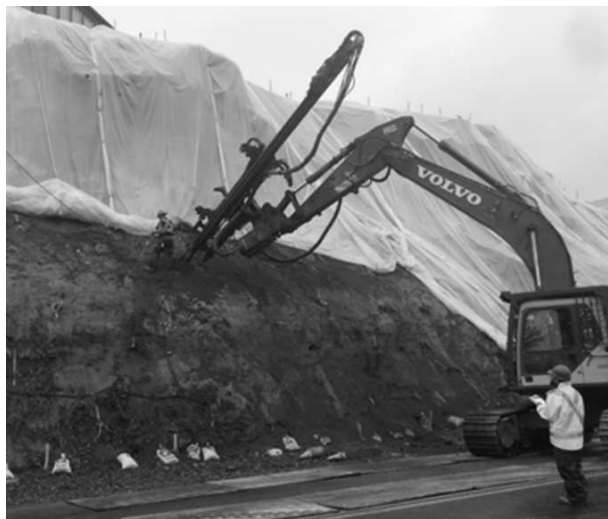
Figure 9. Installation of soil nails with excavator.

Following successful performance tests (as outlined in PTI Recommendation for Prestressed Rock and Soil Anchors 2004), two drills mounted on a zoom boom and an excavator were used (see Fig. 9). The thread bar installation and grouting was performed using a man-lift.
