The paper was published in the proceedings of the 17th African Regional Conference on Soil Mechanics and Geotechnical Engineering and was edited by Prof. Sw Jacobsz. The conference was held in Cape Town, South Africa, on October 07-09 2019.

Flood damage repair to Mambedi lower dam spillway

P. Gouws

PG Consulting Engineers, Johannesburg, South Africa

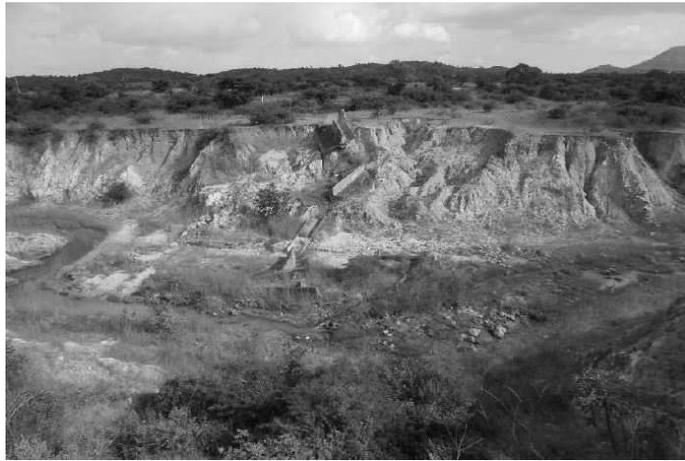
During the floods of February 2000 "mother nature" created an extensive "donga" through the spillway with approximate dimensions of 60m width and 20m depth due to no rock foundation and highly erodible soils. The challenge was to provide a suitable spillway wall and spillway channel with adequate protection to accommodate the RMF as prescribed by the SANCOLD Guidelines.

Figure 1. View of donga at old spillway section

For the repair of the damaged spillway, the existing embankment wall, which was still intact, had to be re-aligned to join the new spillway wall.

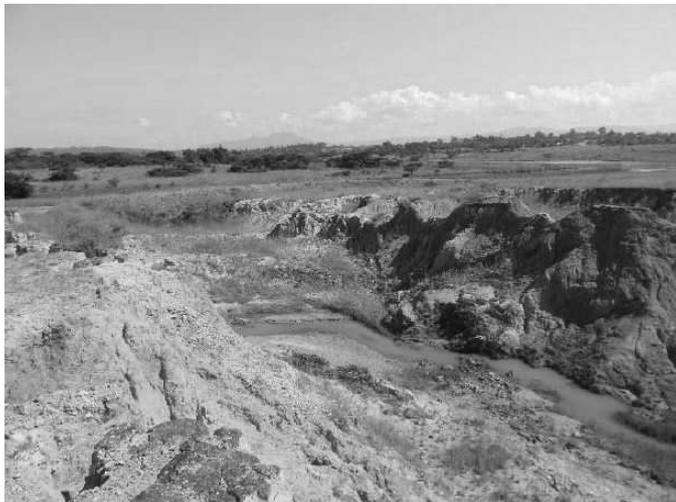
Figure 2. Upstream view of donga

In the case of Mambedi lower dam, the downstream donga had been formed by progressive erosion due to constant water run-off on the banks as well as the stream bed amplified by the dispersive nature of the insitu soil. The chosen downstream solution at Mambedi lower dam required the ability to provide adequate shear resistance to reduce rainfall impact, runoff and scour together with a formalization of the banks using a retaining structure. Thus, the chosen solutions required the provision of short term as well as long term stability.

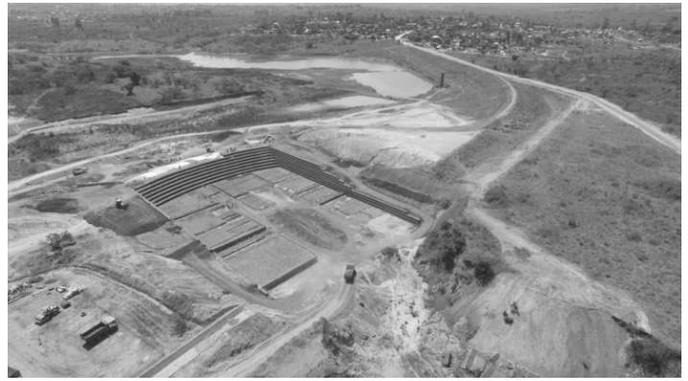
A new embankment wall had to be provided on the right bank, as an extension to the main wall. It was also decided to construct the new embankment walls with the same crest level as the original wall, thus incorporating Phase 2 as well.

In addition to the above, cut-off zones had to be provided and constructed to lengthen the seepage path during full supply state. These cut-off zones had to be taken to a depth of approximately 4-5m to an impermeable strata. The upstream slopes were designed as 1 in 3 and downstream slopes as 1 in 2, for normal

dam engineering standards. The spillway wall located between the new embankments also had to be provided with a cut-off zone with a depth of approximately 6m, to an impermeable medium. The slopes were designed to suit Maccaferri's requirements. Material for the construction of the new embankments, cut-off zones and spillway wall, were sourced from within the dam basin. This represents the same material which was used to construct the existing main embankment. Material from the eroded spillway channel could mainly not be used due to the dispersive nature and had to be spoiled. This caused an additional cost on the project, not budgeted for. Sand for backfilling behind the Terramesh walls had to be imported from the nearby river, at additional expense.

Figure 3. General arrangement of new spillway structure.

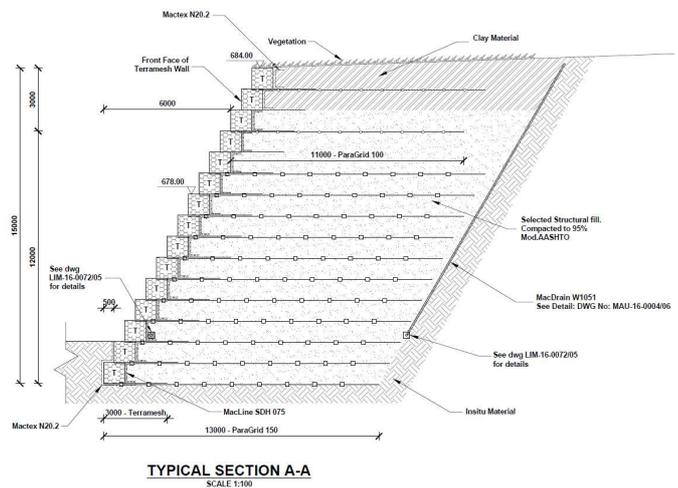
In addition to the standard designs, a subsoil drain was constructed behind the reinforced fill to maintain dry conditions within the fill. To limit the ingress of water into the fill from the channel side (face of the Terramesh wall), a geomembrane liner was installed directly behind the stone facing of the Terramesh walls as indicated on the typical section a-a in Figure 6.

Figure 6. Typical section A-A.

With the above input values, given geometry and requirements from MACRA 2, the Terramesh walls were designed according to BS 8006:2012 to produce safe designs. Checks carried out using Macstars 4.0 included internal stability checks, global stability checks, sliding checks, overturning checks and bearing checks. Using the Macstars 4.0 software, 3 sections of up to 15m high were designed in rapid draw down conditions, which provided satisfactory results in terms of safety and cost.
