The paper was published in the proceedings of the 17th African Regional Conference on Soil Mechanics and Geotechnical Engineering and was edited by Prof. Denis Kalumba. The conference was held in Cape Town, South Africa, on October 07-09 2019.

Flood damage repair to Mambedi lower dam spillway

P. Gouws

J. De Beer

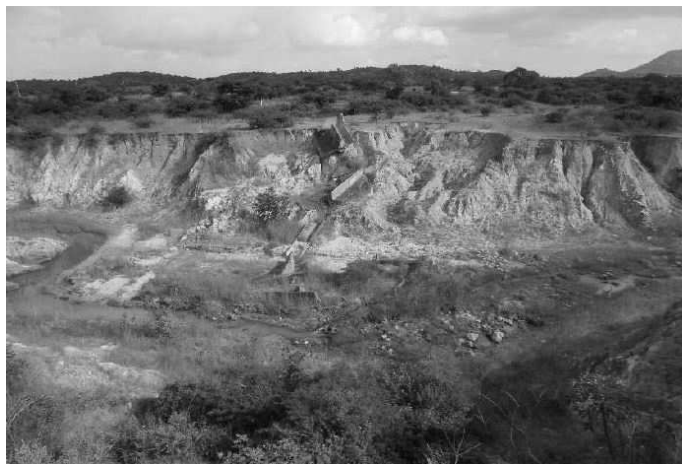
During the floods of February 2000 "mother nature" created an extensive "donga" through the spillway with approximate dimensions of 60m width and 20m depth due to no rock foundation and highly erodible soils. The challenge was to provide a suitable spillway wall and spillway channel with adequate protection to accommodate the RMF as prescribed by the SANCOLD Guidelines.

Figure 1. View of donga at old spillway section

For the repair of the damaged spillway, the existing embankment wall, which was still intact, had to be re-aligned to join the new spillway wall.

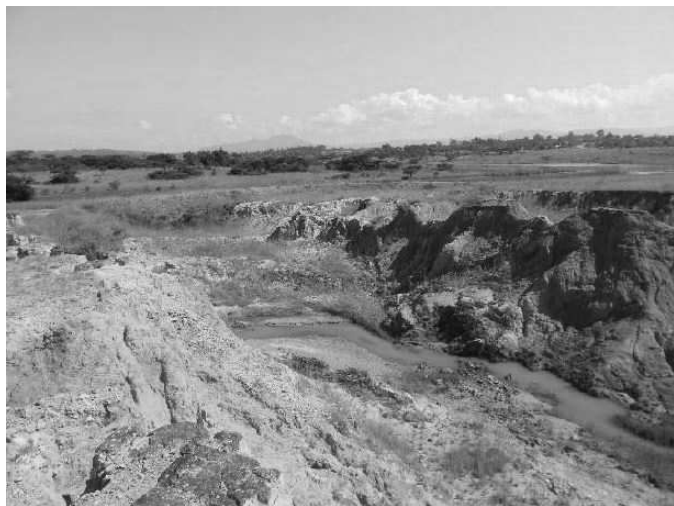
Figure 2. Upstream view of donga

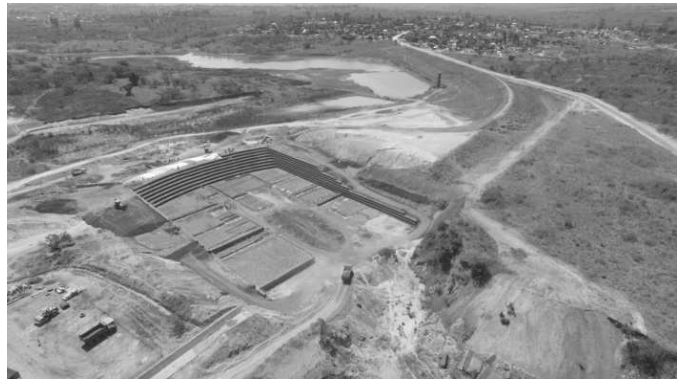
Figure 3. General arrangement of new spillway structure.

A new embankment wall had to be provided on the right bank, as an extension to the main wall. It was also decided to construct the new embankment walls with the same crest level as the original wall, thus incorporating Phase 2 as well.

In addition to the above, cut-off zones had to be provided and constructed to lengthen the seepage path during full supply state. These cut-off zones had to be taken to a depth of approximately 4-5m to an impermeable strata. The upstream slopes were designed as 1 in 3 and downstream slopes as 1 in 2, for normal

dam engineering standards. The spillway wall located between the new embankments also had to be provided with a cut-off zone with a depth of approximately 6m, to an impermeable medium. The slopes were designed to suit Maccaferri's requirements. Material for the construction of the new embankments, cut-off zones and spillway wall, were sourced from within the dam basin. This represents the same material which was used to construct the existing main embankment. Material from the eroded spillway channel could mainly not be used due to the dispersive nature and had to be spoiled. This caused an additional cost on the project, not budgeted for. Sand for backfilling behind the Terramesh walls had to be imported from the nearby river, at additional expense.
