Centrifuge modelling of post failure behaviour of a compacted sandy clay slope induced by rainfall and flood

ABSTRACT: Slope instability of engineered earthworks induced by rainfall can cause considerable damage to infrastructure, economic cost and loss of life. A small-scale physical model test was conducted using the 50gT beam centrifuge at the University of Sheffield in order to investigate the triggering and post-failure mechanisms of slope failure due to rainfall and flood events. The slope model was prepared from a sand-kaolin soil fill, compacted at optimum water content. Close range photogrammetric techniques were used to monitor slope movements and the volumetric changes of the ground during the cycles of wetting and drying as well as the changes in pore water pressure. This paper outlines the post-failure deformation of the slope and shows that movement thereafter can occur spontaneously during heavy rain, suggesting that the slope is in a metastable condition.

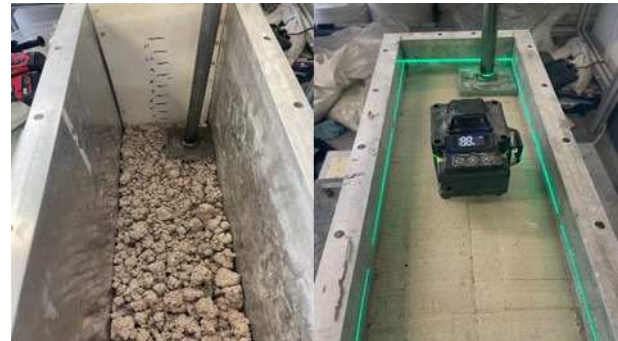
Figure 2-1 Soil preparation and compaction.

The model soil slope described here was formed by compaction, to provide realistic conditions with a slope angle of 1.5:1 (H: V), representative of typical prototype geometries and construction processes. The compaction was conducted into the centrifuge strong box payload in 30 mm thick layers and compacted equally using a steel plate attached to a vibrating machine, as shown in Figure 2-1.

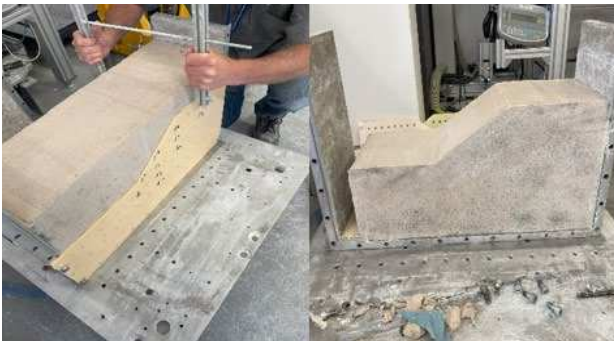
Figure 2-2 Model construction – left: template positioned before cutting compacted slope; right: slope after cutting.

For the test described here, five individual bags of soil were prepared at the optimum moisture content and left overnight to enable even water distribution before use. From these, the soil block was compacted to 98% relative density – i.e. very dense. Using side cutting templates and a wire saw, the compacted soil block was then cut to the required shape, as shown in Figure 2-2. After two days to allow the water pressures in the block to equilibrate, the test was mounted for testing on the centrifuge.

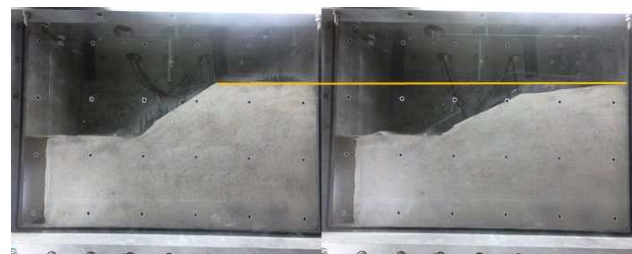
Figure 3-7 Crest settlement during auto balance phase.

The cumulative crest settlement following the auto-balance stage was 15mm, indicating possible slope instability under current climate conditions as presented in Figure 3-7.
