Simulation and numerical back analysis of the load redistribution associated with degrading anchored structures

H.-P. Daxer, G.O. Flatscher, F. Tschuchnigg, M.J. Rebhan

Graz University of Technology, Institute of Soil Mechanics, Foundation Engineering and Computational Geotechnics, Graz, Austria, daxer@tugraz.at, georg.flatscher@student.tugraz.at, franz.tschuchnigg@tugraz.at, rebhan@tugraz.at

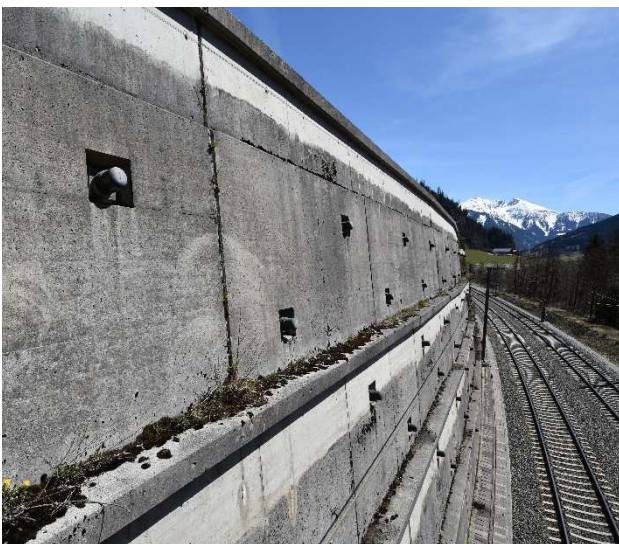
Figure 1: Anchored structure in Austria.

Anchored structures (see Figure 1) commonly serve as a cost-effective solution for permanently stabilising deep cuts or steep slopes along infrastructure routes, especially in Alpine regions. Ensuring the reliability (durability, serviceability and load-bearing capacity) of these structures throughout their service life, which may reach up to 100 years, requires regular condition assessments (FSV, 2013). However, past experiences highlight the multifaceted challenges in assessing the condition of anchored structures (e.g. Stadlbauer and Antony, 2019), affecting both geotechnical and structural engineers (e.g. Rebhan et al., 2022). Addressing the effects of damage to the ground anchors on the (remaining) load-bearing capacity is of utmost importance in this context.

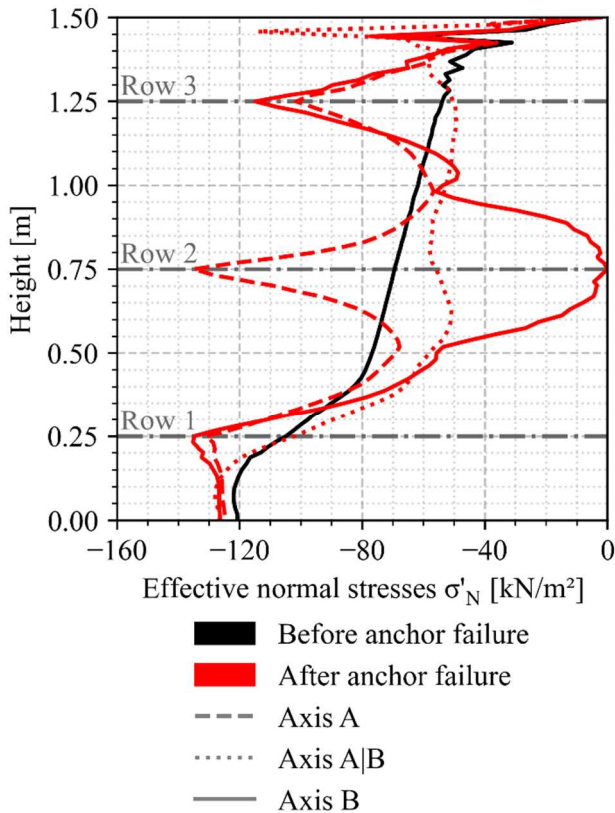
Figure 9 shows the observed earth pressure distributions over the wall height in axes A (dashed line), in the centre between A and B (denoted as A|B; dotted line) and B (solid lines).

Figure 9: Effective normal stresses σ'_N in the axes A, A|B and B.
