*The paper was published in the proceedings of the 11th International Conference on Physical Modelling in Geotechnics (ICPMG2026) and was edited by Ioannis Anastasopoulos. The conference was held from June 8th to June 12th 2026 in Zurich, Switzerland.*

# Reproducing Historical Slope Failure Processes Using a Physical Model

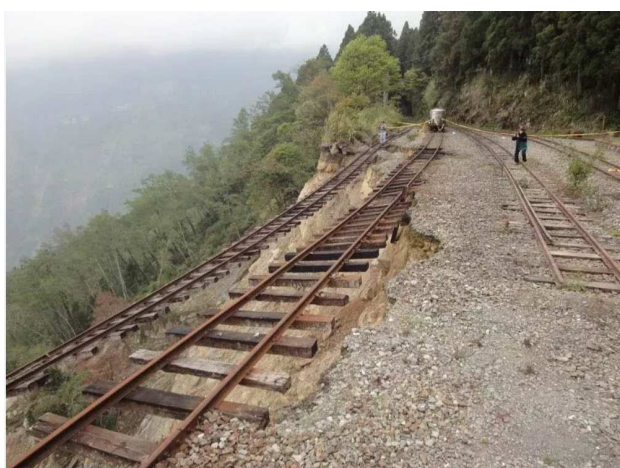
Figure 2. The scarp of the landslide that induced losses of railway foundations in Alishan Mountain.

rise in groundwater levels, generating immense pore water pressure within the slope mass. Under the combined influence of the adverse dip-slope geology and the extreme rainfall of Typhoon Morakot, a catastrophic deep-seated landslide occurred at the Erwanping site. The failure initiated as the shear strength of the saturated colluvium and the weak sandstone-shale interface deteriorated. The landslide exhibited a retrogressive failure mode, causing the slope edge near the railway station to collapse significantly. Approximately 350,000 cubic meters of soil mass slid downslope into the Erwanping Creek. The disaster severely damaged the roadbed of the Alishan Forest Railway, leaving the rails suspended in mid-air, and threatened the structural integrity of the adjacent Youth Activity Center. The collapse also severed the connection to the main external road, Provincial Highway 18. The related figures are shown in Figure 1. and 2.

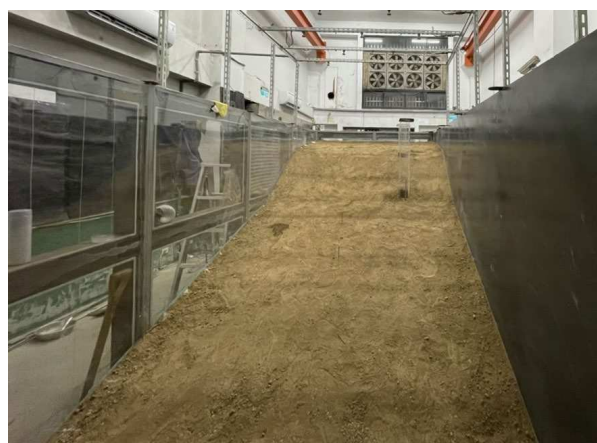
Figure 3. The front view of the tank for physical simulation.

**Large-Scale Physical Modelling Setup** To accurately replicate the failure mechanism of the Erwanping landslide, a large-scale physical model test was conducted in a rigid soil flume with dimensions of 6m (length)  $\times$  2m (width)  $\times$  3m (height). The model geometry was constructed based on a 1:500 scale of the pre-disaster topography of the Erwanping dip slope. The photo of the tank is shown in Figure 3., and the sectional profile of geological stratum and terrain is shown in Figure 4. A water showering system is installed for simulating rainfall shown as Figure 5.
