# Simulation of lateral-spread induced piled bridge abutment damage mechanism

**ABSTRACT:** The Avondale Road Bridge in Christchurch, New Zealand was extensively damaged due to liquefaction and consequent lateral spreading induced by the Canterbury earthquake sequence (2010-2011). The deck acted as a prop, forcing the abutments to rotate around the deck-abutment connection, causing extensive plastic hinging within the foundation piles and also resulted in extensive settlement in the backfill. In order to further study this observed damage mechanism, key bridge parts were modelled at 1:50 scale including piles made of damageable model reinforced concrete (RC). The soil model was modelled on the layered profile of the south abutment, where the most severe damage was manifested. The model was designed, manufactured, assembled and tested in the University of Dundee (UoD) centrifuge facility. The centrifuge test validated the observed damage mechanism, including the pinning effect of the deck, abutment rotation and backfill settlement, providing a benchmark for future testing of possible retrofit solutions.

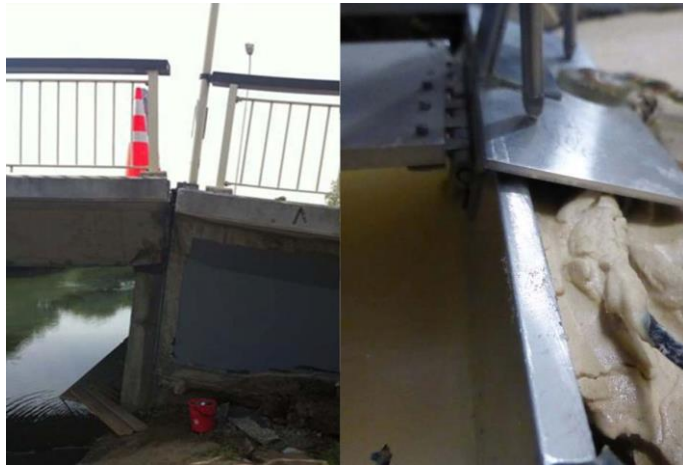
Figure 3. South abutment photographs taken after the Christchurch earthquake; field (left) and centrifuge model (right).

According to the centrifuge testing programme, the centrifuge was stopped after firing the Christchurch earthquake motion, in order to take photos and measurements of the model's rotation. This motion was the one causing the majority of the damage in the field case. The centrifuge was subsequently re-flown for the two 13 June motions before the container was removed from the gondola. The rotation was obvious in both cases, as illustrated in Figures 3

and 4. Rotation measurements were taken with a Fisco Solatronic EN17 Inclinometer at these stages, to complement the LVDT-based data. These post-flight measurements are summarized in Table 6, compared at the same time with the observed values of the field case.

The centrifuge model appeared to rotate more than the field case (Table 6) but the failure mechanism of ‘backwards abutment rotation’ with the deck acting as a prop was the same as observed in the post-earthquake field reconnaissance (Palermo et al. 2011). On excavation of the model, excessive bending and permanent deformation of the piles was also observed, as presented in Figure 5. This permanent deformation was measured with a mean value of 22 mm located at the piles’ deepest point. Plastic hinges with distinctive cracking on the tension side were formed at the connection of the piles with the abutment, while cracks were also observed at the backfill
