The paper was published in the proceedings of the 7th International Conference on Earthquake Geotechnical Engineering and was edited by Francesco Silvestri, Nicola Moraci and Susanna Antonielli. The conference was held in Rome, Italy, 17 - 20 June 2019.

Effects of the Central Italy 2016 seismic sequence on slope stability: Preliminary analysis of some major rock slides

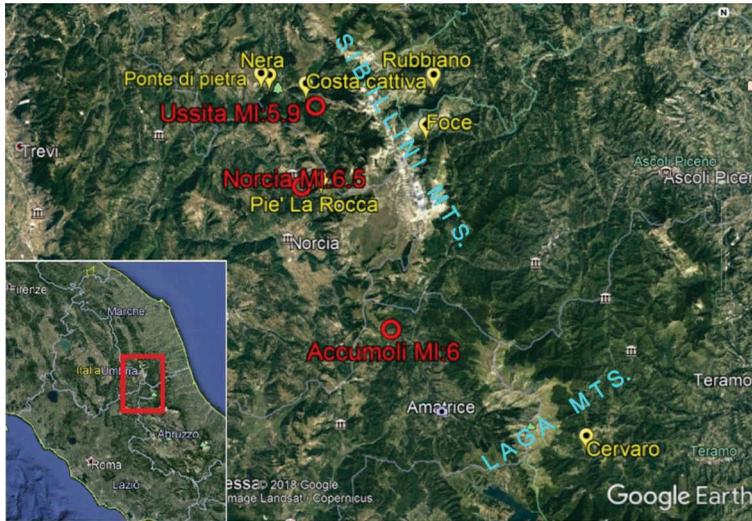
Figure 1. Epicentres of the three major 2016 earthquakes and location of the studied rock slides.

The 2016 Central Italy seismic sequence was characterized by three major shocks (Figures 1 and 2): August 24th M_w 6.0 (Accumoli, also named Amatrice earthquake), October 26th M_w 5.9 (Ussita); October 30th M_w 6.5 (Norcia). The latter is the strongest earthquake recorded after 1980 by the National Seismic Network (RAN- *Rete Accelerometrica Nazionale*).

The rock slides presented in this study are located near Visso and Norcia, as shown in Figure 1. Main features are summarized in Table 2.

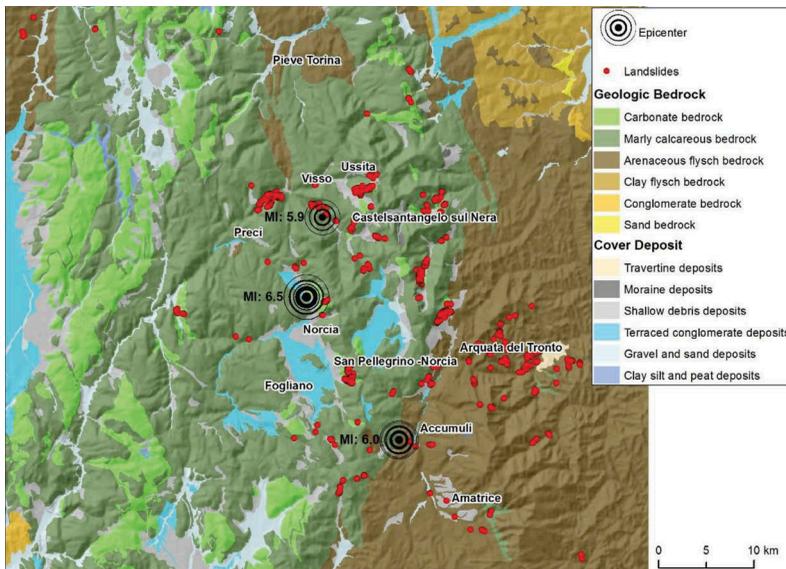
Figure 2. Geological sketch of the study area and distribution of the landslides triggered on natural slopes.

Landslides represent the main ground effects caused by the 2016-2017 seismic sequence, which triggered more than 1500 events (Figure 2), mostly rock falls. Field observations have shown that the landslides mainly affected the limestones and subordinately the sandstones of the *Laga* flysch. They occurred on high steep slopes, the edge of embankments of terraced deposits and road cuts.

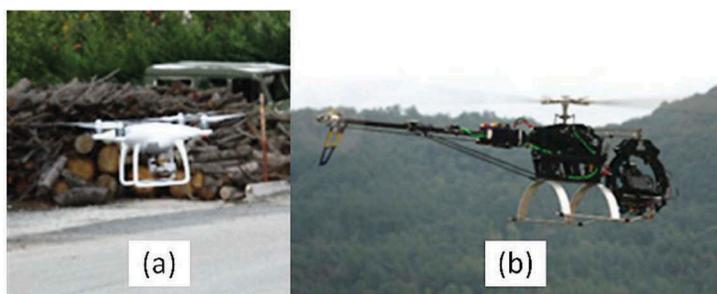
Figure 3. UAVs used for imaging of landslides during 2016 Central Italy reconnaissance

One commercial off-the-shelf (COTS) UAV platform and one modified/customized COTS UAV platform were used in imaging landslides in the Central Italy earthquake reconnaissance. These platforms are shown in Figure 3. The majority of the landslide aerial imaging was performed with the DJI™ Phantom 4 quadrotor platform (Figure 3a). The Phantom 4 is equipped with a 4K video camera that has a 1/2.3" CMOS sensor, 94-degree field of view, 12.4 MP images, and a focal length of infinity. An Align™ TRex 800e helicopter UAV platform modified and customized for aerial photography (Figure 3b) was used to image the rock fall at SR-477 due to its capability to maintain stable flight in higher velocity winds. The TRex 800e has a 3-axis nose gimbal and uses a Nikon™ D750 DSLR camera with 24 MP image resolution, 35.9x24.0 CMOS image sensor, and 35 mm fixed focal length lens.

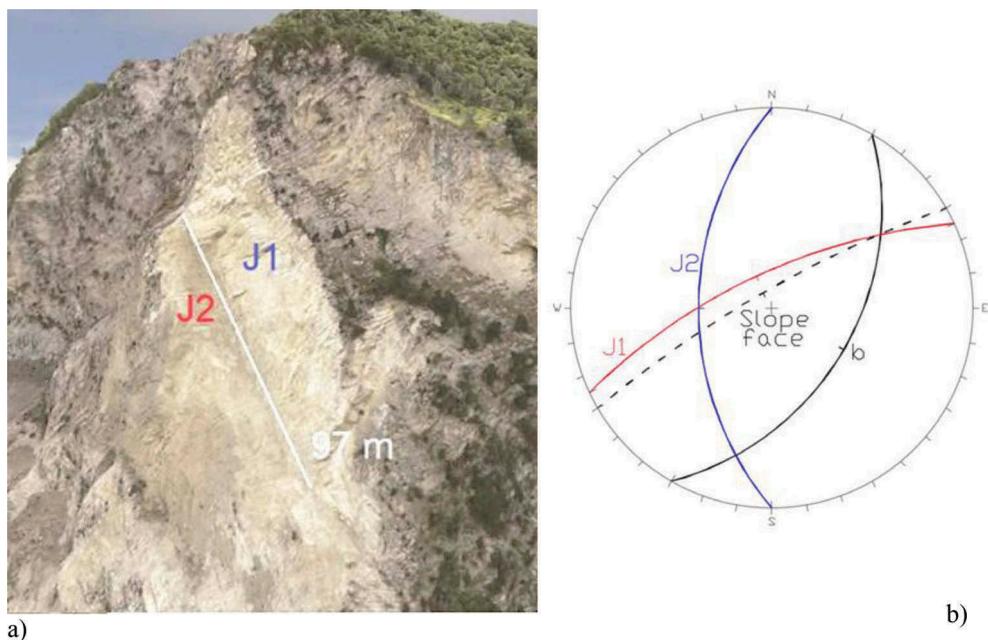
Figure 4. Frontal view from the UAV survey of the Nera rock slide (a) and stereoplot (equal-area projection) of major discontinuities (b). In figure a) the two sliding surfaces are indicated; bedding planes, b in figure (b), dipping toward the rock mass are evident in the photograph a).

The landslide is a rock wedge-slide controlled by the intersection of very persistent fault planes and joints, which evolved into a rock avalanche. Wedge geometry was determined by calculating the orientations of the sliding surfaces and reconstructing the original cliff surface from the detailed 3D model obtained from the UAV surveys. During the demolition/recovery works on the cliff, joint orientations and joint surface conditions were verified with rope access surveys supported by experienced rock climbers.

Layers are less than 1m-thick and oriented $45^{\circ}/120^{\circ}$ (dip/dip direction), i.e. dipping against the slope, whilst the sliding surfaces J1 and J2 have an average orientation of $70^{\circ}/335^{\circ}$ and $50^{\circ}/270^{\circ}$ respectively (Figure 4). Figure 4 shows also the overall orientation of the rock cliff, here schematized as a single plane to better visualize the kinematics. According to a detailed analysis of the UAV models, the rock face is actually composed by two planes belonging to the same sets of the sliding surfaces, J2 and J1, which yield an estimated wedge volume of $32,000 \text{ m}^3$. The corresponding avalanche deposit assuming the loosest debris configuration, is of $46,000 \text{ m}^3$, which is consistent with site observations (Romeo et al., 2017).

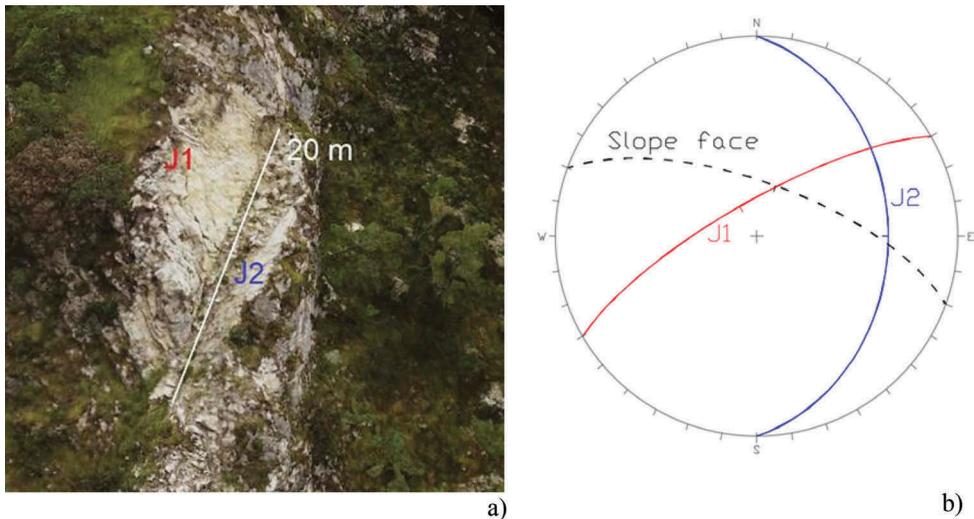
Figure 5. Frontal view from the UAV survey of the Costa Cattiva rock slide (a) and stereo-plot (equal-area projection) of major discontinuities (b). In figure a) the two sliding surfaces are indicated.

The wedge is delimited by two joints (Figure 5): J1 oriented 75°/330° and J2 oriented 35°/090°. The sliding occurred along their intersection line directed at about 50° and daylighting at low-angle from the slope.

This rock slide presents some similarities with the Nera one: in fact, the sliding planes J1 of the two wedges belong to the same set dipping toward northwest at very high angle (Figure 4b). The wedge was likely a prism, whose outer faces were formed by planes oriented as J1 and J2. Also in this case the bedding planes were not sliding surfaces, as the apparent folding would increase waviness and hence provide additional strength.

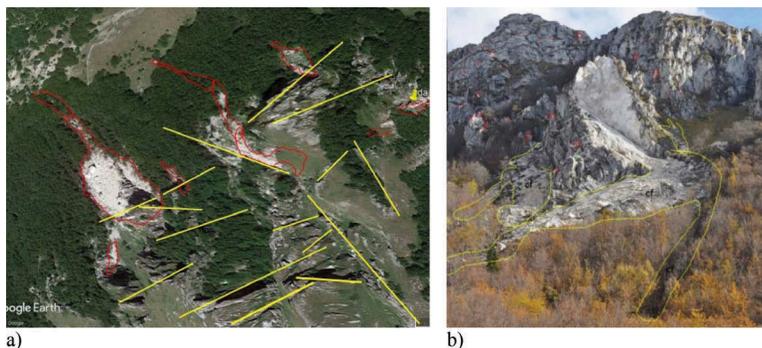
Figure 6. Google Earth image of the rock avalanches and rock falls along the northern flank of Mt. Patino, in yellow the main faults (a); frontal picture of Piè la Rocca rock slide showing the avalanche run-out (b).

On the northern slope of Mount Patino, about 5 km northeast from Norcia, close to the Piè la Rocca village, the August 24th earthquake triggered several landslides having considerable run-out (up to 400 m) They invaded some forestry roads and hiking trails in the Sibillini Mountains National Park (Figure 6a). The greatest event mobilized about 15,000 m³ of massive limestone with a wedge-sliding mechanism with a maximum height of about 25 m (Figure 6b).

After an initial planar sliding, the rock wedge, crumbled down the slope towards N knocking down large trees and fragmenting into blocks up to 1,500 m³ in volume. Some fragmented blocks, about 5-10 m³ in volume, reached the valley bottom and the hiking trail. The close range photos taken from the drone highlighted many open joints that isolate large blocks standing on the slide scar in precarious stability conditions.

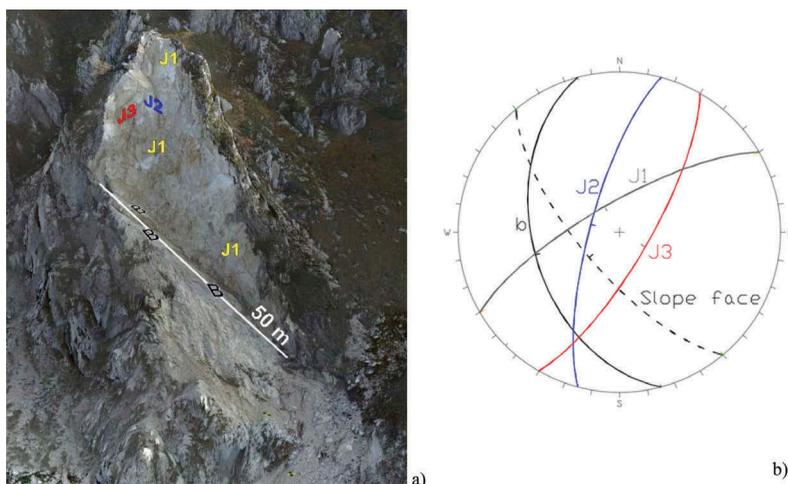
Figure 7. UAV front view of the Piè la Rocca rock slide with indication of the discontinuities delimiting the wedge (a); stereoplot (equal-angle projection) of major discontinuities (b).

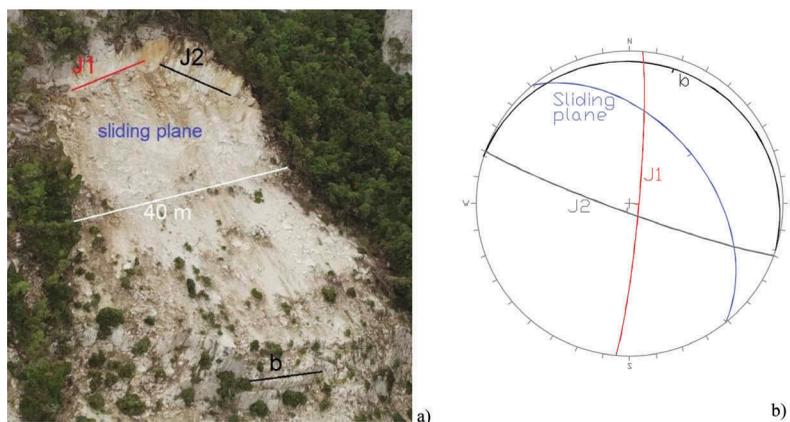
Figure 8. UAV view of the Ponte di Pietra rock slide with indication of the main joint sets (a) and stereonet (equal-area projection) of joint sets (b).

Among these, the Ponte di Pietra rock slide (Figure 8), mobilized 5,000-7,000 m³ and generated a rock avalanche with a runout of about 250 m. The slide scar is located 200 m above the valley bottom, on a steep cliff delimiting a gorge that is almost perpendicular to the Nera River (striking 110°).

The geo-structural model (Figure 8) shows the average orientation of the sliding plane that is about 50°/050°. The sliding surface, now covered by debris, is probably formed by a combination of bedding planes, oriented at about 10°/020°, and two subvertical joint sets J1 and J2, thus forming the large steps visible along the whole slope. The J2 system, oriented 85°/200°, is parallel to the gorge and is more or less orthogonal to the other, J1 oriented 85°/095°. The 40-m-wide tension crack can be regarded itself as the combination of these two systems. Rock mass folding induces local variations of the estimated bedding attitude.

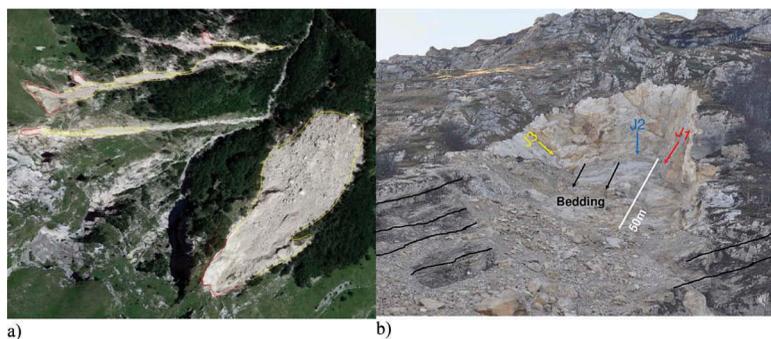
Figure 9. General view (Google Earth image) (a) and front view (b) of the Foce rock slide with indication of the main joint sets.

The 2016 earthquakes triggered many rock slides and rock falls on the flank of Mt. Bove and Mt. Vettore, formed by massive limestones (*Calcare Massiccio Fm.*). One of the largest events involved some 30,000 m³ on the flank of a glacial valley close to the village of Foce, at an elevation of 1700 m a.s.l. The main sliding surface coincided more or less with a persistent bedding joint (Figure 9). The sliding mass was delimited by three major joints: a 75°/120° oriented joint at the back (J1) and two joint J2 and J3 on the lateral sides, oriented 70°/020° and 60°/330° respectively. The landslide debris is formed by large blocks (up to 1,000 m³) that knocked down high-trunk trees and extended over an area of 30,000 m² with a runout exceeding 400 m.

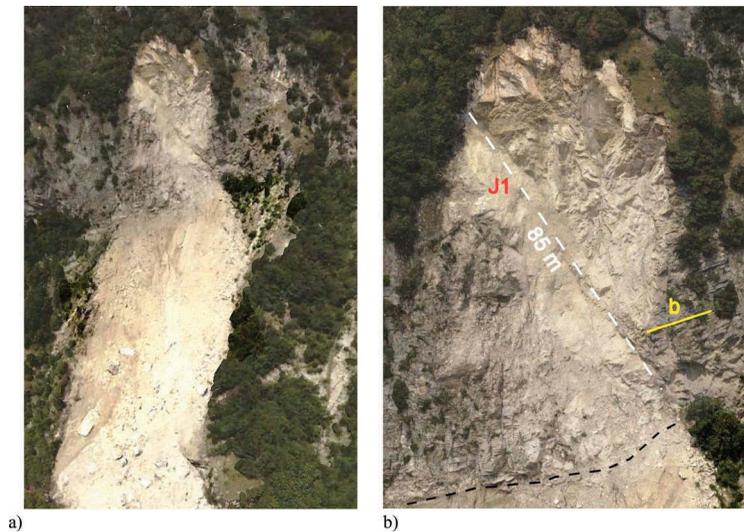
Figure 10. UAV front view of the Rubbiano rock slide (a) and indication of the sliding joint surface, J1, bedding traces, b, and thrust plane trace (dashed line at the picture bottom) (b).

The model obtained by BYU from UAV images shows again that a wedge slid along a major discontinuity (J1 in Figure 10b) oriented about 80°/070°. The back of the wedge is a

complex surface with average orientation of $60^{\circ}/270^{\circ}$, which is composed by a mosaic of joints belonging to different sets, including the J1 set as well and the bedding, here intensely folded. Several joints likely exhibit signs of tensile failure. The cliff is about $70^{\circ}/115^{\circ}$ oriented.

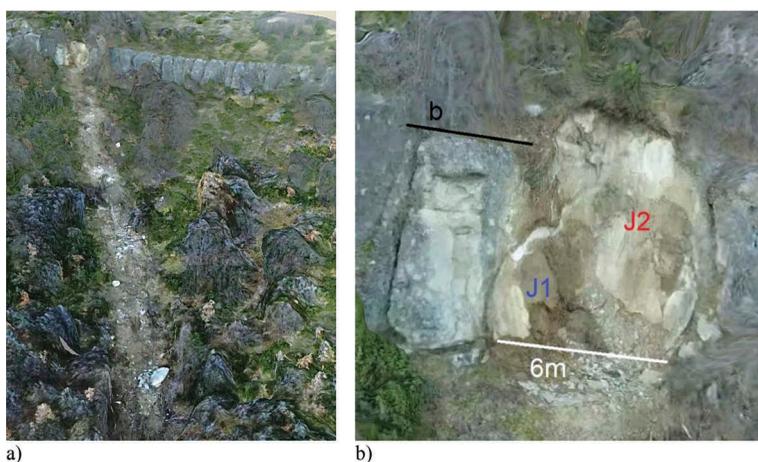
Figure 11. UAV front view of the Cervaro landslide and of the very uppermost part of the runout path (high erosional) (a); detail of the landslide scar the trace of bedding, b, and the main subvertical joint sets (J1 and J2) are indicated (b).

This rock fall is well representative of a number of events that affected the ledges formed by thick sandstone layers of the *Laga Fm.*, on top of mountain slopes of the Laga Mts., in the southernmost part of the earthquake damage area (Abruzzo region). Major events were recorded during the October 30th earthquake. At Cervaro (Figure 11a) the rock mass is

characterized by alternations of sub-horizontal or gently-dipping (some 15°) sandstone layers (up to 8 m thick) and thinner mudstone layers. Field surveys and models based on UAV imagery indicate that vertical fractures normal to the slope face (spaced up to 8-9 m) and tension cracks parallel to the slope crosscut the whole sandstone layer (Figure 11b), thus delimiting blocks tens of cubic meters in volume. The rock fall mobilized about 170 m³, with a volume of the largest detached block of 55 m³. The average size of fragmented blocks along the rock fall path (Figure 11a) was 4 m, with a maximum runout distance of 0.5 km (Franke et al., 2018).
